## Profile/Photo Observation Report

Street:	<b>Rush St.</b>	Flow Control:	<b>Not Controlled</b>
City:	<b>Hobart, IN</b>	Year Renewed:	
Location:	<b>Light Highway</b>	Tape/Media #:	
Purpose:	<b>Routine Assessment</b>	Dia/Height:	<b>10"</b>
Use:	<b>Sanitary</b>	Material:	<b>VCP</b>
Drain Area:	<b>NA</b>	Lining:	
Category:	<b>NA</b>		
Comment:

Location Details:		Direction of Survey:	<b>Upstream</b>
US MH:	<b>M-904-047</b>	DS MH:	<b>M-904-048</b>
		Total Length Surveyed (ft):	<b>35.0</b>

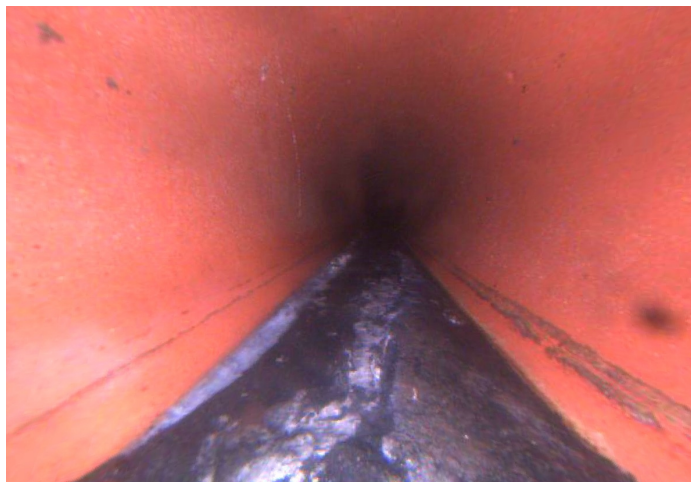
Code: **AMH**  
Description: **Manhole**

Distance (ft): **.0**  
Structural Grade: **0**  
O&M Grade: **0**  
Clock Start/From:  
Clock To:  
1st Value:  
2nd Value:  
Value Percent:  
Continuous Index:  
Within 8" of Joint: **NO**  
Remarks: **M-904-048**

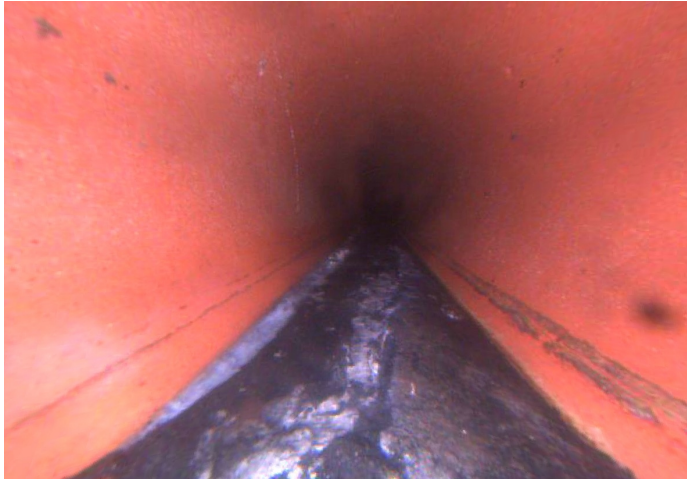
Code: **MWL**  
Description: **Water Level**

Distance (ft): **.0**  
Structural Grade: **0**  
O&M Grade: **0**  
Clock Start/From:  
Clock To:  
1st Value:  
2nd Value:  
Value Percent: **10.000**  
Continuous Index:  
Within 8" of Joint: **NO**  
Remarks:

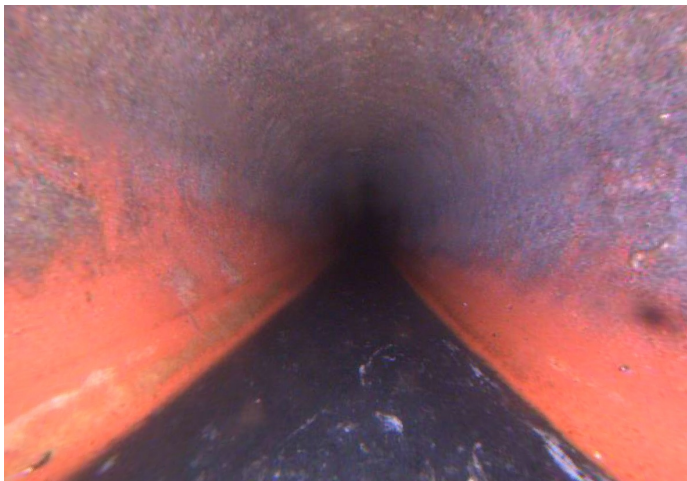
Code: **MSA**  
Description: **Abandoned Survey**

Distance (ft): **35.0**  
Structural Grade: **0**  
O&M Grade: **0**  
Clock Start/From:  
Clock To:  
1st Value:  
2nd Value:  
Value Percent:  
Continuous Index:  
Within 8" of Joint: **NO**  
Remarks: **Unknown**
