Profile/Photo Observation Report

Date:	10/05/2018	Weather:		Coding:	PACP 6.0
Pipe Length (ft):	241.6	Owner:	NA	Pre Clean:	Not Known
P.O.#:		Surveyor:	Justin Gonzales	PSR:	P-904-048-047
Customer:		Clean Date:	01/01/1900	Shape:	C

Street:	RUSH ST & HICKEY PL	Flow Control:	Not Controlled
City:	Hobart, IN	Year Renewed:	
Location:	Light Highway	Tape/Media #:	
Purpose:	Routine Assessment	Dia/Height:	10"
Use:	Sanitary	Material:	VCP
Drain Area:	NA	Lining:	
Category:	NA		
Comment:

Location Details:		Direction of Survey:	Downstream
US MH:	M-904-047	DS MH:	M-904-048
		Total Length Surveyed (ft):	237.8

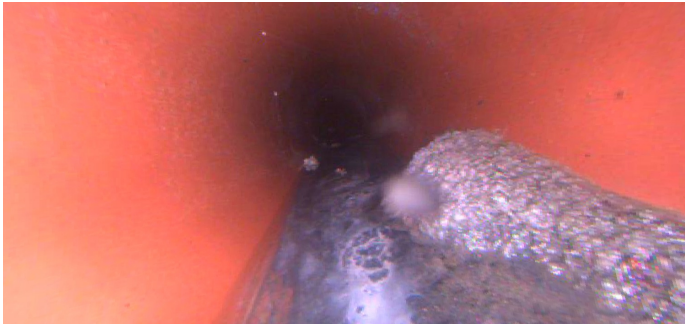
Code:	MWL
Description:	Water Level

Distance (ft):	.0
Structural Grade:	0
O&M Grade:	0
Clock Start/From:	
Clock To:	
1st Value:	
2nd Value:	
Value Percent:	10.000
Continuous Index:	
Within 8" of Joint:	NO
Remarks:

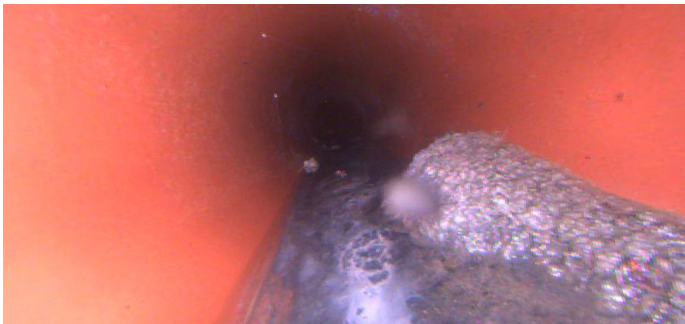
Code:	RBB
Description:	Roots Ball Barrel

Distance (ft):	.0
Structural Grade:	0
O&M Grade:	5
Clock Start/From:	4
Clock To:	5
1st Value:	
2nd Value:	
Value Percent:	55.000
Continuous Index:	
Within 8" of Joint:	NO
Remarks:

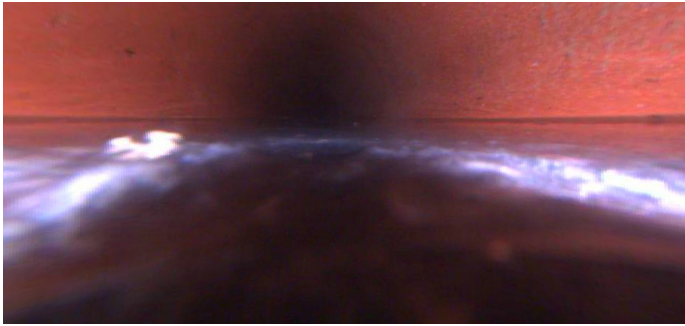
Code: **MWLS**
Description: **Water Level Sag**

Distance (ft): **45.0**
Structural Grade: **3**
O&M Grade: **3**
Clock Start/From:
Clock To:
1st Value:
2nd Value:
Value Percent: **50.000**
Continuous Index:
Within 8" of Joint: **NO**
Remarks:

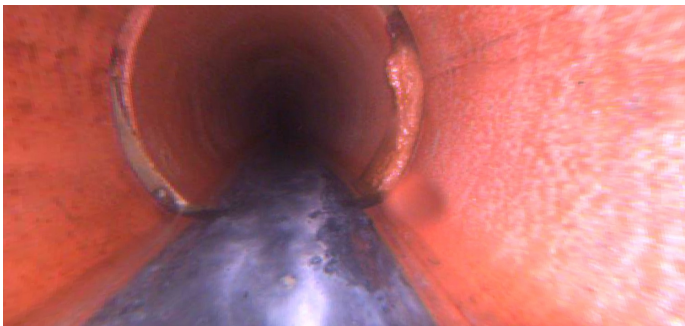
Code: **DAE**
Description: **Deposits Attached Encrustation**

Distance (ft): **88.6**
Structural Grade: **0**
O&M Grade: **2**
Clock Start/From: **3**
Clock To: **5**
1st Value:
2nd Value:
Value Percent: **5.000**
Continuous Index:
Within 8" of Joint: **YES**
Remarks:

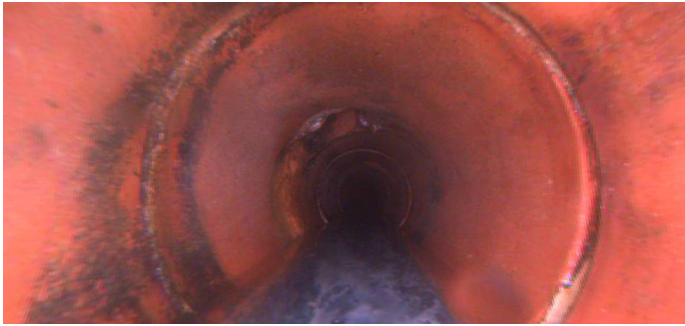
Code: **IS**
Description: **Infil Stain**

Distance (ft): **94.6**
Structural Grade: **0**
O&M Grade: **0**
Clock Start/From: **7**
Clock To: **12**
1st Value:
2nd Value:
Value Percent:
Continuous Index:
Within 8" of Joint: **YES**
Remarks:

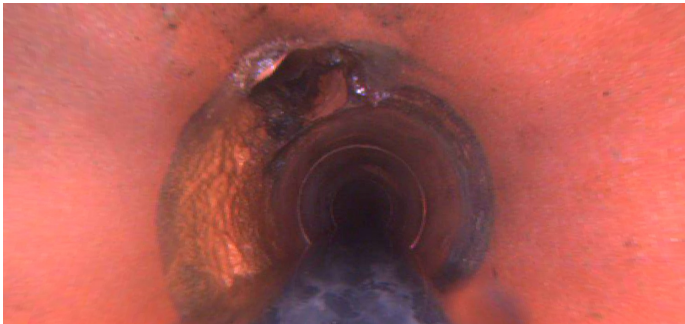
Code: **DAE**
Description: **Deposits Attached Encrustation**

Distance (ft): **95.3**
Structural Grade: **0**
O&M Grade: **2**
Clock Start/From: **7**
Clock To: **10**
1st Value:
2nd Value:
Value Percent: **5.000**
Continuous Index:
Within 8" of Joint: **NO**
Remarks:

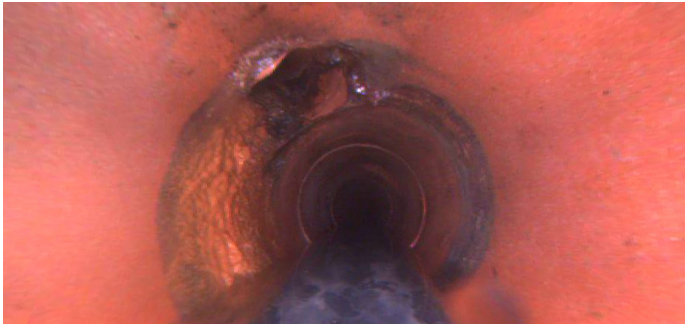
Code: **TB**
Description: **Tap Break-in**

Distance (ft): **95.3**
Structural Grade: **0**
O&M Grade: **0**
Clock Start/From: **11**
Clock To:
1st Value: **4.000**
2nd Value:
Value Percent:
Continuous Index:
Within 8" of Joint:
Remarks:

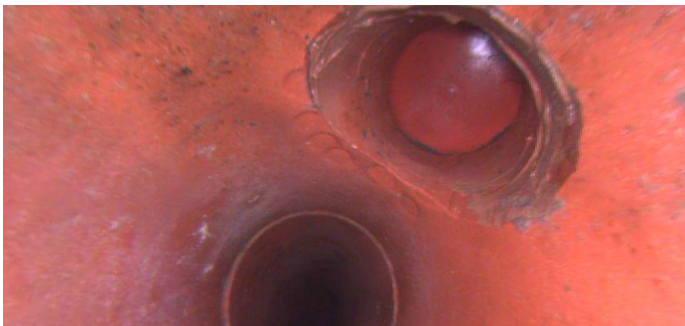
Code: **TFC**
Description: **Tap Factory Capped**

Distance (ft): **97.7**
Structural Grade: **0**
O&M Grade: **0**
Clock Start/From: **2**
Clock To:
1st Value: **4.000**
2nd Value:
Value Percent:
Continuous Index:
Within 8" of Joint:
Remarks:

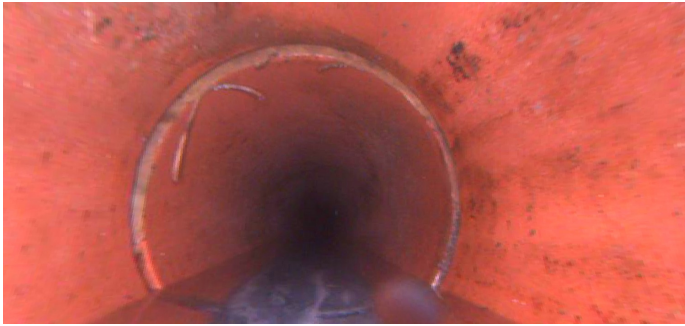
Code: **RFJ**
Description: **Roots Fine Joint**

Distance (ft): **104.1**
Structural Grade: **0**
O&M Grade: **1**
Clock Start/From: **9**
Clock To: **11**
1st Value:
2nd Value:
Value Percent:
Continuous Index:
Within 8" of Joint: **YES**
Remarks:

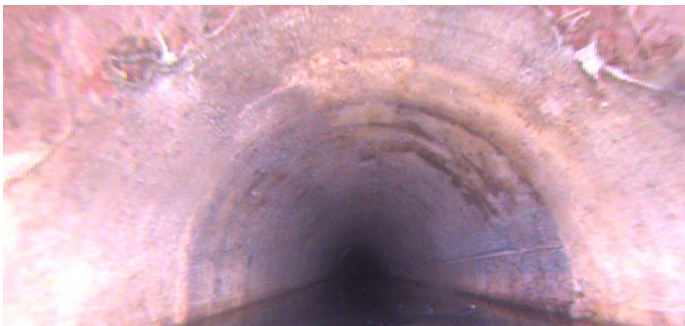
Code: **RPR**
Description: **Repair Point Pipe Replaced**

Distance (ft): **151.8**
Structural Grade: **0**
O&M Grade: **0**
Clock Start/From:
Clock To:
1st Value:
2nd Value:
Value Percent:
Continuous Index:
Within 8" of Joint: **NO**
Remarks: **CIP TO PVC**

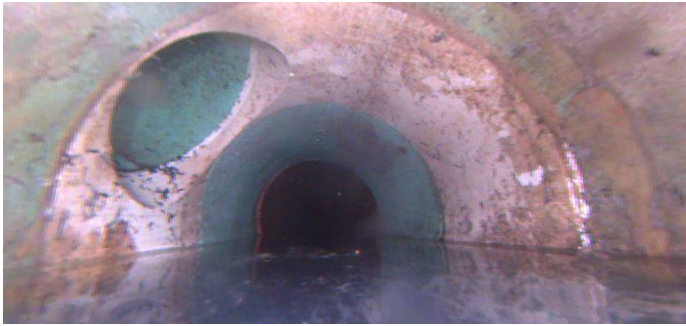
Code: **TF**
Description: **Tap Factory**

Distance (ft): **156.4**
Structural Grade: **0**
O&M Grade: **0**
Clock Start/From: **10**
Clock To:
1st Value: **4.000**
2nd Value:
Value Percent:
Continuous Index:
Within 8" of Joint:
Remarks:

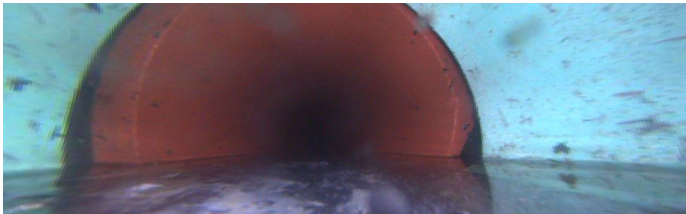
Code: **RPR**
Description: **Repair Point Pipe Replaced**

Distance (ft): **157.8**
Structural Grade: **0**
O&M Grade: **0**
Clock Start/From:
Clock To:
1st Value:
2nd Value:
Value Percent:
Continuous Index:
Within 8" of Joint: **NO**
Remarks: **PVC END**

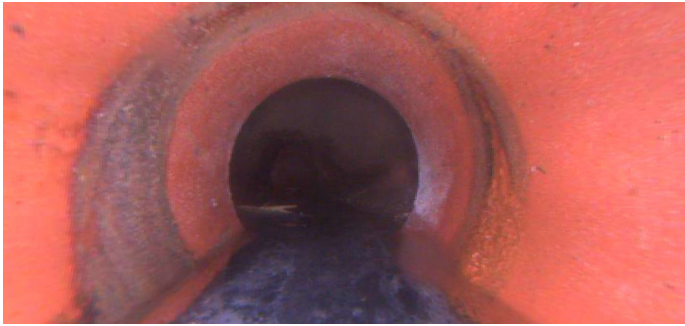
Code: **IS**
Description: **Infil Stain**

Distance (ft): **235.7**
Structural Grade: **0**
O&M Grade: **0**
Clock Start/From: **7**
Clock To: **5**
1st Value:
2nd Value:
Value Percent:
Continuous Index:
Within 8" of Joint:
Remarks:
