## Profile/Photo Observation Report

Street:	<b>Rush St.</b>	Flow Control:	<b>Not Controlled</b>
City:	<b>Hobart, IN</b>	Year Renewed:	
Location:	<b>Light Highway</b>	Tape/Media #:	
Purpose:	<b>Routine Assessment</b>	Dia/Height:	<b>10"</b>
Use:	<b>Sanitary</b>	Material:	<b>VCP</b>
Drain Area:	<b>NA</b>	Lining:	
Category:	<b>NA</b>		
Comment:

Location Details:		Direction of Survey:	<b>Downstream</b>
US MH:	<b>M-904-047</b>	DS MH:	<b>M-904-048</b>
		Total Length Surveyed (ft):	<b>237.8</b>

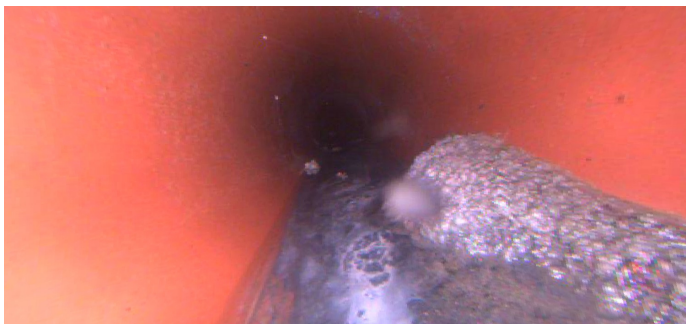
Code: **AMH**  
Description: **Manhole**

Distance (ft): **.0**  
Structural Grade: **0**  
O&M Grade: **0**  
Clock Start/From:  
Clock To:  
1st Value:  
2nd Value:  
Value Percent:  
Continuous Index:  
Within 8" of Joint: **NO**  
Remarks: **M-904-047**

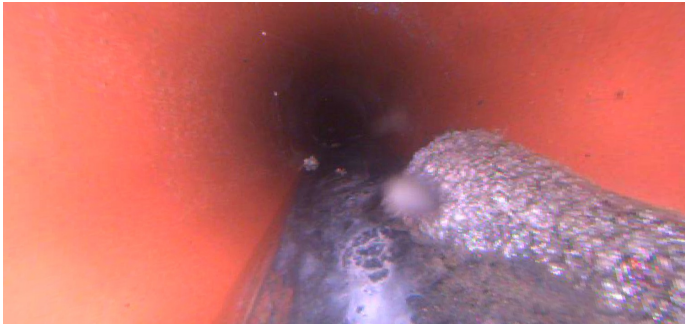
Code:	<b>MWL</b>
Description:	<b>Water Level</b>

Distance (ft):	<b>.0</b>
Structural Grade:	<b>0</b>
O&M Grade:	<b>0</b>
Clock Start/From:	
Clock To:	
1st Value:	
2nd Value:	
Value Percent:	<b>10.000</b>
Continuous Index:	
Within 8" of Joint:	<b>NO</b>
Remarks:

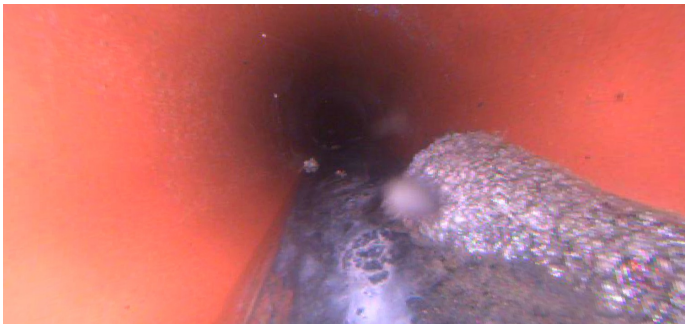
Code:	<b>RBB</b>
Description:	<b>Roots Ball Barrel</b>

Distance (ft):	<b>.0</b>
Structural Grade:	<b>0</b>
O&M Grade:	<b>5</b>
Clock Start/From:	<b>4</b>
Clock To:	<b>5</b>
1st Value:	
2nd Value:	
Value Percent:	<b>55.000</b>
Continuous Index:	
Within 8" of Joint:	<b>NO</b>
Remarks:

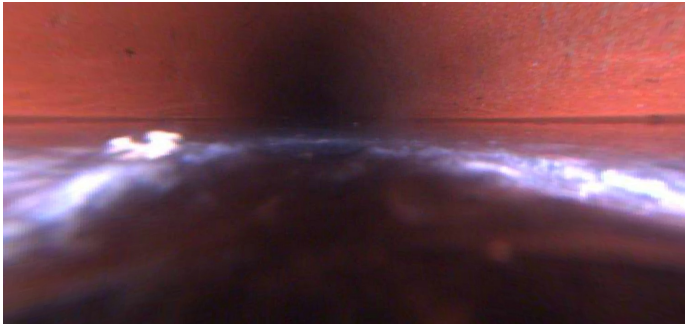
Code: **MWLS**  
Description: **Water Level Sag**

Distance (ft): **45.0**  
Structural Grade: **3**  
O&M Grade: **3**  
Clock Start/From:  
Clock To:  
1st Value:  
2nd Value:  
Value Percent: **50.000**  
Continuous Index:  
Within 8" of Joint: **NO**  
Remarks:

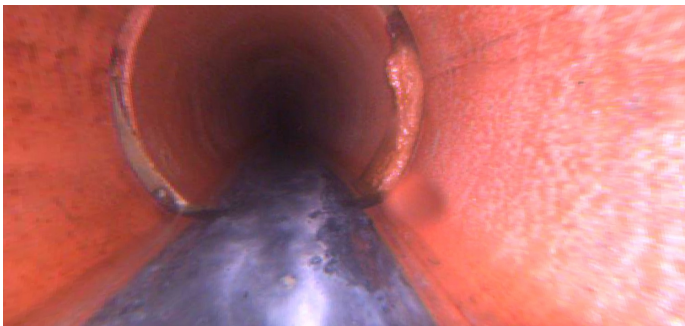
Code: **DAE**  
Description: **Deposits Attached Encrustation**

Distance (ft): **88.6**  
Structural Grade: **0**  
O&M Grade: **2**  
Clock Start/From: **3**  
Clock To: **5**  
1st Value:  
2nd Value:  
Value Percent: **5.000**  
Continuous Index:  
Within 8" of Joint: **YES**  
Remarks:

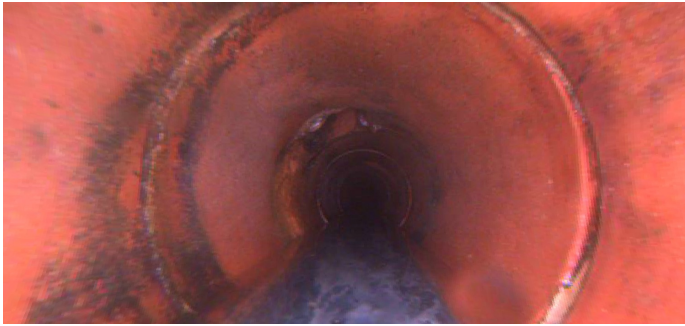
Code: **IS**  
Description: **Infil Stain**

Distance (ft): **94.6**  
Structural Grade: **0**  
O&M Grade: **0**  
Clock Start/From: **7**  
Clock To: **12**  
1st Value:  
2nd Value:  
Value Percent:  
Continuous Index:  
Within 8" of Joint: **YES**  
Remarks:

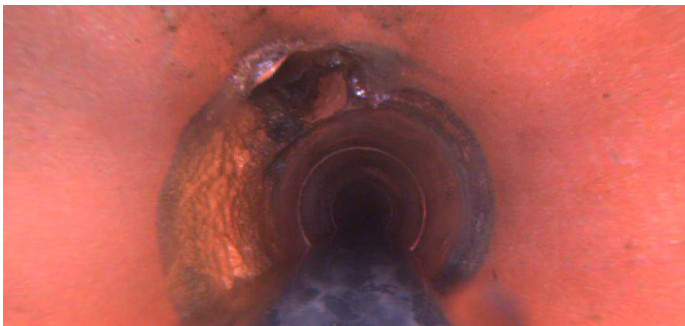
Code: **DAE**  
Description: **Deposits Attached Encrustation**

Distance (ft): **95.3**  
Structural Grade: **0**  
O&M Grade: **2**  
Clock Start/From: **7**  
Clock To: **10**  
1st Value:  
2nd Value:  
Value Percent: **5.000**  
Continuous Index:  
Within 8" of Joint: **NO**  
Remarks:

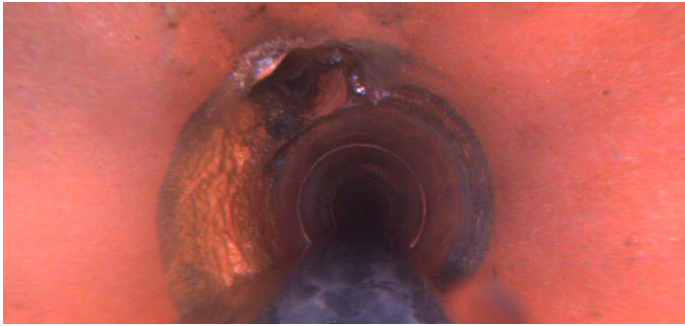
Code: **TB**  
Description: **Tap Break-in**

Distance (ft): **95.3**  
Structural Grade: **0**  
O&M Grade: **0**  
Clock Start/From: **11**  
Clock To:  
1st Value: **4.000**  
2nd Value:  
Value Percent:  
Continuous Index:  
Within 8" of Joint:  
Remarks:

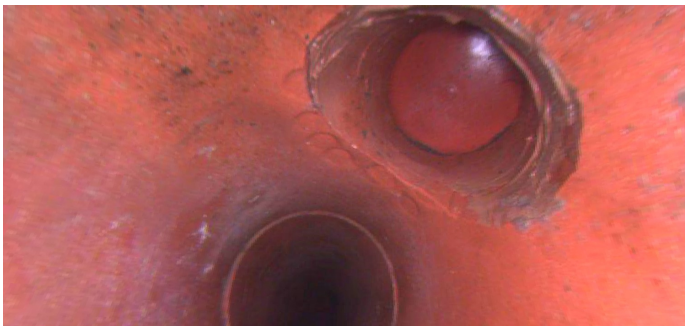
Code: **TFC**  
Description: **Tap Factory Capped**

Distance (ft): **97.7**  
Structural Grade: **0**  
O&M Grade: **0**  
Clock Start/From: **2**  
Clock To:  
1st Value: **4.000**  
2nd Value:  
Value Percent:  
Continuous Index:  
Within 8" of Joint:  
Remarks:

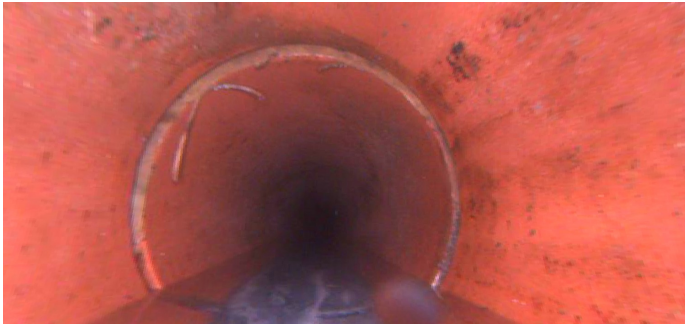
Code: **RFJ**  
Description: **Roots Fine Joint**

Distance (ft): **104.1**  
Structural Grade: **0**  
O&M Grade: **1**  
Clock Start/From: **9**  
Clock To: **11**  
1st Value:  
2nd Value:  
Value Percent:  
Continuous Index:  
Within 8" of Joint: **YES**  
Remarks:

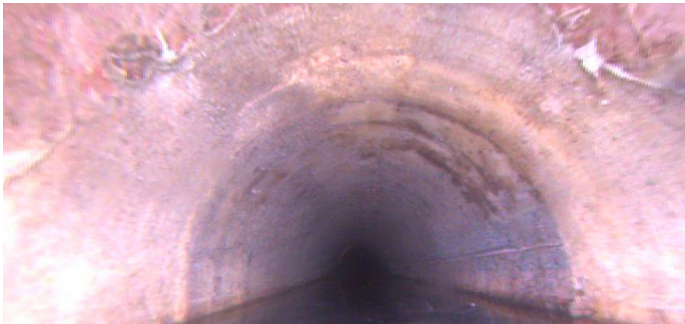
Code: **RPR**  
Description: **Repair Point Pipe Replaced**

Distance (ft): **151.8**  
Structural Grade: **0**  
O&M Grade: **0**  
Clock Start/From:  
Clock To:  
1st Value:  
2nd Value:  
Value Percent:  
Continuous Index:  
Within 8" of Joint: **NO**  
Remarks: **CIP TO PVC**

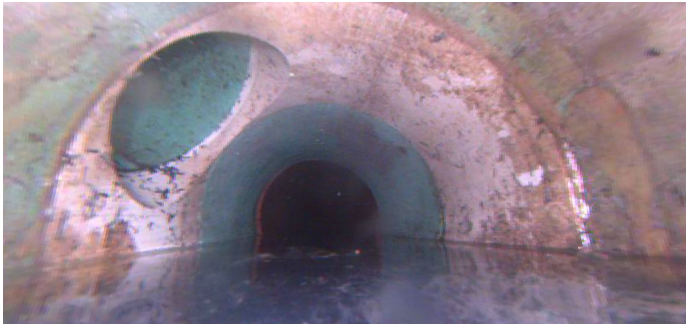
Code: **TF**  
Description: **Tap Factory**

Distance (ft): **156.4**  
Structural Grade: **0**  
O&M Grade: **0**  
Clock Start/From: **10**  
Clock To:  
1st Value: **4.000**  
2nd Value:  
Value Percent:  
Continuous Index:  
Within 8" of Joint:  
Remarks:

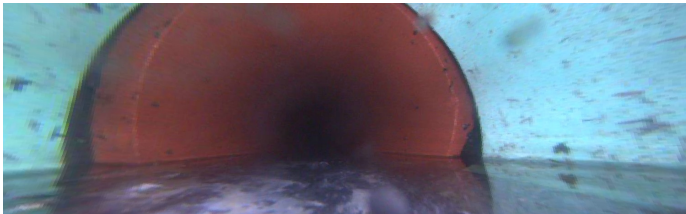
Code: **RPR**  
Description: **Repair Point Pipe Replaced**

Distance (ft): **157.8**  
Structural Grade: **0**  
O&M Grade: **0**  
Clock Start/From:  
Clock To:  
1st Value:  
2nd Value:  
Value Percent:  
Continuous Index:  
Within 8" of Joint: **NO**  
Remarks: **PVC END**

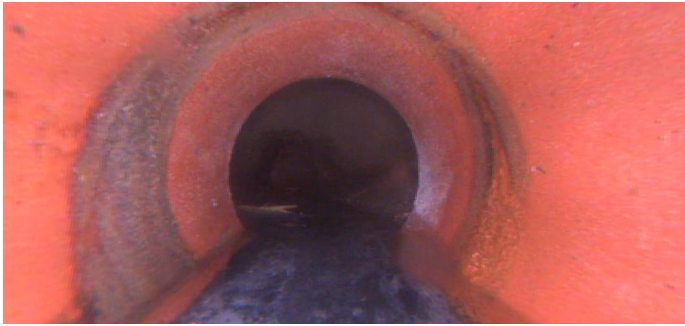
Code: **IS**  
Description: **Infil Stain**

Distance (ft): **235.7**  
Structural Grade: **0**  
O&M Grade: **0**  
Clock Start/From: **7**  
Clock To: **5**  
1st Value:  
2nd Value:  
Value Percent:  
Continuous Index:  
Within 8" of Joint:  
Remarks:

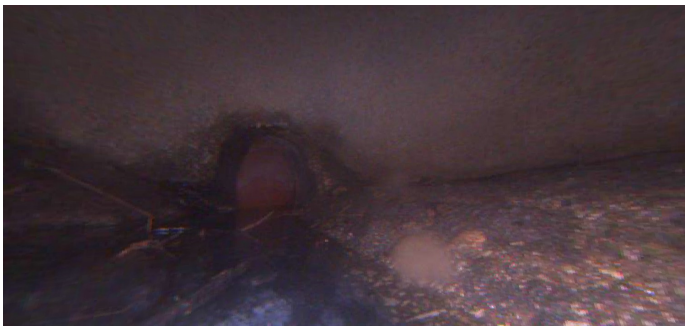
Code: **AMH**  
Description: **Manhole**

Distance (ft): **237.8**  
Structural Grade: **0**  
O&M Grade: **0**  
Clock Start/From:  
Clock To:  
1st Value:  
2nd Value:  
Value Percent:  
Continuous Index:  
Within 8" of Joint: **NO**  
Remarks: **M-904-048**
