Profile/Photo Observation Report

Date:	05/04/2018	Weather:		Coding:	PACP 4.2
Pipe Length (ft):	311.5	Owner:	City of Hobart	Pre Clean:	No Pre-Cleaning
P.O.#:	2004	Surveyor:	SAN	PSR:	P-904-051-052
Customer:	Red Zone	Clean Date:		Shape:	C

Street:	211 N Hobart Rd	Flow Control:	Not Controlled
City:	Hobart In	Year Renewed:	
Location:	Easement/Right of Way	Tape/Media #:	Deliverable 1
Purpose:	Routine Assessment	Dia/Height:	18"
Use:	Sanitary	Material:	VCP
Drain Area:	Northeast	Lining:	
Category:	NA		
Comment:	443-3		
Location Details:	Treeline between houses	Direction of Survey:	Upstream
US MH:	M-904-051	DS MH:	M-904-052
		Total Length Surveyed (ft):	311.5

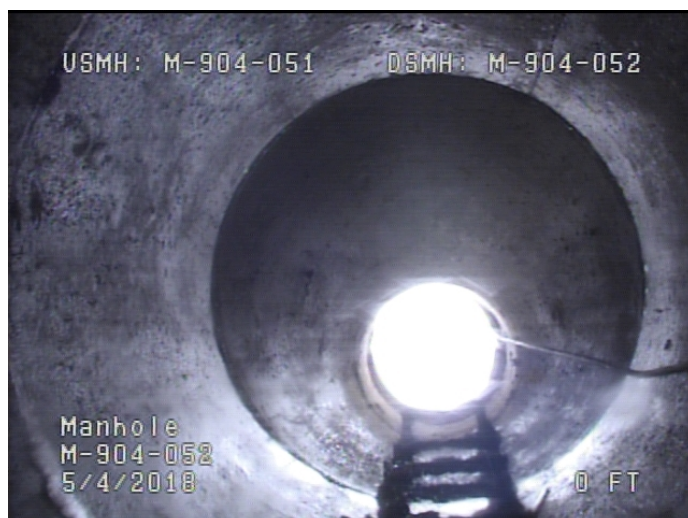
Code: **AMH**
 Description: **Manhole**

Distance (ft): **.0**
 Structural Grade: **0**
 O&M Grade: **0**
 Clock Start/From:
 Clock To:
 1st Value:
 2nd Value:
 Value Percent:
 Continuous Index:
 Within 8" of Joint: **NO**
 Remarks: **M-904-052**

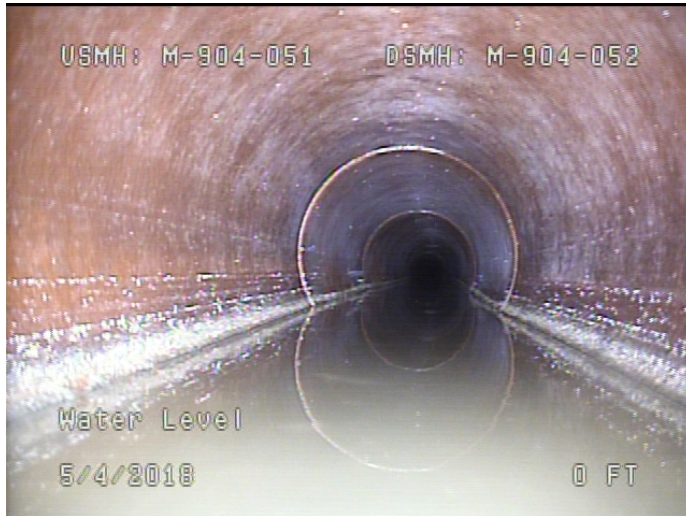
Code:	MWL
Description:	Water Level
Distance (ft):	.0
Structural Grade:	0
O&M Grade:	0
Clock Start/From:	
Clock To:	
1st Value:	
2nd Value:	
Value Percent:	15.000
Continuous Index:	
Within 8" of Joint:	NO
Remarks:

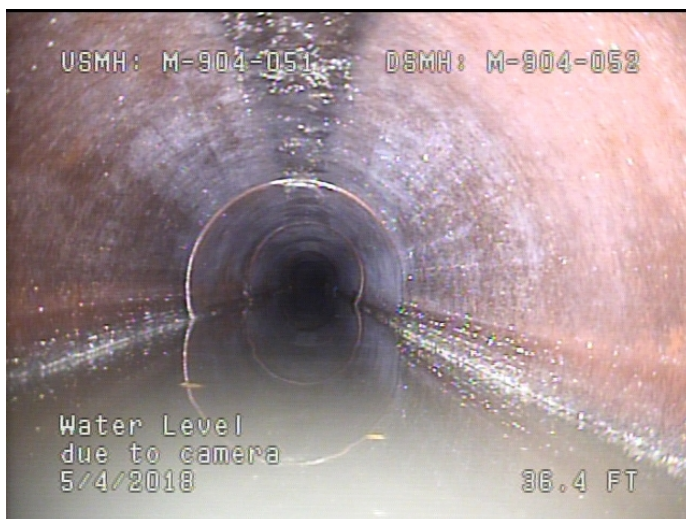
Code:	MWL
Description:	Water Level
Distance (ft):	36.4
Structural Grade:	0
O&M Grade:	0
Clock Start/From:	
Clock To:	
1st Value:	
2nd Value:	
Value Percent:	25.000
Continuous Index:	
Within 8" of Joint:	NO
Remarks:	due to camera

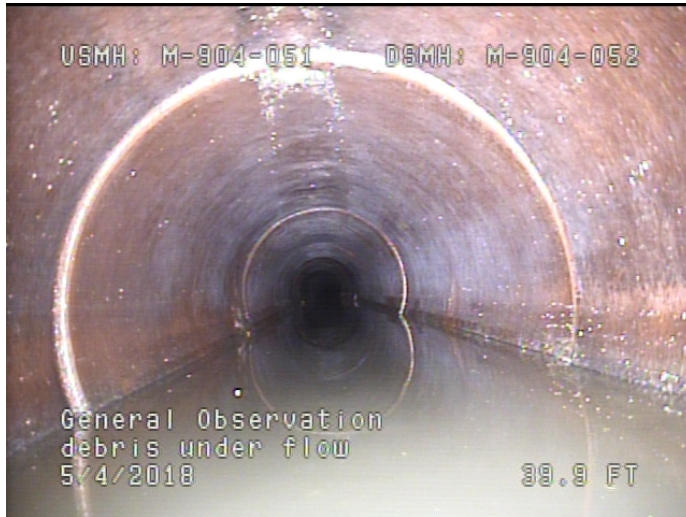
Code:	MGO
Description:	General Observation
Distance (ft):	39.9
Structural Grade:	0
O&M Grade:	0
Clock Start/From:	
Clock To:	
1st Value:	
2nd Value:	
Value Percent:	
Continuous Index:	
Within 8" of Joint:	NO
Remarks:	debris under flow

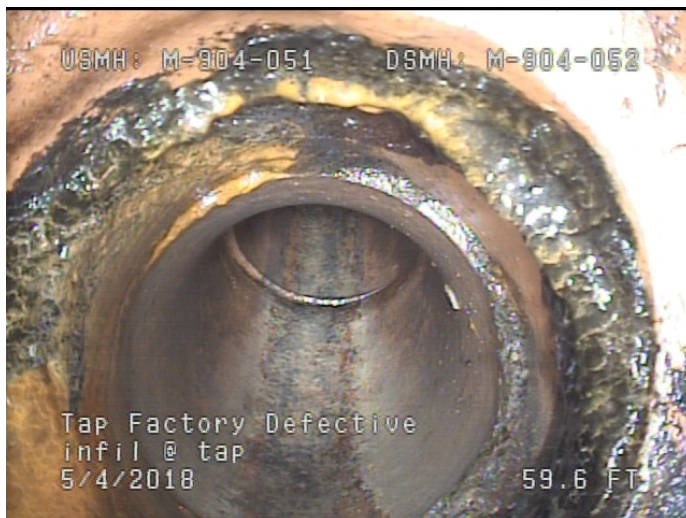
Code:	TFD
Description:	Tap Factory Defective
Distance (ft):	59.6
Structural Grade:	0
O&M Grade:	2
Clock Start/From:	10
Clock To:	
1st Value:	4.000
2nd Value:	
Value Percent:	
Continuous Index:	
Within 8" of Joint:	NO
Remarks:	infil @ tap

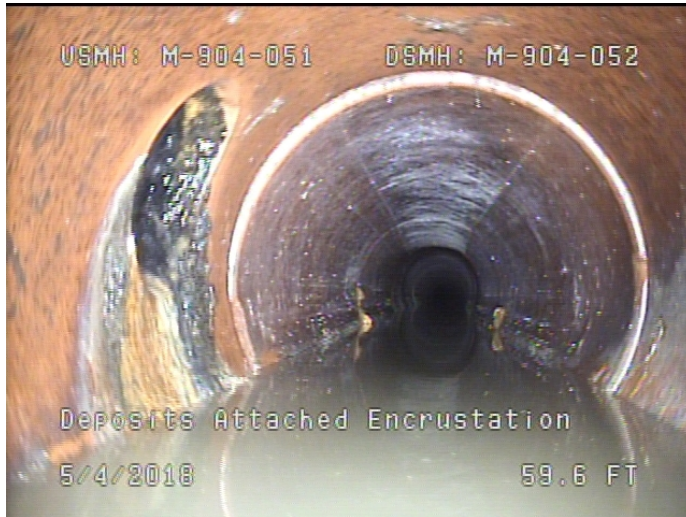
Code:	DAE
Description:	Deposits Attached Encrustation
Distance (ft):	59.6
Structural Grade:	0
O&M Grade:	2
Clock Start/From:	8
Clock To:	11
1st Value:	
2nd Value:	
Value Percent:	10.000
Continuous Index:	
Within 8" of Joint:	NO
Remarks:

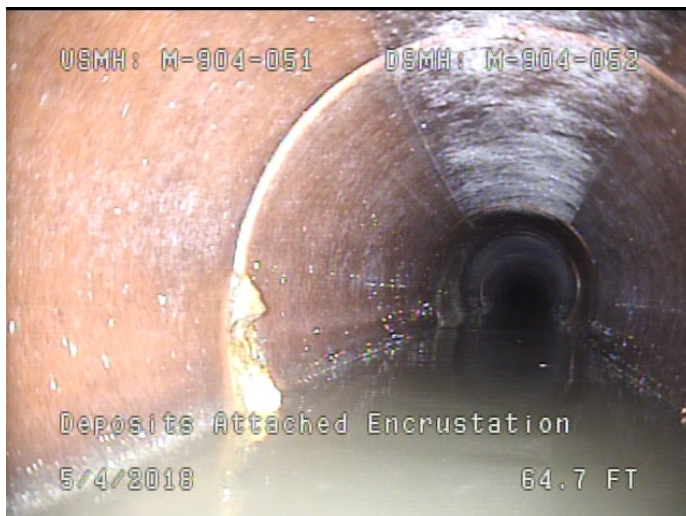
Code:	DAE
Description:	Deposits Attached Encrustation
Distance (ft):	64.7
Structural Grade:	0
O&M Grade:	2
Clock Start/From:	4
Clock To:	8
1st Value:	
2nd Value:	
Value Percent:	10.000
Continuous Index:	
Within 8" of Joint:	YES
Remarks:

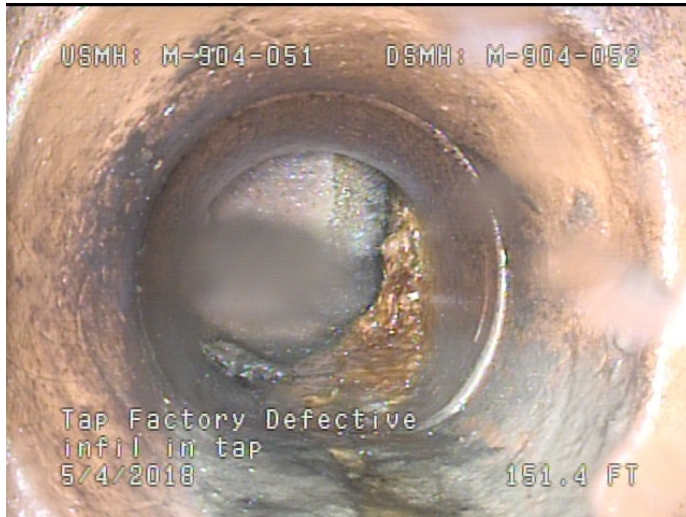
Code:	TFD
Description:	Tap Factory Defective
Distance (ft):	151.4
Structural Grade:	0
O&M Grade:	2
Clock Start/From:	10
Clock To:	
1st Value:	4.000
2nd Value:	
Value Percent:	
Continuous Index:	
Within 8" of Joint:	NO
Remarks:	infil in tap

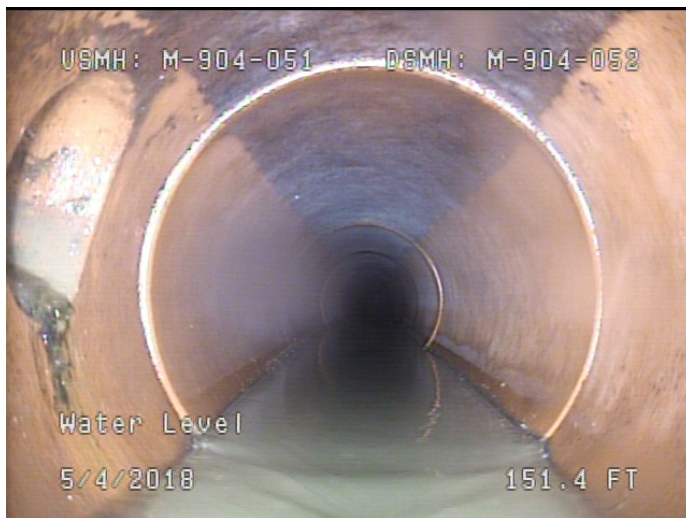
Code:	MWL
Description:	Water Level
Distance (ft):	151.4
Structural Grade:	0
O&M Grade:	0
Clock Start/From:	
Clock To:	
1st Value:	
2nd Value:	
Value Percent:	10.000
Continuous Index:	
Within 8" of Joint:	NO
Remarks:

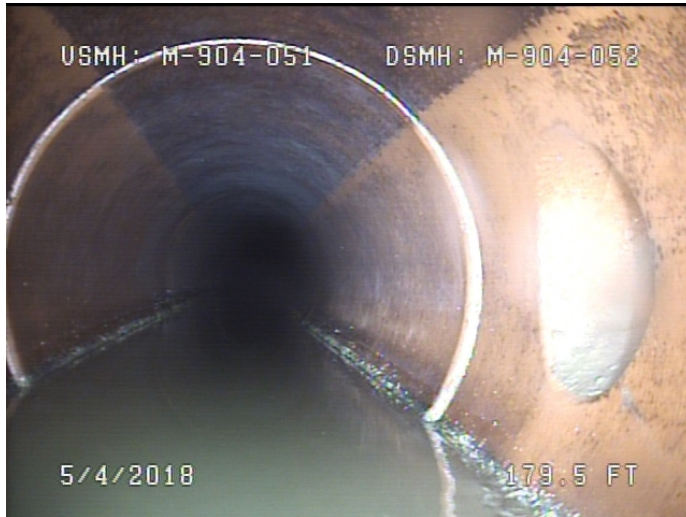
Code: **TFC**
 Description: **Tap Factory Capped**

Distance (ft): **179.4**
 Structural Grade: **0**
 O&M Grade: **0**
 Clock Start/From: **3**
 Clock To:
 1st Value: **4.000**
 2nd Value:
 Value Percent:
 Continuous Index:
 Within 8" of Joint: **NO**
 Remarks:

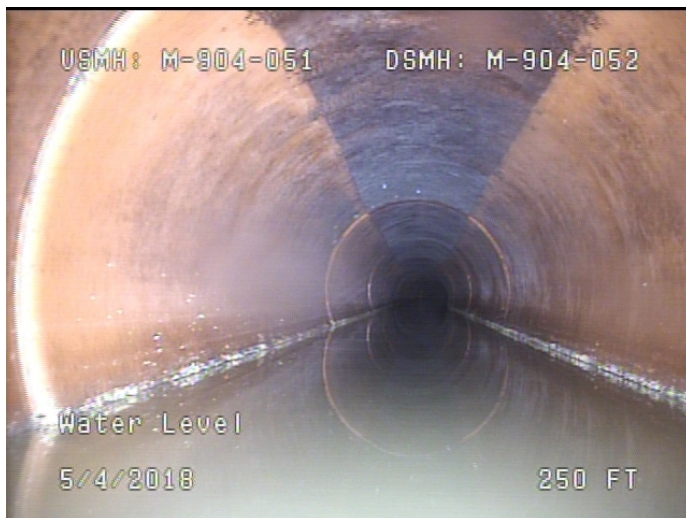
Code: **MWL**
 Description: **Water Level**

Distance (ft): **250.0**
 Structural Grade: **0**
 O&M Grade: **0**
 Clock Start/From:
 Clock To:
 1st Value:
 2nd Value:
 Value Percent: **25.000**
 Continuous Index:
 Within 8" of Joint: **NO**
 Remarks:

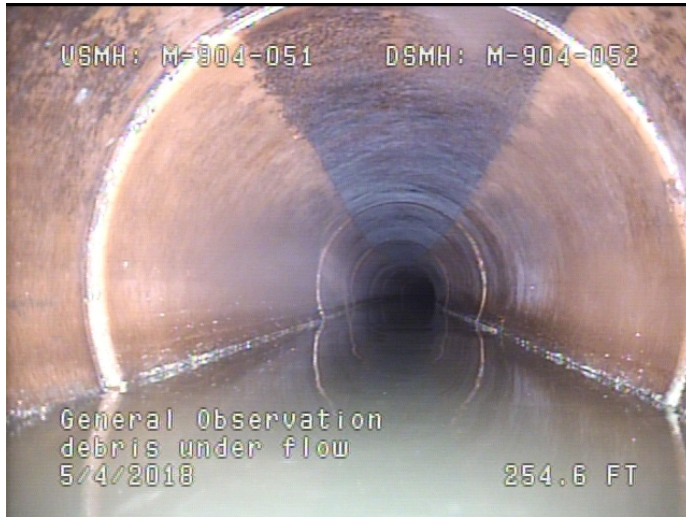
Code: **MGO**
 Description: **General Observation**

Distance (ft): **254.6**
 Structural Grade: **0**
 O&M Grade: **0**
 Clock Start/From:
 Clock To:
 1st Value:
 2nd Value:
 Value Percent:
 Continuous Index:
 Within 8" of Joint: **NO**
 Remarks: **debris under flow**

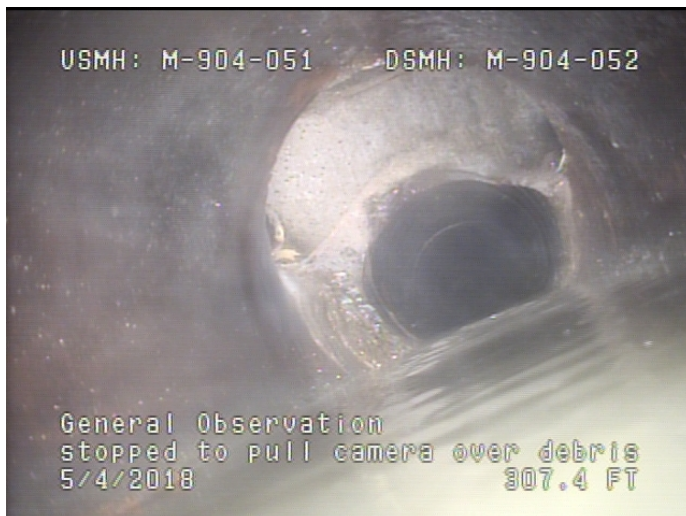
Code: **MGO**
 Description: **General Observation**

Distance (ft): **307.4**
 Structural Grade: **0**
 O&M Grade: **0**
 Clock Start/From:
 Clock To:
 1st Value:
 2nd Value:
 Value Percent:
 Continuous Index:
 Within 8" of Joint: **NO**
 Remarks: **stopped to pull camera over debris**

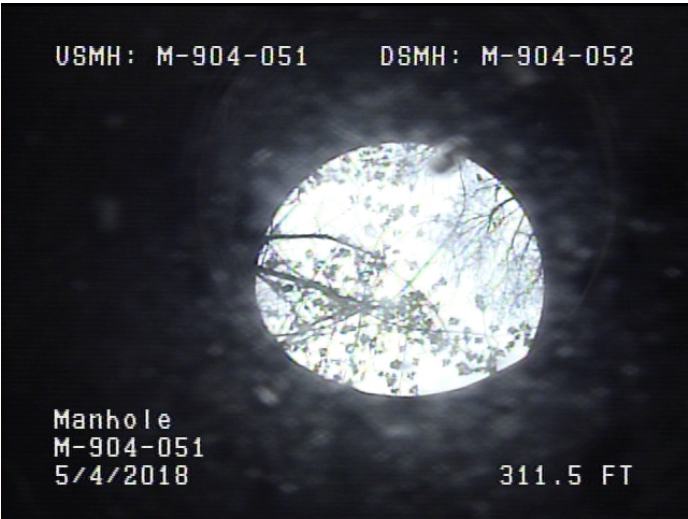
Code:	AMH
Description:	Manhole
Distance (ft):	311.5
Structural Grade:	0
O&M Grade:	0
Clock Start/From:	
Clock To:	
1st Value:	
2nd Value:	
Value Percent:	
Continuous Index:	
Within 8" of Joint:	NO
Remarks:	M-904-051
