## Profile/Photo Observation Report

Street:	<b>N HOBART RD</b>	Flow Control:	<b>Not Controlled</b>
City:	<b>Hobart, IN</b>	Year Renewed:	
Location:	<b>Other</b>	Tape/Media #:	
Purpose:	<b>Not Known</b>	Dia/Height:	<b>10"</b>
Use:	<b>Sanitary</b>	Material:	<b>VCP</b>
Drain Area:	<b>NA</b>	Lining:	
Category:	<b>NA</b>		
Comment:

Location Details:		Direction of Survey:	<b>Downstream</b>
US MH:	<b>M-904-059</b>	DS MH:	<b>M-804-064</b>
		Total Length Surveyed (ft):	<b>7.8</b>

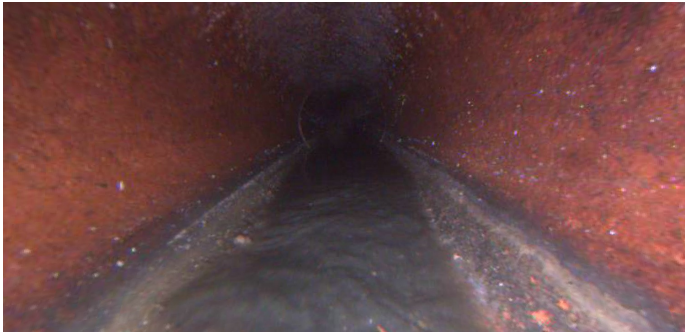
Code:	<b>MWL</b>
Description:	<b>Water Level</b>

Distance (ft):	<b>.0</b>
Structural Grade:	<b>0</b>
O&M Grade:	<b>0</b>
Clock Start/From:	
Clock To:	
1st Value:	
2nd Value:	
Value Percent:	<b>10.000</b>
Continuous Index:	
Within 8" of Joint:	<b>NO</b>
Remarks:

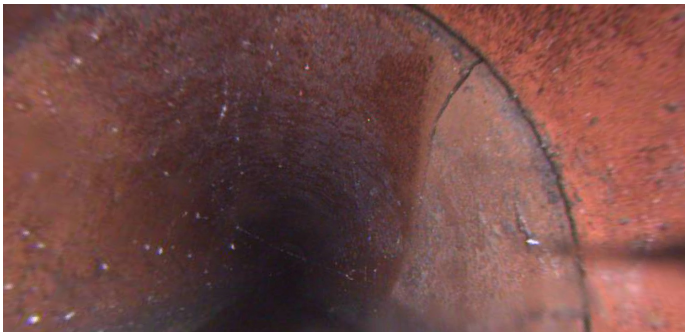
Code:	<b>FS</b>
Description:	<b>Fracture Spiral</b>

Distance (ft):	<b>7.8</b>
Structural Grade:	<b>3</b>
O&M Grade:	<b>0</b>
Clock Start/From:	<b>2</b>
Clock To:	<b>4</b>
1st Value:	
2nd Value:	
Value Percent:	
Continuous Index:	
Within 8" of Joint:	<b>YES</b>
Remarks:

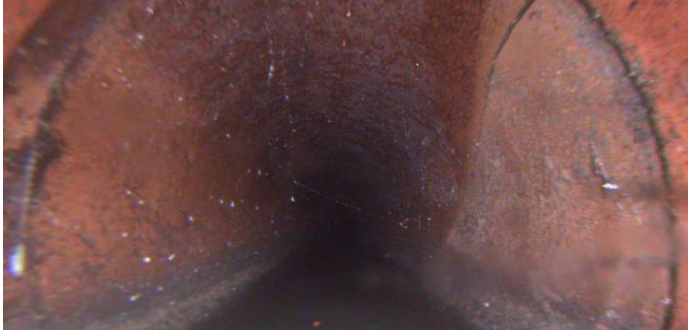
Code:	<b>MSA</b>
Description:	<b>Abandoned Survey</b>
Distance (ft):	<b>7.8</b>
Structural Grade:	<b>0</b>
O&M Grade:	<b>0</b>
Clock Start/From:	
Clock To:	
1st Value:	
2nd Value:	
Value Percent:	
Continuous Index:	
Within 8" of Joint:	<b>NO</b>
Remarks:	<b>UNKNOWN</b>
