Profile/Photo Observation Report

Street:	Division St.	Flow Control:	Not Controlled
City:	Hobart, IN	Year Renewed:	
Location:	Other	Tape/Media #:	
Purpose:	Not Known	Dia/Height:	10"
Use:	Sanitary	Material:	VCP
Drain Area:	NA	Lining:	
Category:	NA		
Comment:

Location Details:		Direction of Survey:	Downstream
US MH:	M-904-059	DS MH:	M-804-064
		Total Length Surveyed (ft):	7.8

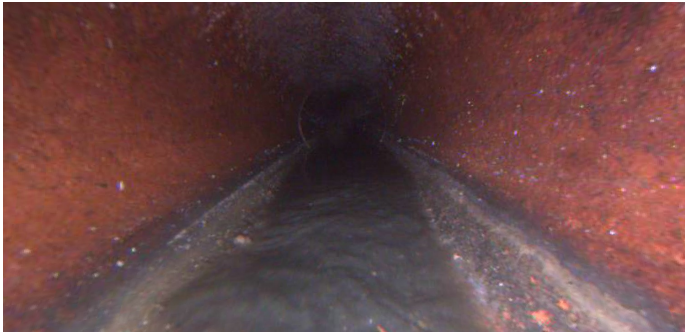
Code:	MWL
Description:	Water Level

Distance (ft):	.0
Structural Grade:	0
O&M Grade:	0
Clock Start/From:	
Clock To:	
1st Value:	
2nd Value:	
Value Percent:	10.000
Continuous Index:	
Within 8" of Joint:	NO
Remarks:

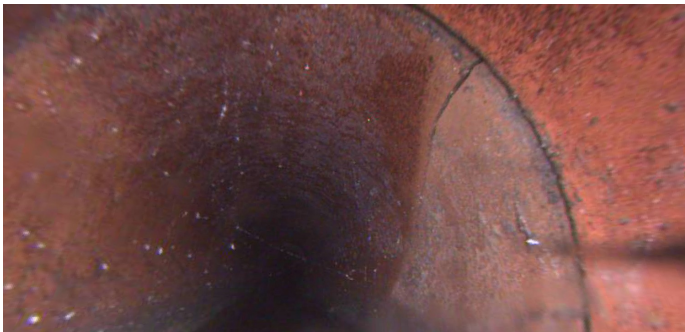
Code:	FS
Description:	Fracture Spiral

Distance (ft):	7.8
Structural Grade:	3
O&M Grade:	0
Clock Start/From:	2
Clock To:	4
1st Value:	
2nd Value:	
Value Percent:	
Continuous Index:	
Within 8" of Joint:	YES
Remarks:

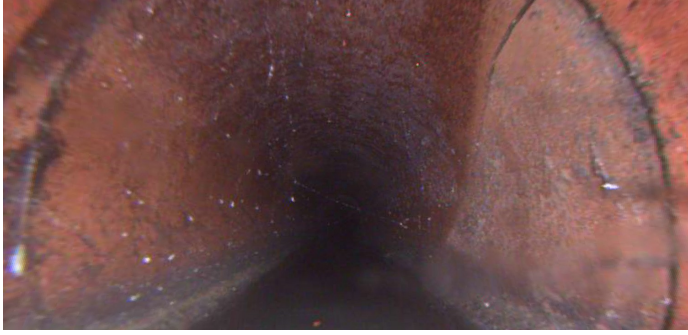
Code:	MSA
Description:	Abandoned Survey
Distance (ft):	7.8
Structural Grade:	0
O&M Grade:	0
Clock Start/From:	
Clock To:	
1st Value:	
2nd Value:	
Value Percent:	
Continuous Index:	
Within 8" of Joint:	NO
Remarks:	UNKNOWN
