Profile/Photo Observation Report

Date:	10/04/2018	Weather:		Coding:	PACP 6.0
Pipe Length (ft):	306.1	Owner:	NA	Pre Clean:	Not Known
P.O.#:		Surveyor:	Justin Gonzales	PSR:	P-904-059-064
Customer:		Clean Date:	01/01/1900	Shape:	C

Street:	N HOBART RD	Flow Control:	Not Controlled
City:	Hobart, IN	Year Renewed:	
Location:	Light Highway	Tape/Media #:	
Purpose:	Routine Assessment	Dia/Height:	10"
Use:	Sanitary	Material:	VCP
Drain Area:	NA	Lining:	
Category:	NA		
Comment:

Location Details:		Direction of Survey:	Downstream
US MH:	M-904-059	DS MH:	M-804-064
		Total Length Surveyed (ft):	302.5

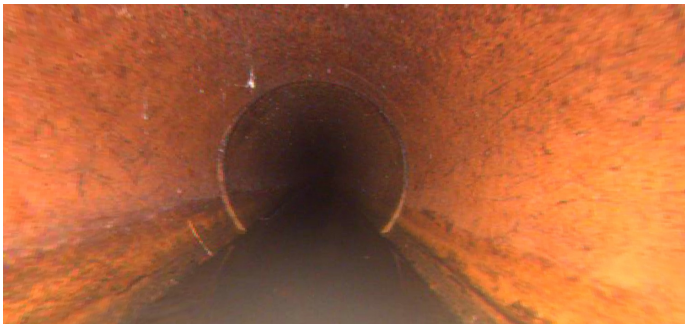
Code: **AMH**
Description: **Manhole**

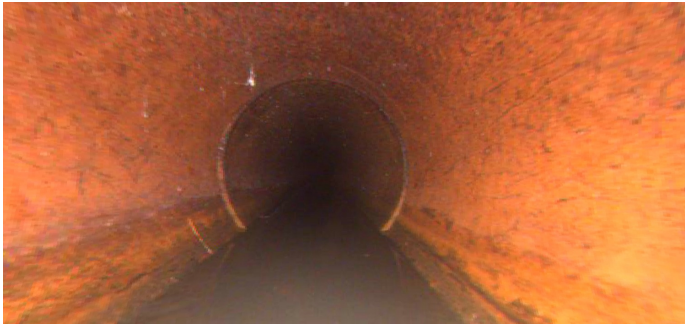
Code:	MWL
Description:	Water Level

Distance (ft):	.0
Structural Grade:	0
O&M Grade:	0
Clock Start/From:	
Clock To:	
1st Value:	
2nd Value:	
Value Percent:	10.000
Continuous Index:	
Within 8" of Joint:	NO
Remarks:

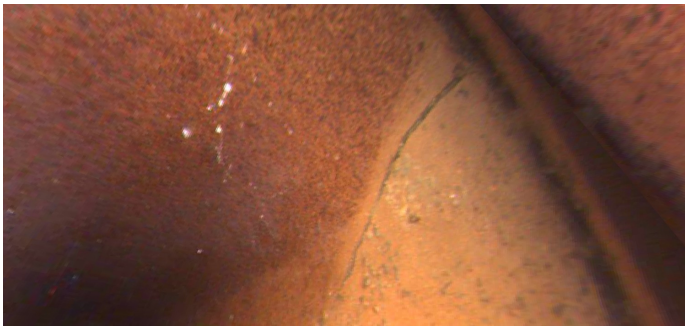
Code:	CC
Description:	Crack Circumferential

Distance (ft):	8.7
Structural Grade:	1
O&M Grade:	0
Clock Start/From:	2
Clock To:	3
1st Value:	
2nd Value:	
Value Percent:	
Continuous Index:	
Within 8" of Joint:	YES
Remarks:

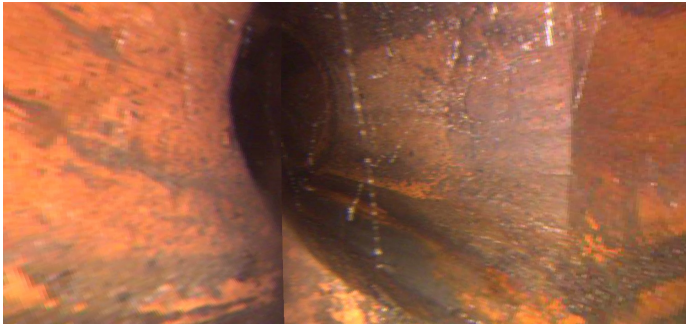
Code: **TF**
Description: **Tap Factory**

Distance (ft): **14.4**
Structural Grade: **0**
O&M Grade: **0**
Clock Start/From: **9**
Clock To:
1st Value: **6.000**
2nd Value:
Value Percent:
Continuous Index:
Within 8" of Joint:
Remarks:

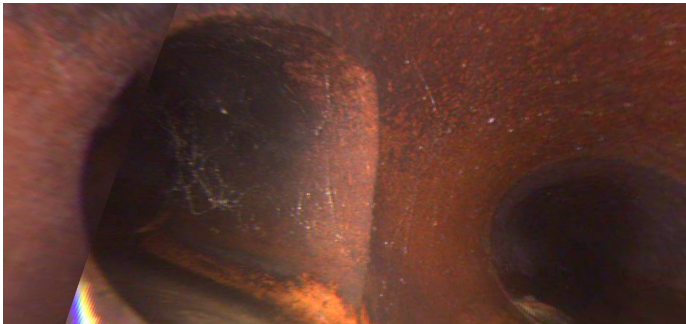
Code: **TF**
Description: **Tap Factory**

Distance (ft): **56.3**
Structural Grade: **0**
O&M Grade: **0**
Clock Start/From: **9**
Clock To:
1st Value: **4.000**
2nd Value:
Value Percent:
Continuous Index:
Within 8" of Joint:
Remarks:

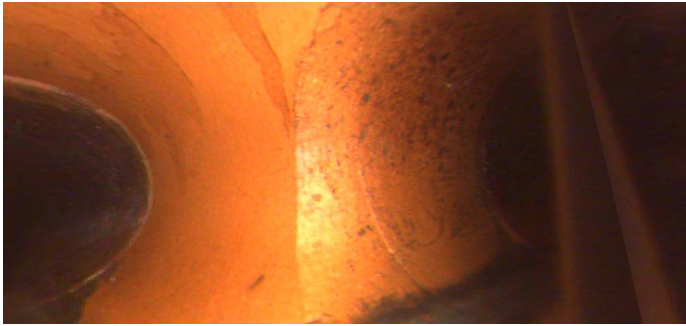
Code: **TF**
Description: **Tap Factory**

Distance (ft): **68.5**
Structural Grade: **0**
O&M Grade: **0**
Clock Start/From: **3**
Clock To:
1st Value: **4.000**
2nd Value:
Value Percent:
Continuous Index:
Within 8" of Joint:
Remarks:

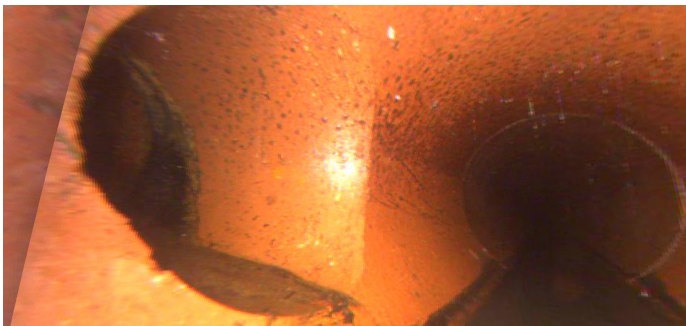
Code: **TF**
Description: **Tap Factory**

Distance (ft): **126.0**
Structural Grade: **0**
O&M Grade: **0**
Clock Start/From: **9**
Clock To:
1st Value: **4.000**
2nd Value:
Value Percent:
Continuous Index:
Within 8" of Joint:
Remarks:

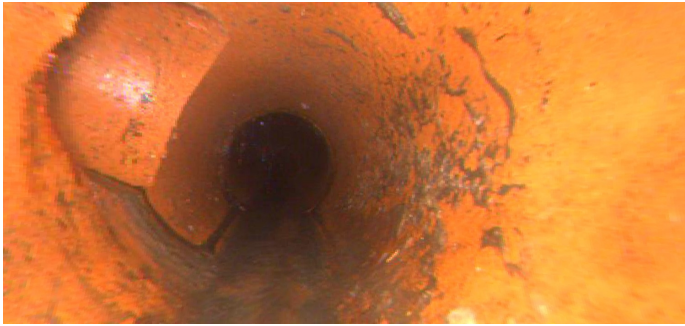
Code: **TF**
Description: **Tap Factory**

Distance (ft): **213.3**
Structural Grade: **0**
O&M Grade: **0**
Clock Start/From: **9**
Clock To:
1st Value: **4.000**
2nd Value:
Value Percent:
Continuous Index:
Within 8" of Joint:
Remarks:

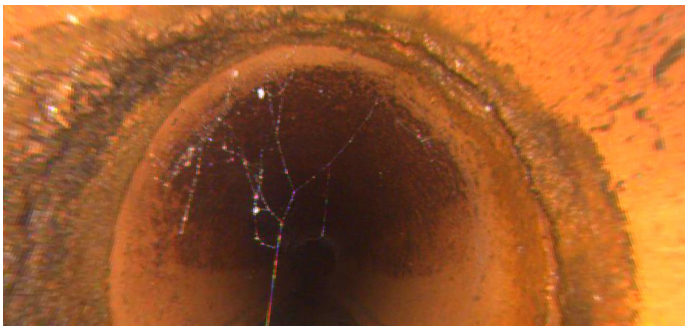
Code: **IS**
Description: **Infil Stain**

Distance (ft): **214.9**
Structural Grade: **0**
O&M Grade: **0**
Clock Start/From: **7**
Clock To: **5**
1st Value:
2nd Value:
Value Percent:
Continuous Index:
Within 8" of Joint: **YES**
Remarks:

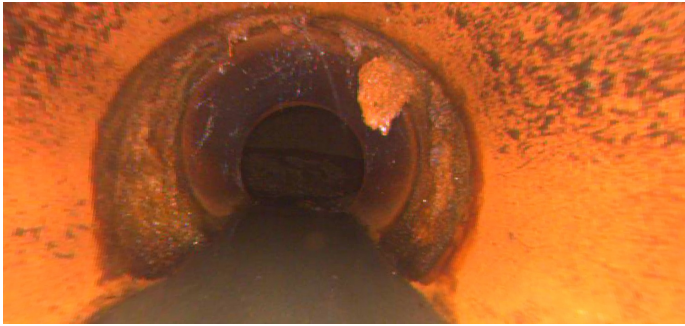
Code: **DAE**
Description: **Deposits Attached Encrustation**

Distance (ft): **299.5**
Structural Grade: **0**
O&M Grade: **2**
Clock Start/From: **7**
Clock To: **5**
1st Value:
2nd Value:
Value Percent: **5.000**
Continuous Index:
Within 8" of Joint: **YES**
Remarks:

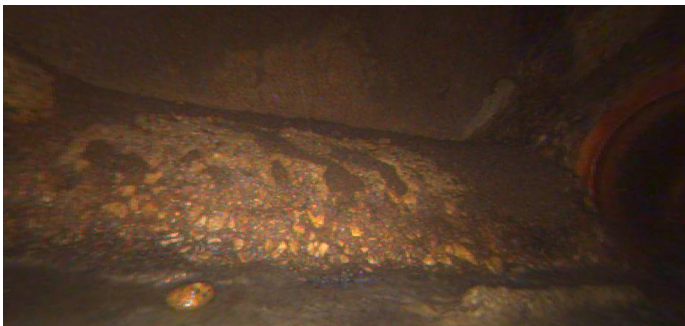
Code: **AMH**
Description: **Manhole**

Distance (ft): **302.5**
Structural Grade: **0**
O&M Grade: **0**
Clock Start/From:
Clock To:
1st Value:
2nd Value:
Value Percent:
Continuous Index:
Within 8" of Joint: **NO**
Remarks: **M-804-064**
