Profile/Photo Observation Report

| Street: | DIVISION ST | Flow Control: | Not Controlled |
| City: | Hobart, IN | Year Renewed: | |

| US MH: | M-904-060 | DS MH: | M-904-059 |

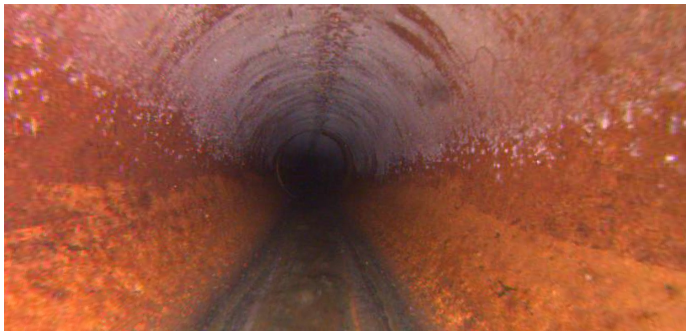
Code: **AMH**
Description: **Manhole**

Distance (ft): **.0**
Structural Grade: **0**
O&M Grade: **0**
Clock Start/From:
Clock To:
1st Value:
2nd Value:
Value Percent:
Continuous Index:
Within 8" of Joint: **NO**
Remarks: **M-904-060**

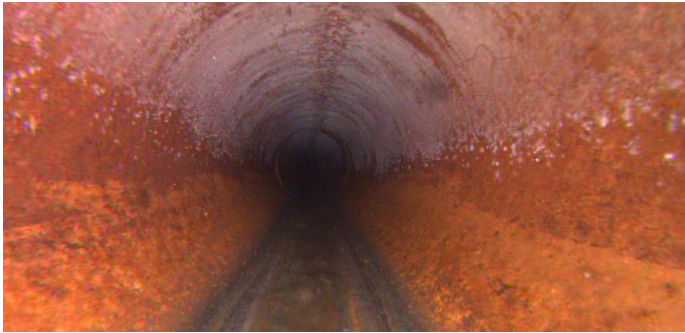
| Code: | MWL |
| Description: | Water Level |

| Value Percent: | 5.000 |

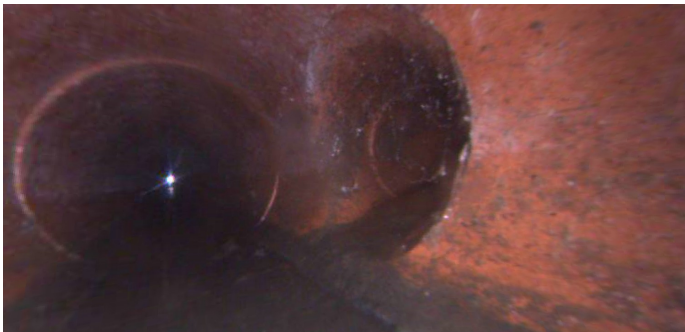
| Code: | TFA |
| Description: | Tap Factory Active |

| Distance (ft): | 39.6 |

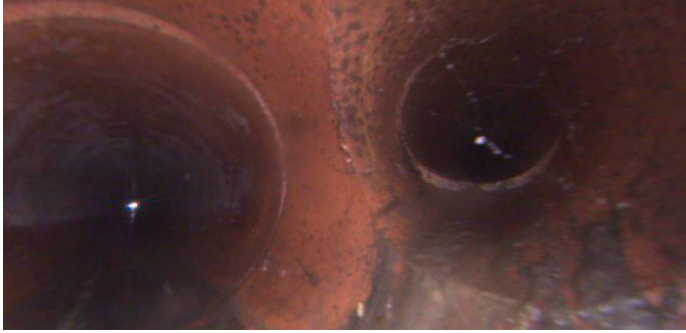
Code: **TF**
Description: **Tap Factory**

Distance (ft): **61.2**
Structural Grade: **0**
O&M Grade: **0**
Clock Start/From: **9**
Clock To:
1st Value: **4.000**
2nd Value:
Value Percent:
Continuous Index:
Within 8" of Joint:
Remarks:

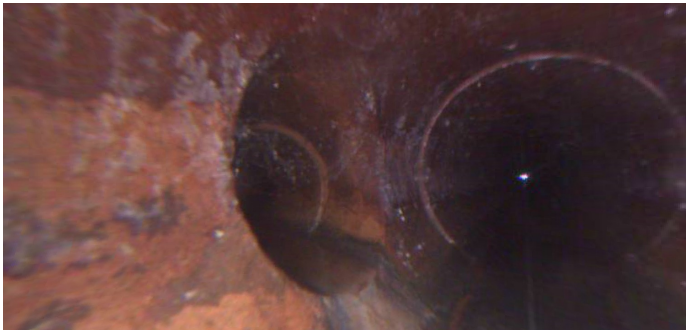
Code: **TFA**
Description: **Tap Factory Active**

Distance (ft): **93.6**
Structural Grade: **0**
O&M Grade: **0**
Clock Start/From: **3**
Clock To:
1st Value: **4.000**
2nd Value:
Value Percent:
Continuous Index:
Within 8" of Joint:
Remarks:

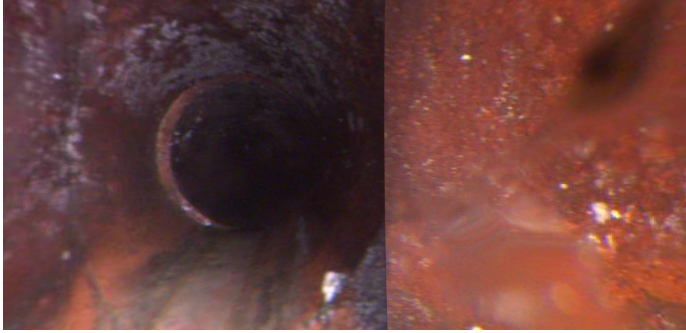
Code: **TFA**
Description: **Tap Factory Active**

Distance (ft): **140.3**
Structural Grade: **0**
O&M Grade: **0**
Clock Start/From: **9**
Clock To:
1st Value: **4.000**
2nd Value:
Value Percent:
Continuous Index:
Within 8" of Joint:
Remarks:

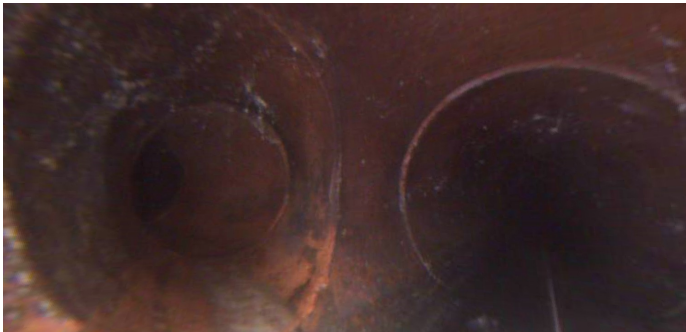
Code: **TFA**
Description: **Tap Factory Active**

Distance (ft): **197.4**
Structural Grade: **0**
O&M Grade: **0**
Clock Start/From: **3**
Clock To:
1st Value: **4.000**
2nd Value:
Value Percent:
Continuous Index:
Within 8" of Joint:
Remarks:

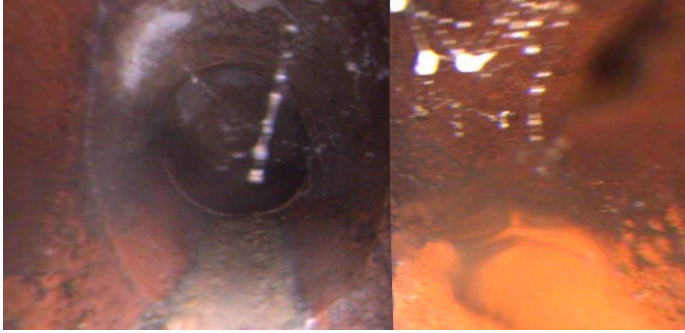
Code: **TF**
Description: **Tap Factory**

Distance (ft): **204.4**
Structural Grade: **0**
O&M Grade: **0**
Clock Start/From: **9**
Clock To:
1st Value: **4.000**
2nd Value:
Value Percent:
Continuous Index:
Within 8" of Joint:
Remarks:

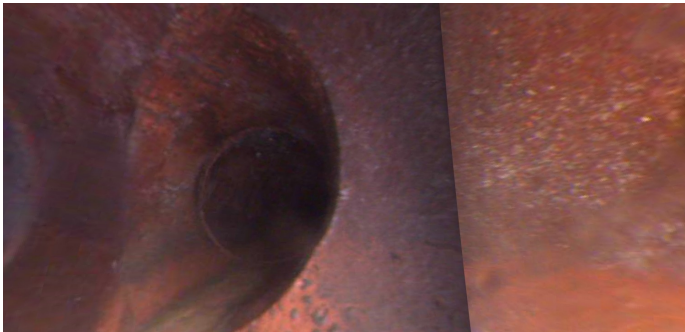
Code: **TFA**
Description: **Tap Factory Active**

Distance (ft): **246.7**
Structural Grade: **0**
O&M Grade: **0**
Clock Start/From: **9**
Clock To:
1st Value: **4.000**
2nd Value:
Value Percent:
Continuous Index:
Within 8" of Joint:
Remarks:

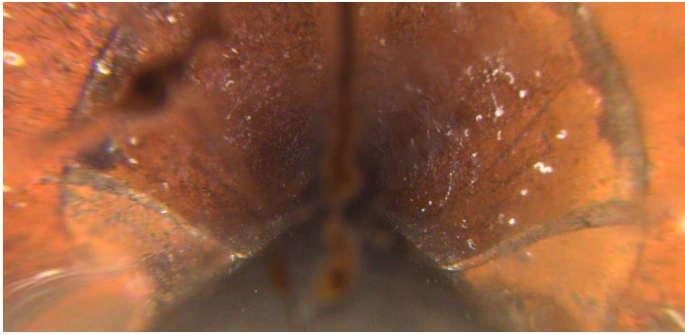
| | Position | Code | Observation | Video (sec) | Grade |
|--|---|---|---|---|---|
| | 312.0 | FM | Fracture Multiple | 758 | S 4 |

Code: **FM**
Description: **Fracture Multiple**

Distance (ft): **312.0**
Structural Grade: **4**
O&M Grade: **0**
Clock Start/From: **8**
Clock To: **4**
1st Value:
2nd Value:
Value Percent:
Continuous Index:
Within 8" of Joint: **YES**
Remarks:

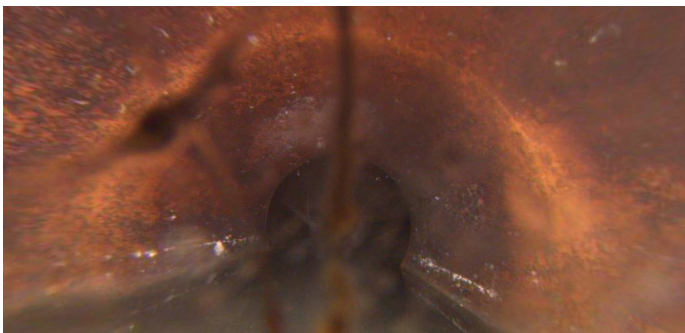
| | Position | Code | Observation | Video (sec) | Grade |
|--|---|---|---|---|---|
| | 335.9 | FC | Fracture Circumferential | 817 | S 2 |

Code: **FC**
Description: **Fracture Circumferential**

Distance (ft): **335.9**
Structural Grade: **2**
O&M Grade: **0**
Clock Start/From: **8**
Clock To: **4**
1st Value:
2nd Value:
Value Percent:
Continuous Index:
Within 8" of Joint:
Remarks:

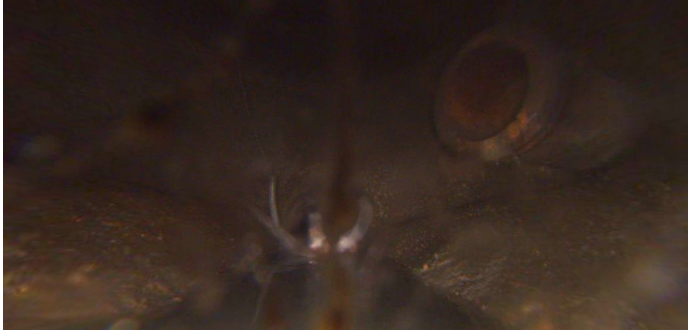
| Code: | AMH |
| Description: | Manhole |
| Distance (ft): | 337.8 |
| Remarks: | M-904-059 |
