Profile/Photo Observation Report

Date:	04/05/2018	Weather:		Coding:	PACP 6.0
Pipe Length (ft):	325.0	Owner:	NA	Pre Clean:	Not Known
P.O.#:		Surveyor:	Jen Costello	PSR:	P-904-062-061
Customer:		Clean Date:	01/01/1900	Shape:	C

Street:	DIVISION ST & SHELBY ST	Flow Control:	Not Controlled
City:	Hobart, IN	Year Renewed:	
Location:	Other	Tape/Media #:	
Purpose:	Not Known	Dia/Height:	10"
Use:	Sanitary	Material:	VCP
Drain Area:	NA	Lining:	
Category:	NA		
Comment:

Location Details:		Direction of Survey:	Downstream
US MH:	M-904-062	DS MH:	M-904-061
		Total Length Surveyed (ft):	319.9

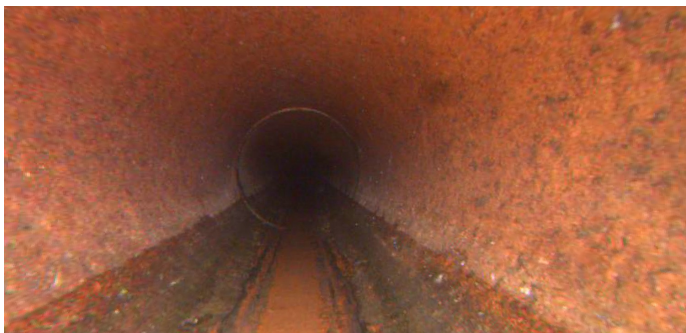
Code: **AMH**
Description: **Manhole**

Distance (ft): **.0**
Structural Grade: **0**
O&M Grade: **0**
Clock Start/From:
Clock To:
1st Value:
2nd Value:
Value Percent:
Continuous Index:
Within 8" of Joint: **NO**
Remarks: **M-904-062**

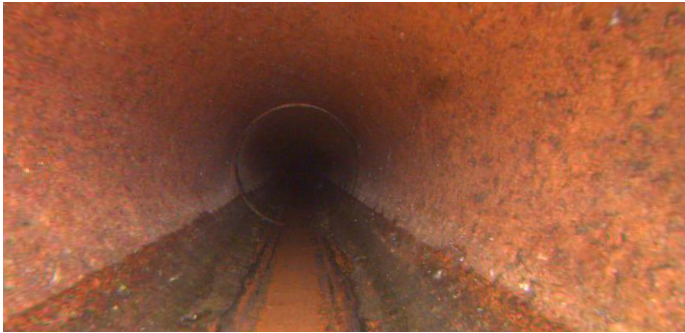
Code:	MWL
Description:	Water Level

Distance (ft):	.0
Structural Grade:	0
O&M Grade:	0
Clock Start/From:	
Clock To:	
1st Value:	
2nd Value:	
Value Percent:	5.000
Continuous Index:	
Within 8" of Joint:	NO
Remarks:

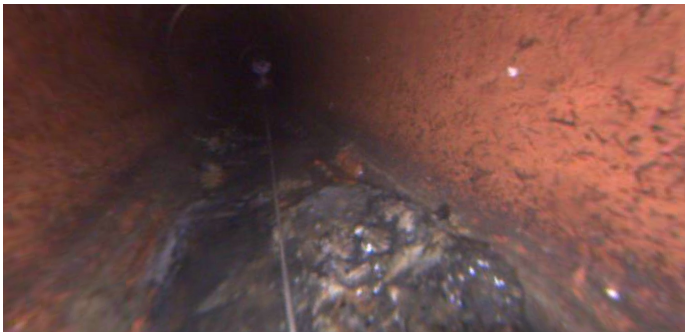
Code:	OBR
Description:	Obstacle Rocks

Distance (ft):	15.0
Structural Grade:	0
O&M Grade:	2
Clock Start/From:	6
Clock To:	7
1st Value:	
2nd Value:	
Value Percent:	5.000
Continuous Index:	
Within 8" of Joint:	NO
Remarks:

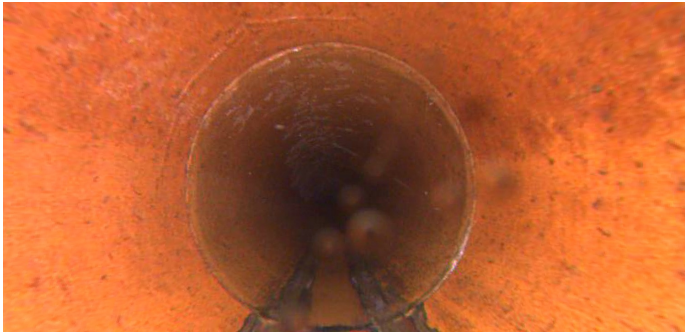
Code: **CC**
Description: **Crack Circumferential**

Distance (ft): **27.0**
Structural Grade: **1**
O&M Grade: **0**
Clock Start/From: **9**
Clock To: **12**
1st Value:
2nd Value:
Value Percent:
Continuous Index:
Within 8" of Joint:
Remarks:

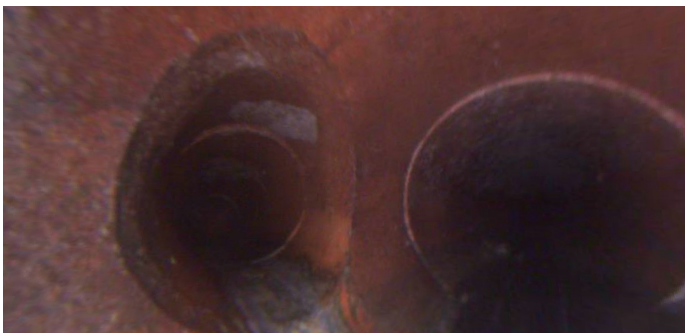
Code: **TFA**
Description: **Tap Factory Active**

Distance (ft): **68.9**
Structural Grade: **0**
O&M Grade: **0**
Clock Start/From: **3**
Clock To:
1st Value: **4.000**
2nd Value:
Value Percent:
Continuous Index:
Within 8" of Joint:
Remarks:

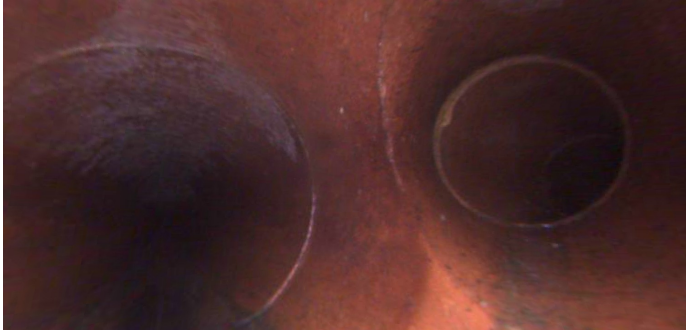
Code: **TF**
Description: **Tap Factory**

Distance (ft): **80.7**
Structural Grade: **0**
O&M Grade: **0**
Clock Start/From: **9**
Clock To:
1st Value: **4.000**
2nd Value:
Value Percent:
Continuous Index:
Within 8" of Joint:
Remarks:

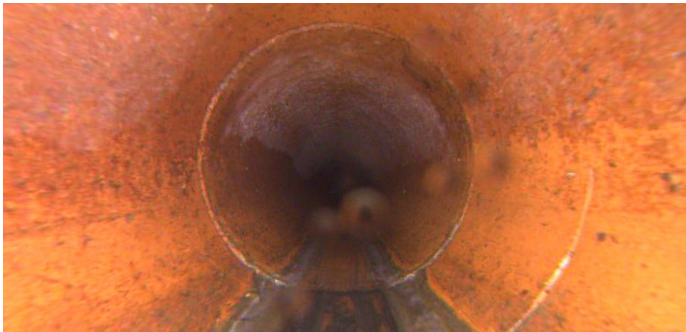
Code: **FC**
Description: **Fracture Circumferential**

Distance (ft): **120.9**
Structural Grade: **2**
O&M Grade: **0**
Clock Start/From: **3**
Clock To: **5**
1st Value:
2nd Value:
Value Percent:
Continuous Index:
Within 8" of Joint:
Remarks:

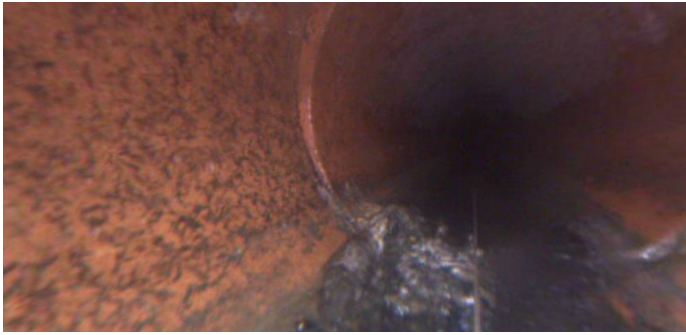
Code: **DSZ**
Description: **Deposits Settled Other**

Distance (ft): **127.5**
Structural Grade: **0**
O&M Grade: **2**
Clock Start/From: **4**
Clock To: **5**
1st Value:
2nd Value:
Value Percent: **5.000**
Continuous Index:
Within 8" of Joint: **YES**
Remarks: **MISC**

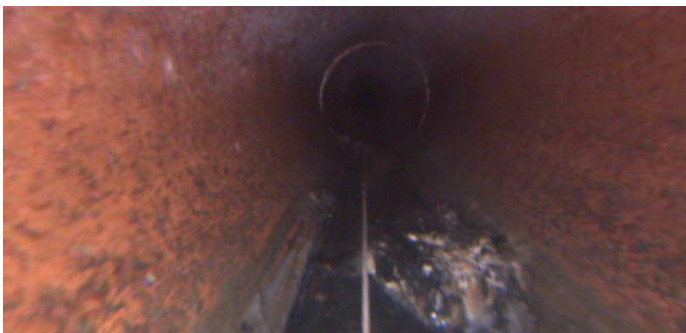
Code: **DSZ**
Description: **Deposits Settled Other**

Distance (ft): **129.2**
Structural Grade: **0**
O&M Grade: **2**
Clock Start/From: **5**
Clock To: **6**
1st Value:
2nd Value:
Value Percent: **5.000**
Continuous Index:
Within 8" of Joint: **NO**
Remarks: **MISC**

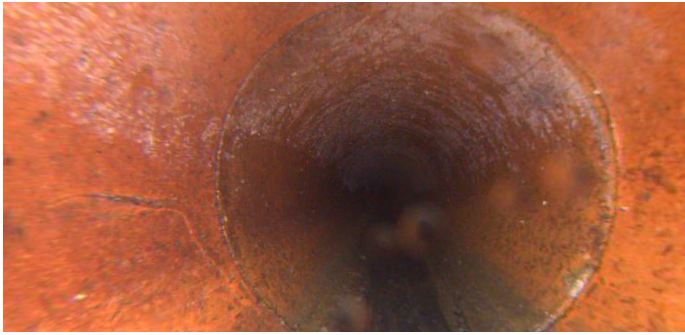
Code: **FS**
Description: **Fracture Spiral**

Distance (ft): **146.4**
Structural Grade: **3**
O&M Grade: **0**
Clock Start/From: **7**
Clock To: **9**
1st Value:
2nd Value:
Value Percent:
Continuous Index:
Within 8" of Joint: **YES**
Remarks:

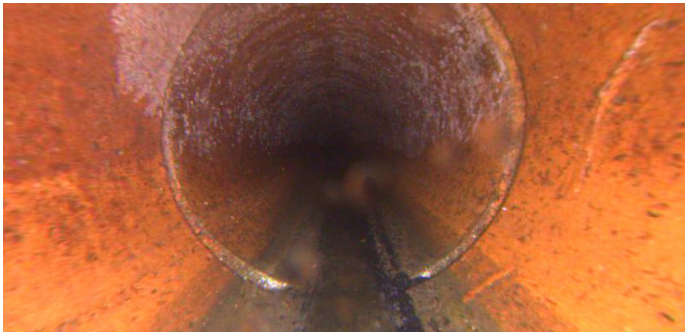
Code: **FC**
Description: **Fracture Circumferential**

Distance (ft): **166.4**
Structural Grade: **2**
O&M Grade: **0**
Clock Start/From: **3**
Clock To: **4**
1st Value:
2nd Value:
Value Percent:
Continuous Index:
Within 8" of Joint: **YES**
Remarks:

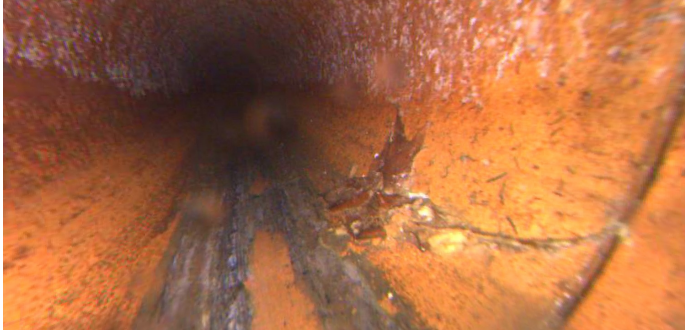
Code: **RFJ**
Description: **Roots Fine Joint**

Distance (ft): **197.0**
Structural Grade: **0**
O&M Grade: **1**
Clock Start/From: **3**
Clock To:
1st Value:
2nd Value:
Value Percent:
Continuous Index:
Within 8" of Joint: **YES**
Remarks:

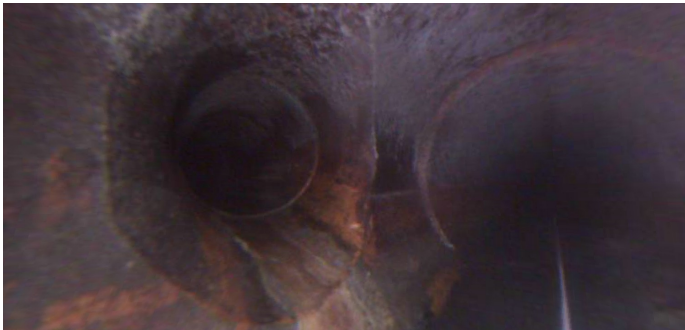
Code: **TFA**
Description: **Tap Factory Active**

Distance (ft): **273.6**
Structural Grade: **0**
O&M Grade: **0**
Clock Start/From: **3**
Clock To:
1st Value: **4.000**
2nd Value:
Value Percent:
Continuous Index:
Within 8" of Joint:
Remarks:

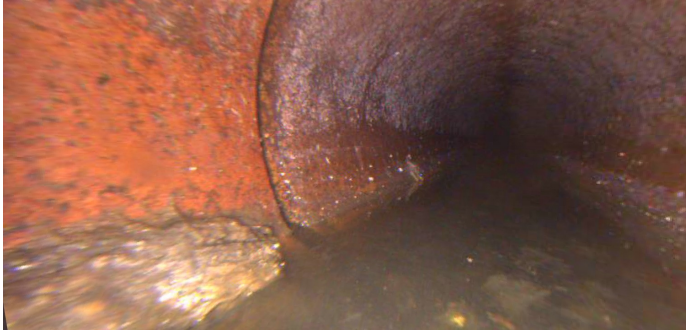
Code: **DAE**
Description: **Deposits Attached Encrustation**

Distance (ft): **298.9**
Structural Grade: **0**
O&M Grade: **2**
Clock Start/From: **8**
Clock To: **9**
1st Value:
2nd Value:
Value Percent: **5.000**
Continuous Index:
Within 8" of Joint: **NO**
Remarks:

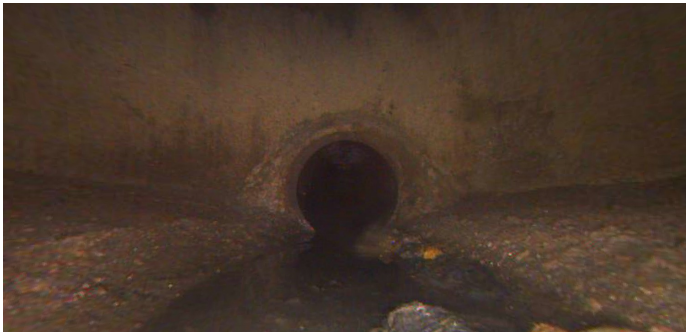
Code: **AMH**
Description: **Manhole**

Distance (ft): **319.9**
Structural Grade: **0**
O&M Grade: **0**
Clock Start/From:
Clock To:
1st Value:
2nd Value:
Value Percent:
Continuous Index:
Within 8" of Joint: **NO**
Remarks: **M-904-061**
