Profile/Photo Observation Report

Date:	04/05/2018	Weather:		Coding:	PACP 6.0
Pipe Length (ft):	325.0	Owner:	NA	Pre Clean:	Not Known
P.O.#:		Surveyor:	Jen Costello	PSR:	P-904-062-061
Customer:		Clean Date:	01/01/1900	Shape:	C

Street:	Division St.	Flow Control:	Not Controlled
City:	Hobart, IN	Year Renewed:	
Location:	Other	Tape/Media #:	
Purpose:	Not Known	Dia/Height:	10"
Use:	Sanitary	Material:	VCP
Drain Area:	NA	Lining:	
Category:	NA		
Comment:

Location Details:		Direction of Survey:	Downstream
US MH:	M-904-062	DS MH:	M-904-061
		Total Length Surveyed (ft):	319.9

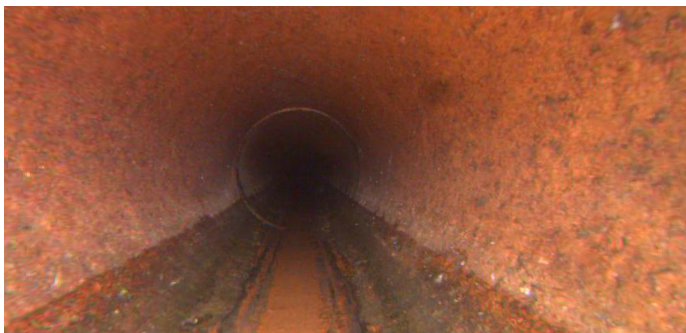
Code: **AMH**
Description: **Manhole**

Distance (ft): **.0**
Structural Grade: **0**
O&M Grade: **0**
Clock Start/From:
Clock To:
1st Value:
2nd Value:
Value Percent:
Continuous Index:
Within 8" of Joint: **NO**
Remarks: **M-904-062**

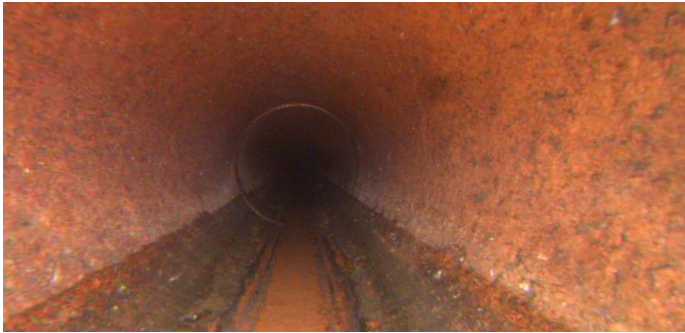
Code:	MWL
Description:	Water Level

Distance (ft):	.0
Structural Grade:	0
O&M Grade:	0
Clock Start/From:	
Clock To:	
1st Value:	
2nd Value:	
Value Percent:	5.000
Continuous Index:	
Within 8" of Joint:	NO
Remarks:

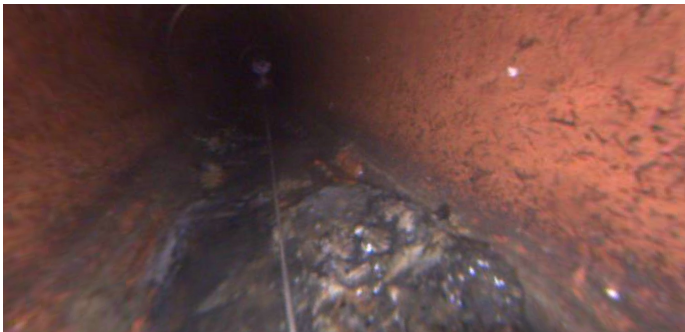
Code:	OBR
Description:	Obstacle Rocks

Distance (ft):	15.0
Structural Grade:	0
O&M Grade:	2
Clock Start/From:	6
Clock To:	7
1st Value:	
2nd Value:	
Value Percent:	5.000
Continuous Index:	
Within 8" of Joint:	NO
Remarks:

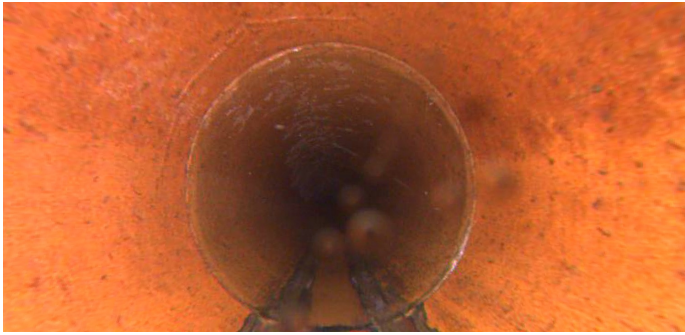
Code: **CC**
Description: **Crack Circumferential**

Distance (ft): **27.0**
Structural Grade: **1**
O&M Grade: **0**
Clock Start/From: **9**
Clock To: **12**
1st Value:
2nd Value:
Value Percent:
Continuous Index:
Within 8" of Joint:
Remarks:

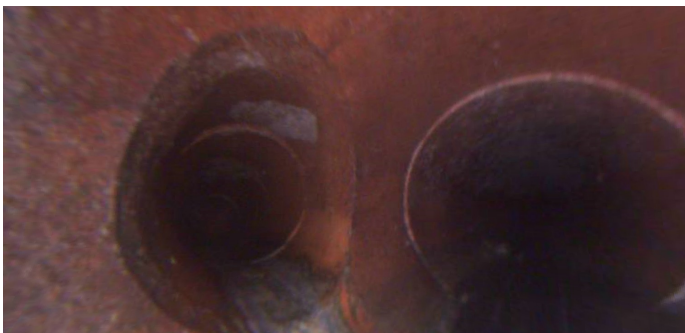
Code: **TFA**
Description: **Tap Factory Active**

Distance (ft): **68.9**
Structural Grade: **0**
O&M Grade: **0**
Clock Start/From: **3**
Clock To:
1st Value: **4.000**
2nd Value:
Value Percent:
Continuous Index:
Within 8" of Joint:
Remarks:

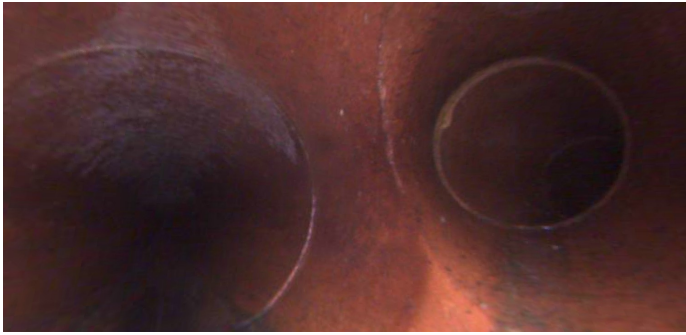
Code: **TF**
Description: **Tap Factory**

Distance (ft): **80.7**
Structural Grade: **0**
O&M Grade: **0**
Clock Start/From: **9**
Clock To:
1st Value: **4.000**
2nd Value:
Value Percent:
Continuous Index:
Within 8" of Joint:
Remarks:

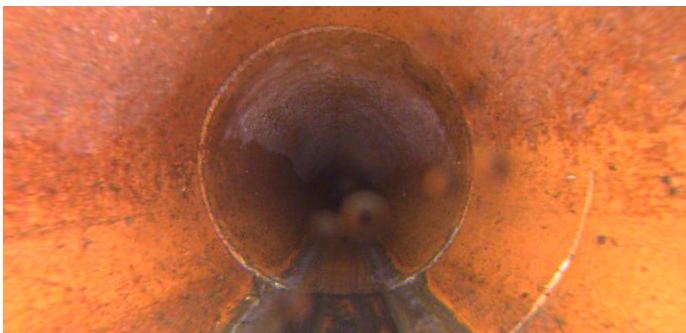
Code: **FC**
Description: **Fracture Circumferential**

Distance (ft): **120.9**
Structural Grade: **2**
O&M Grade: **0**
Clock Start/From: **3**
Clock To: **5**
1st Value:
2nd Value:
Value Percent:
Continuous Index:
Within 8" of Joint:
Remarks:

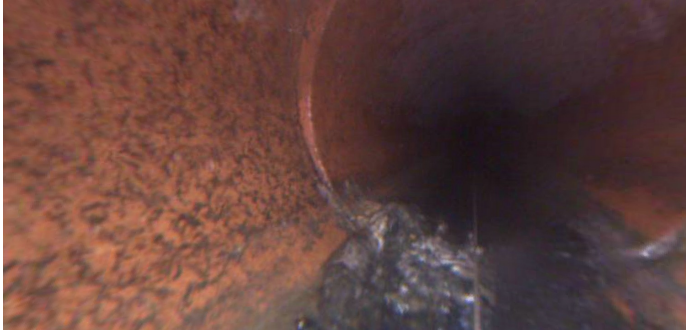
Code: **DSZ**
Description: **Deposits Settled Other**

Distance (ft): **127.5**
Structural Grade: **0**
O&M Grade: **2**
Clock Start/From: **4**
Clock To: **5**
1st Value:
2nd Value:
Value Percent: **5.000**
Continuous Index:
Within 8" of Joint: **YES**
Remarks: **MISC**

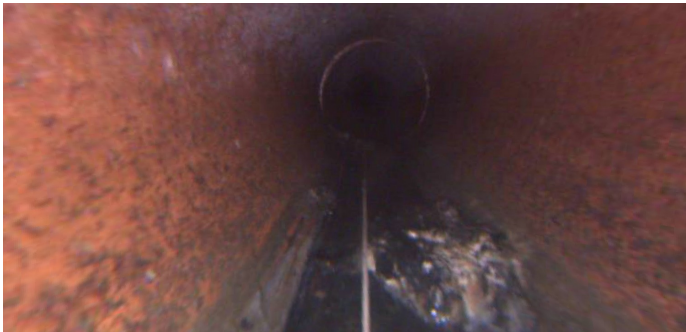
Code: **DSZ**
Description: **Deposits Settled Other**

Distance (ft): **129.2**
Structural Grade: **0**
O&M Grade: **2**
Clock Start/From: **5**
Clock To: **6**
1st Value:
2nd Value:
Value Percent: **5.000**
Continuous Index:
Within 8" of Joint: **NO**
Remarks: **MISC**

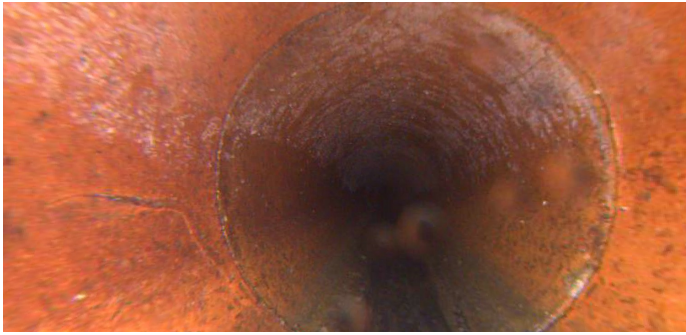
Code: **FS**
Description: **Fracture Spiral**

Distance (ft): **146.4**
Structural Grade: **3**
O&M Grade: **0**
Clock Start/From: **7**
Clock To: **9**
1st Value:
2nd Value:
Value Percent:
Continuous Index:
Within 8" of Joint: **YES**
Remarks:

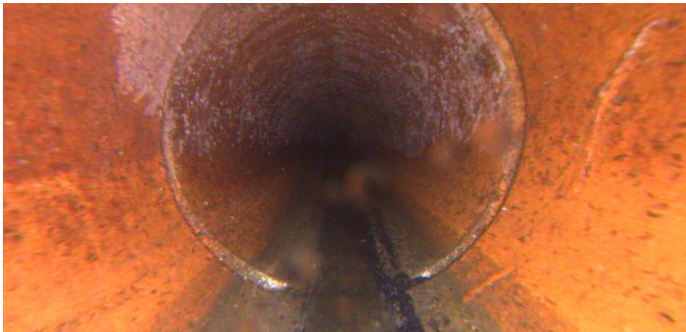
Code: **FC**
Description: **Fracture Circumferential**

Distance (ft): **166.4**
Structural Grade: **2**
O&M Grade: **0**
Clock Start/From: **3**
Clock To: **4**
1st Value:
2nd Value:
Value Percent:
Continuous Index:
Within 8" of Joint: **YES**
Remarks:

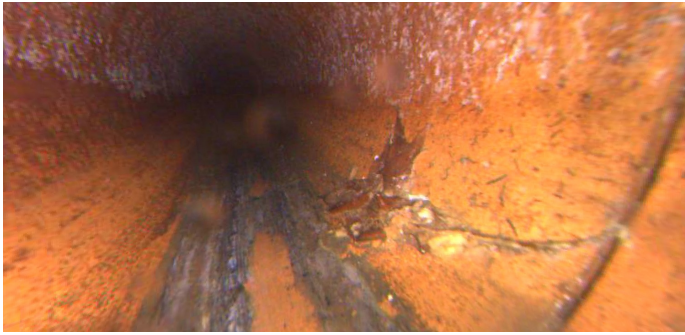
Code: **RFJ**
Description: **Roots Fine Joint**

Distance (ft): **197.0**
Structural Grade: **0**
O&M Grade: **1**
Clock Start/From: **3**
Clock To:
1st Value:
2nd Value:
Value Percent:
Continuous Index:
Within 8" of Joint: **YES**
Remarks:

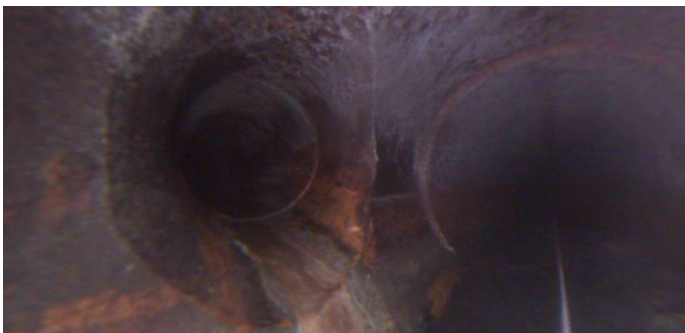
Code: **TFA**
Description: **Tap Factory Active**

Distance (ft): **273.6**
Structural Grade: **0**
O&M Grade: **0**
Clock Start/From: **3**
Clock To:
1st Value: **4.000**
2nd Value:
Value Percent:
Continuous Index:
Within 8" of Joint:
Remarks:

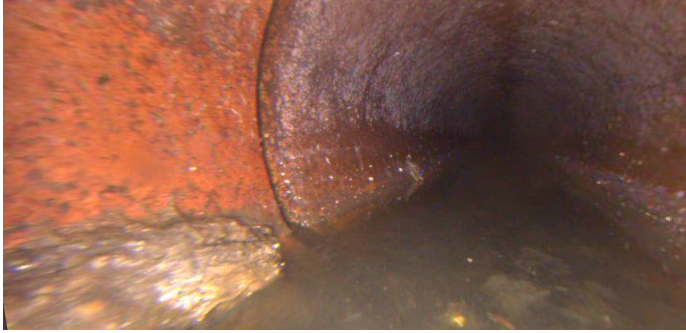
Code: **DAE**
Description: **Deposits Attached Encrustation**

Distance (ft): **298.9**
Structural Grade: **0**
O&M Grade: **2**
Clock Start/From: **8**
Clock To: **9**
1st Value:
2nd Value:
Value Percent: **5.000**
Continuous Index:
Within 8" of Joint: **NO**
Remarks:

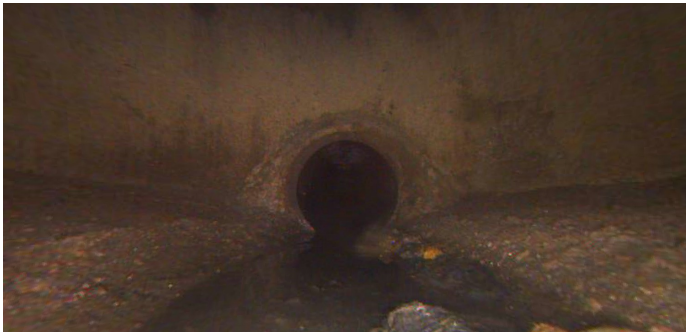
Code: **AMH**
Description: **Manhole**

Distance (ft): **319.9**
Structural Grade: **0**
O&M Grade: **0**
Clock Start/From:
Clock To:
1st Value:
2nd Value:
Value Percent:
Continuous Index:
Within 8" of Joint: **NO**
Remarks: **M-904-061**
