## Profile/Photo Observation Report

Street:	<b>Shelby St.</b>	Flow Control:	<b>Not Controlled</b>
City:	<b>Hobart, IN</b>	Year Renewed:	
Location:	<b>Other</b>	Tape/Media #:	
Purpose:	<b>Not Known</b>	Dia/Height:	<b>8"</b>
Use:	<b>Sanitary</b>	Material:	<b>VCP</b>
Drain Area:	<b>NA</b>	Lining:	
Category:	<b>NA</b>		
Comment:

Location Details:		Direction of Survey:	<b>Upstream</b>
US MH:	<b>M-904-062</b>	DS MH:	<b>M-904-063</b>
		Total Length Surveyed (ft):	<b>23.8</b>

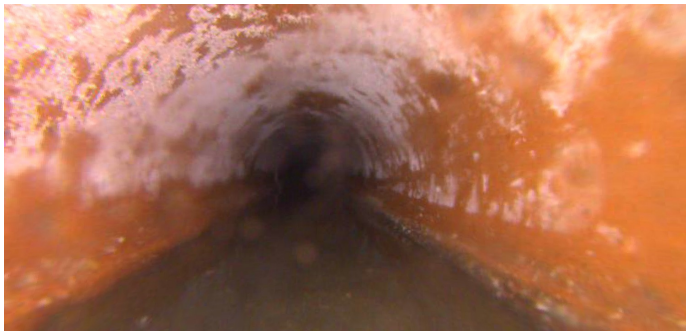
Code: **AMH**  
Description: **Manhole**

Distance (ft): **.0**  
Structural Grade: **0**  
O&M Grade: **0**  
Clock Start/From:  
Clock To:  
1st Value:  
2nd Value:  
Value Percent:  
Continuous Index:  
Within 8" of Joint: **NO**  
Remarks: **M-904-063**

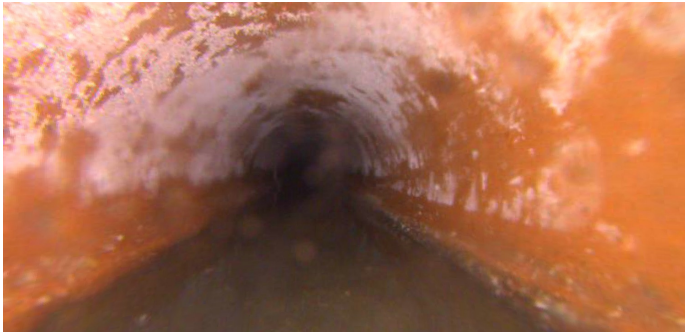
Code:	<b>MWL</b>
Description:	<b>Water Level</b>

Distance (ft):	<b>.0</b>
Structural Grade:	<b>0</b>
O&M Grade:	<b>0</b>
Clock Start/From:	
Clock To:	
1st Value:	
2nd Value:	
Value Percent:	<b>20.000</b>
Continuous Index:	
Within 8" of Joint:	<b>NO</b>
Remarks:

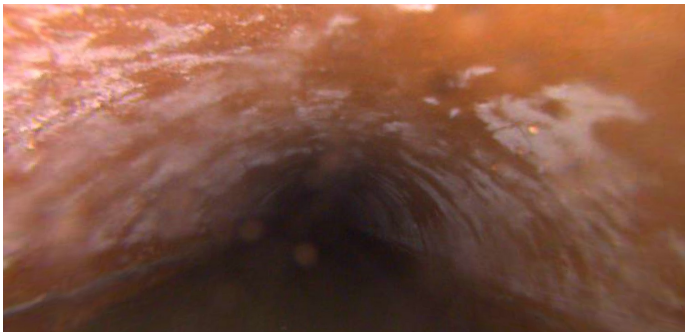
Code:	<b>MSA</b>
Description:	<b>Abandoned Survey</b>

Distance (ft):	<b>23.8</b>
Structural Grade:	<b>0</b>
O&M Grade:	<b>0</b>
Clock Start/From:	
Clock To:	
1st Value:	
2nd Value:	
Value Percent:	
Continuous Index:	
Within 8" of Joint:	<b>NO</b>
Remarks:	<b>DEBRIS UNDER WATER</b>
