Profile/Photo Observation Report

Street:	DIVISION ST & SHELBY ST	Flow Control:	Not Controlled
City:	Hobart, IN	Year Renewed:	
Location:	Other	Tape/Media #:	
Purpose:	Not Known	Dia/Height:	8"
Use:	Sanitary	Material:	VCP
Drain Area:	NA	Lining:	
Category:	NA		
Comment:

Location Details:		Direction of Survey:	Downstream
US MH:	M-904-062	DS MH:	M-904-063
		Total Length Surveyed (ft):	166.6

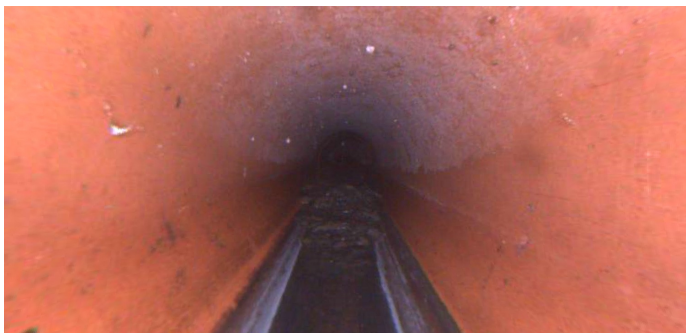
Code: **AMH**
Description: **Manhole**

Distance (ft): **.0**
Structural Grade: **0**
O&M Grade: **0**
Clock Start/From:
Clock To:
1st Value:
2nd Value:
Value Percent:
Continuous Index:
Within 8" of Joint: **NO**
Remarks: **M-904-062**

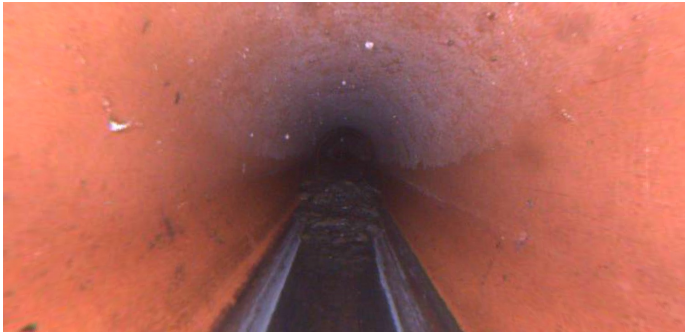
Code:	MWL
Description:	Water Level

Distance (ft):	.0
Structural Grade:	0
O&M Grade:	0
Clock Start/From:	
Clock To:	
1st Value:	
2nd Value:	
Value Percent:	5.000
Continuous Index:	
Within 8" of Joint:	NO
Remarks:

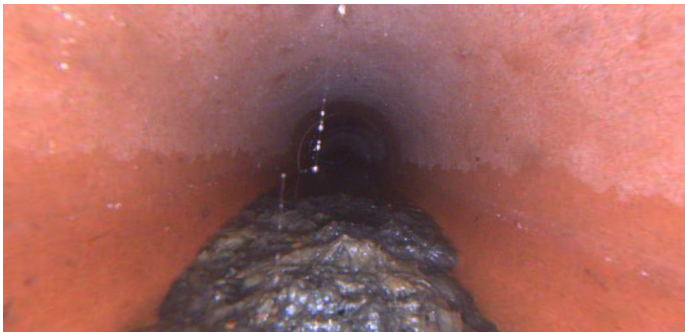
Code:	DSZ
Description:	Deposits Settled Other

Distance (ft):	2.5
Structural Grade:	0
O&M Grade:	3
Clock Start/From:	4
Clock To:	8
1st Value:	
2nd Value:	
Value Percent:	20.000
Continuous Index:	
Within 8" of Joint:	NO
Remarks:	MISC

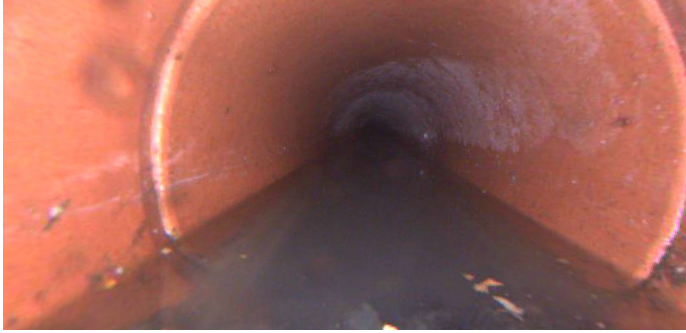
Code: **MWL**
Description: **Water Level**

Distance (ft): **4.1**
Structural Grade: **0**
O&M Grade: **0**
Clock Start/From:
Clock To:
1st Value:
2nd Value:
Value Percent: **5.000**
Continuous Index:
Within 8" of Joint: **NO**
Remarks:

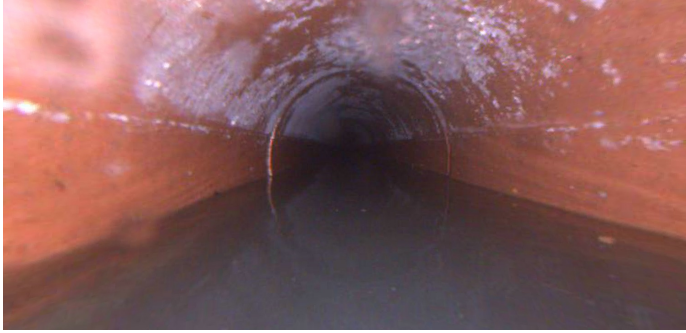
Code: **MWL**
Description: **Water Level**

Distance (ft): **18.4**
Structural Grade: **0**
O&M Grade: **0**
Clock Start/From:
Clock To:
1st Value:
2nd Value:
Value Percent: **40.000**
Continuous Index:
Within 8" of Joint: **NO**
Remarks:

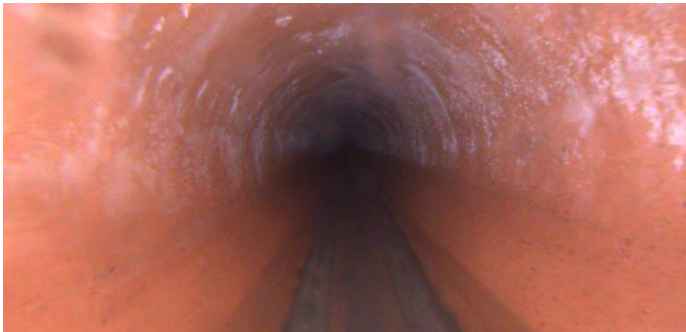
Code: **MWL**
Description: **Water Level**

Distance (ft): **41.6**
Structural Grade: **0**
O&M Grade: **0**
Clock Start/From:
Clock To:
1st Value:
2nd Value:
Value Percent: **5.000**
Continuous Index:
Within 8" of Joint: **NO**
Remarks:

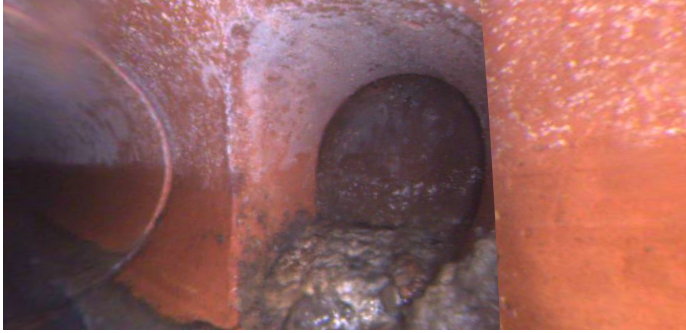
Code: **TFC**
Description: **Tap Factory Capped**

Distance (ft): **80.7**
Structural Grade: **0**
O&M Grade: **0**
Clock Start/From: **3**
Clock To:
1st Value: **4.000**
2nd Value:
Value Percent:
Continuous Index:
Within 8" of Joint:
Remarks:

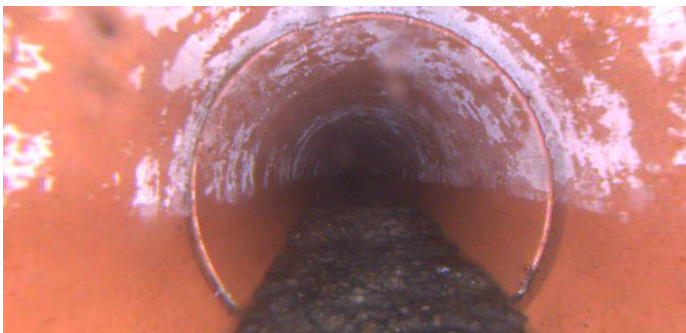
Code: **DSF**
Description: **Deposits Settled Fine**

Distance (ft): **141.4**
Structural Grade: **0**
O&M Grade: **2**
Clock Start/From: **5**
Clock To: **7**
1st Value:
2nd Value:
Value Percent: **10.000**
Continuous Index:
Within 8" of Joint: **NO**
Remarks:

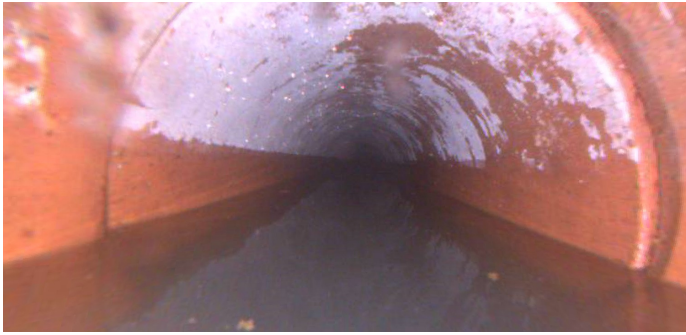
Code: **MWL**
Description: **Water Level**

Distance (ft): **146.7**
Structural Grade: **0**
O&M Grade: **0**
Clock Start/From:
Clock To:
1st Value:
2nd Value:
Value Percent: **40.000**
Continuous Index:
Within 8" of Joint: **NO**
Remarks:

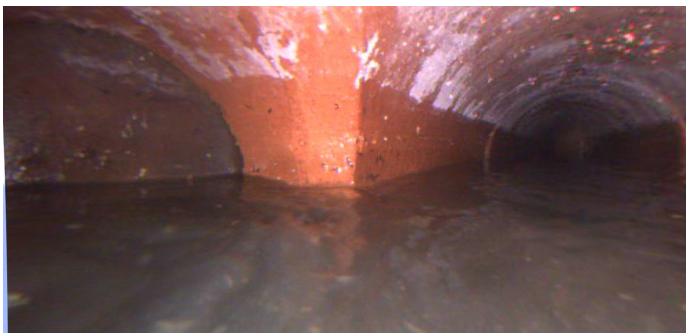
Code: **TFC**
Description: **Tap Factory Capped**

Distance (ft): **153.6**
Structural Grade: **0**
O&M Grade: **0**
Clock Start/From: **3**
Clock To:
1st Value: **4.000**
2nd Value:
Value Percent:
Continuous Index:
Within 8" of Joint:
Remarks:
