## Profile/Photo Observation Report

Street:	<b>DIVISION ST &amp; SHELBY ST</b>	Flow Control:	<b>Not Controlled</b>
City:	<b>Hobart, IN</b>	Year Renewed:	
Location:	<b>Light Highway</b>	Tape/Media #:	
Purpose:	<b>Routine Assessment</b>	Dia/Height:	<b>8"</b>
Use:	<b>Sanitary</b>	Material:	<b>VCP</b>
Drain Area:	<b>NA</b>	Lining:	
Category:	<b>NA</b>		
Comment:

Location Details:		Direction of Survey:	<b>Upstream</b>
US MH:	<b>M-904-062</b>	DS MH:	<b>M-904-063</b>
		Total Length Surveyed (ft):	<b>40.6</b>

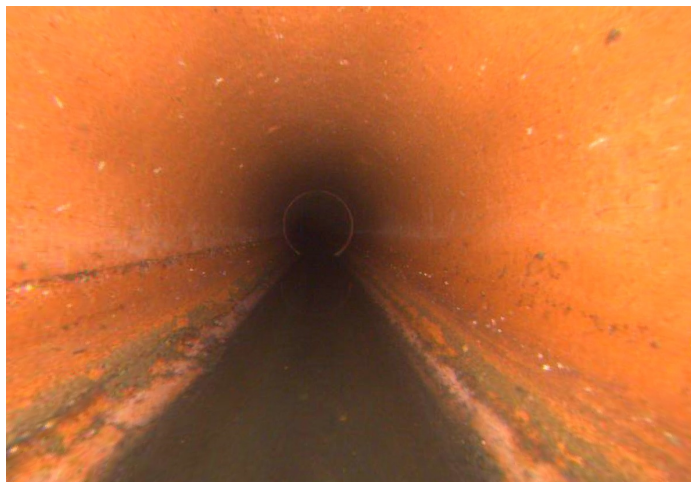
Code: **AMH**  
Description: **Manhole**

Distance (ft): **.0**  
Structural Grade: **0**  
O&M Grade: **0**  
Clock Start/From:  
Clock To:  
1st Value:  
2nd Value:  
Value Percent:  
Continuous Index:  
Within 8" of Joint: **NO**  
Remarks: **M-904-063**

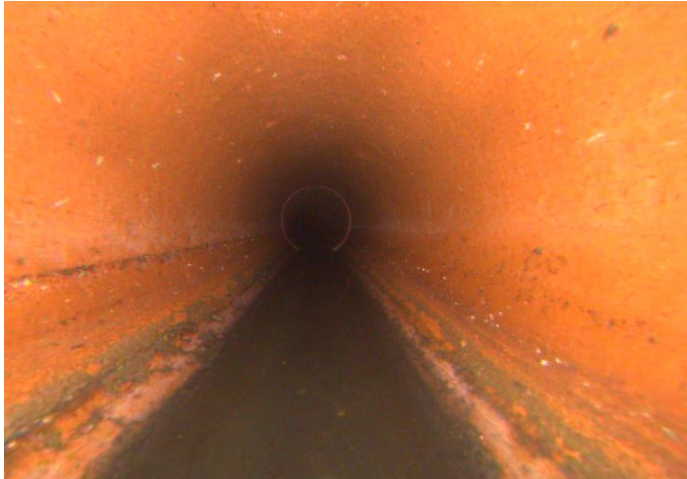
Code:	<b>MWL</b>
Description:	<b>Water Level</b>
Distance (ft):	<b>.0</b>
Structural Grade:	<b>0</b>
O&M Grade:	<b>0</b>
Clock Start/From:	
Clock To:	
1st Value:	
2nd Value:	
Value Percent:	<b>10.000</b>
Continuous Index:	
Within 8" of Joint:	<b>NO</b>
Remarks:

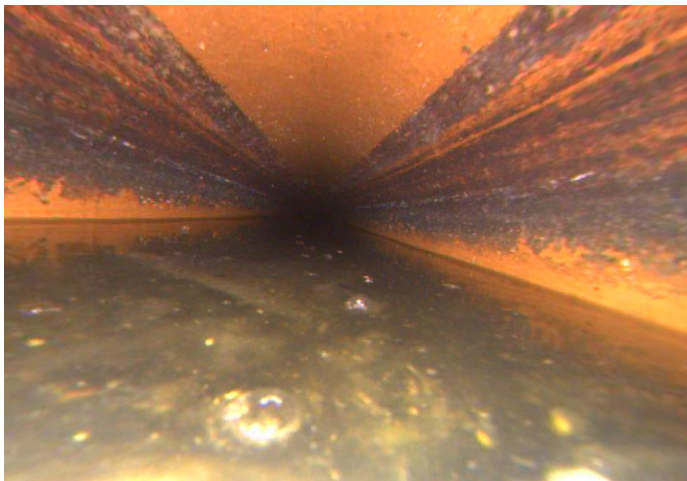
Code:	<b>MWL</b>
Description:	<b>Water Level</b>
Distance (ft):	<b>36.1</b>
Structural Grade:	<b>0</b>
O&M Grade:	<b>0</b>
Clock Start/From:	
Clock To:	
1st Value:	
2nd Value:	
Value Percent:	<b>45.000</b>
Continuous Index:	
Within 8" of Joint:	<b>NO</b>
Remarks:

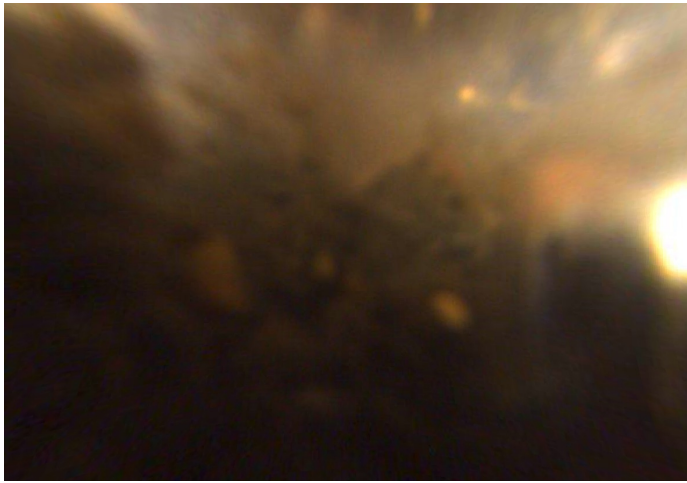
Code: **MCU**  
Description: **Camera Underwater**

Distance (ft): **38.5**  
Structural Grade: **0**  
O&M Grade: **4**  
Clock Start/From:  
Clock To:  
1st Value:  
2nd Value:  
Value Percent:  
Continuous Index:  
Within 8" of Joint: **NO**  
Remarks:
