## Profile/Photo Observation Report

Street:	<b>Shelby St.</b>	Flow Control:	<b>Not Controlled</b>
City:	<b>Hobart, IN</b>	Year Renewed:	
Location:	<b>Light Highway</b>	Tape/Media #:	
Purpose:	<b>Routine Assessment</b>	Dia/Height:	<b>8"</b>
Use:	<b>Sanitary</b>	Material:	<b>VCP</b>
Drain Area:	<b>NA</b>	Lining:	
Category:	<b>NA</b>		
Comment:

Location Details:		Direction of Survey:	<b>Upstream</b>
US MH:	<b>M-904-062</b>	DS MH:	<b>M-904-063</b>
		Total Length Surveyed (ft):	<b>40.6</b>

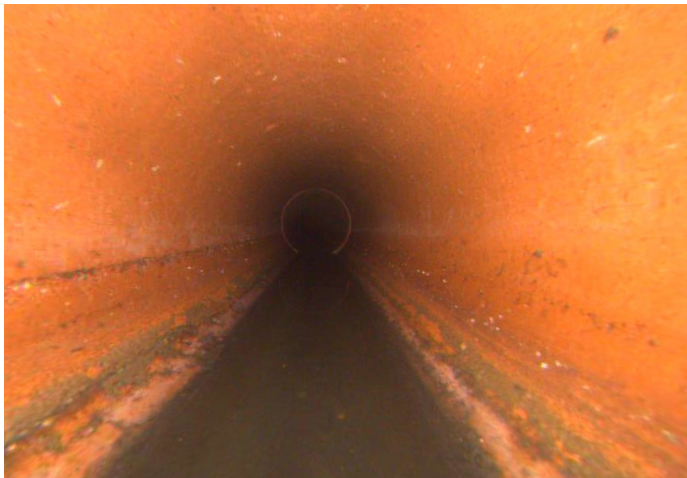
Code: **AMH**  
 Description: **Manhole**

Distance (ft): **.0**  
 Structural Grade: **0**  
 O&M Grade: **0**  
 Clock Start/From:  
 Clock To:  
 1st Value:  
 2nd Value:  
 Value Percent:  
 Continuous Index:  
 Within 8" of Joint: **NO**  
 Remarks: **M-904-063**

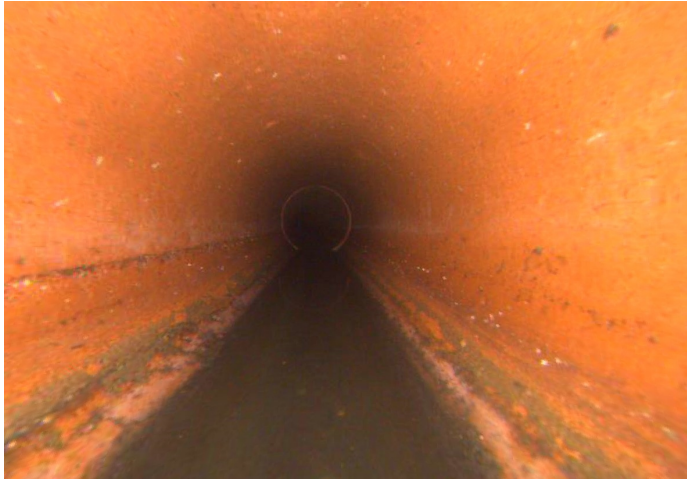
Code: **MWL**  
Description: **Water Level**

Distance (ft): **.0**  
Structural Grade: **0**  
O&M Grade: **0**  
Clock Start/From:  
Clock To:  
1st Value:  
2nd Value:  
Value Percent: **10.000**  
Continuous Index:  
Within 8" of Joint: **NO**  
Remarks:

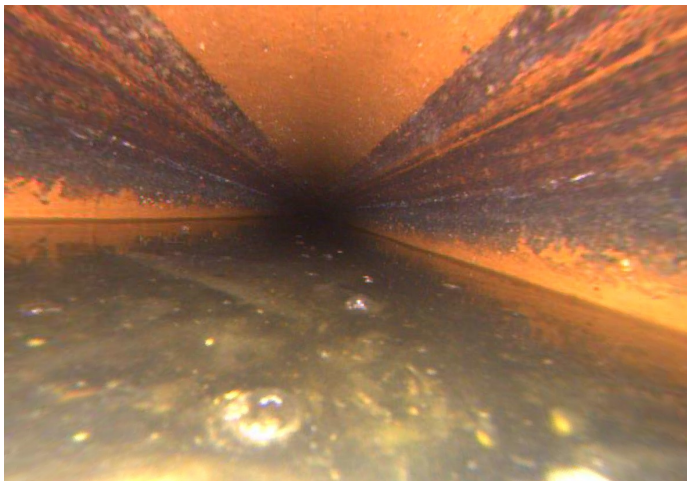
Code: **MWL**  
Description: **Water Level**

Distance (ft): **36.1**  
Structural Grade: **0**  
O&M Grade: **0**  
Clock Start/From:  
Clock To:  
1st Value:  
2nd Value:  
Value Percent: **45.000**  
Continuous Index:  
Within 8" of Joint: **NO**  
Remarks:

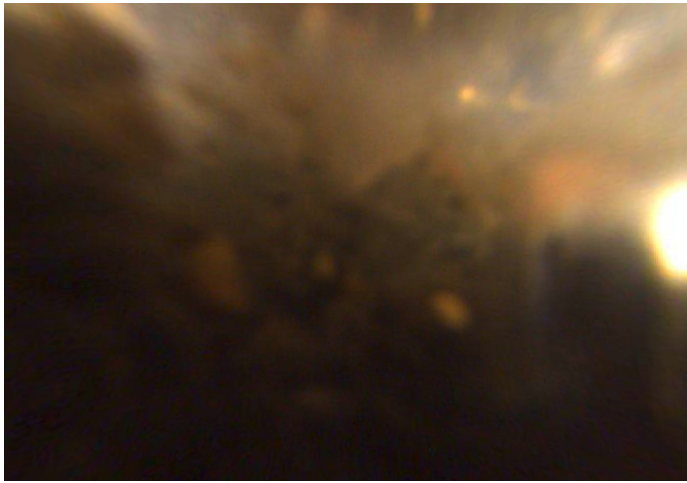
Code: **MCU**  
Description: **Camera Underwater**

Distance (ft): **38.5**  
Structural Grade: **0**  
O&M Grade: **4**  
Clock Start/From:  
Clock To:  
1st Value:  
2nd Value:  
Value Percent:  
Continuous Index:  
Within 8" of Joint: **NO**  
Remarks:
