## Profile/Photo Observation Report

Street:	<b>SHELBY ST</b>	Flow Control:	<b>Not Controlled</b>
City:	<b>Hobart, IN</b>	Year Renewed:	
Location:	<b>Other</b>	Tape/Media #:	
Purpose:	<b>Not Known</b>	Dia/Height:	<b>8"</b>
Use:	<b>Sanitary</b>	Material:	<b>PVC</b>
Drain Area:	<b>NA</b>	Lining:	
Category:	<b>NA</b>		
Comment:

Location Details:		Direction of Survey:	<b>Upstream</b>
US MH:	<b>M-904-063</b>	DS MH:	<b>M-904-072</b>
		Total Length Surveyed (ft):	<b>17.0</b>

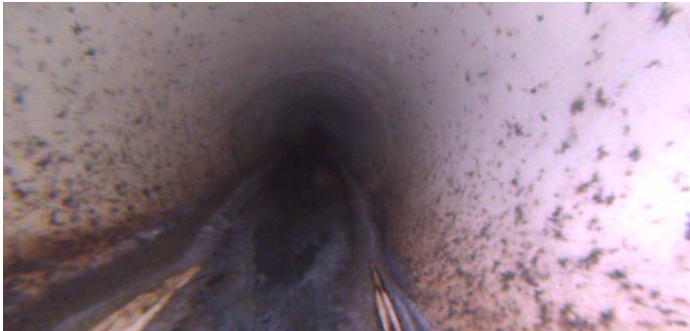
Code: AMH

Description: Manhole

Remarks: M-904-072

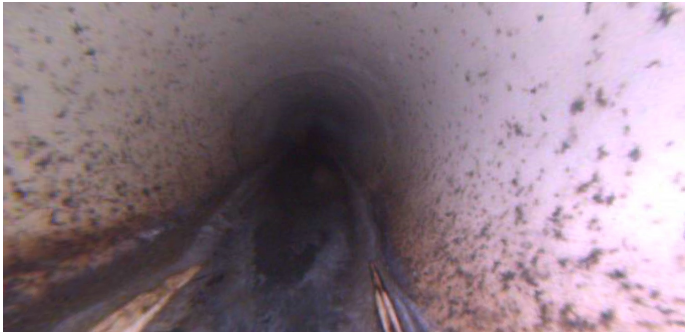
Code:	<b>MWL</b>
Description:	<b>Water Level</b>

Distance (ft):	<b>.0</b>
Structural Grade:	<b>0</b>
O&M Grade:	<b>0</b>
Clock Start/From:	
Clock To:	
1st Value:	
2nd Value:	
Value Percent:	<b>5.000</b>
Continuous Index:	
Within 8" of Joint:	<b>NO</b>
Remarks:

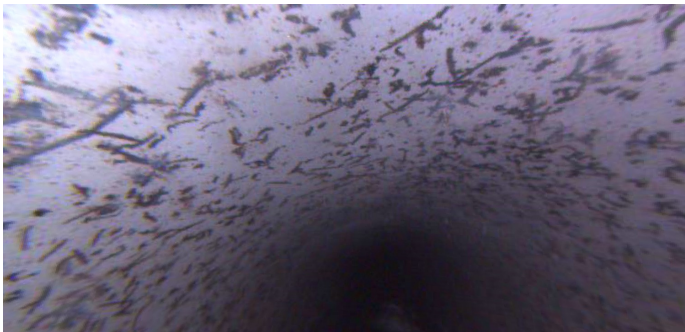
Code:	<b>MSA</b>
Description:	<b>Abandoned Survey</b>

Distance (ft):	<b>17.0</b>
Structural Grade:	<b>0</b>
O&M Grade:	<b>0</b>
Clock Start/From:	
Clock To:	
1st Value:	
2nd Value:	
Value Percent:	
Continuous Index:	
Within 8" of Joint:	<b>NO</b>
Remarks:	<b>DEBRIS UNDER WATER</b>
