## Profile/Photo Observation Report

Street:	<b>Shelby St.</b>	Flow Control:	<b>Not Controlled</b>
City:	<b>Hobart, IN</b>	Year Renewed:	
Location:	<b>Other</b>	Tape/Media #:	
Purpose:	<b>Not Known</b>	Dia/Height:	<b>8"</b>
Use:	<b>Sanitary</b>	Material:	<b>PVC</b>
Drain Area:	<b>NA</b>	Lining:	
Category:	<b>NA</b>		
Comment:

Location Details:		Direction of Survey:	<b>Upstream</b>
US MH:	<b>M-904-063</b>	DS MH:	<b>M-904-072</b>
		Total Length Surveyed (ft):	<b>17.0</b>

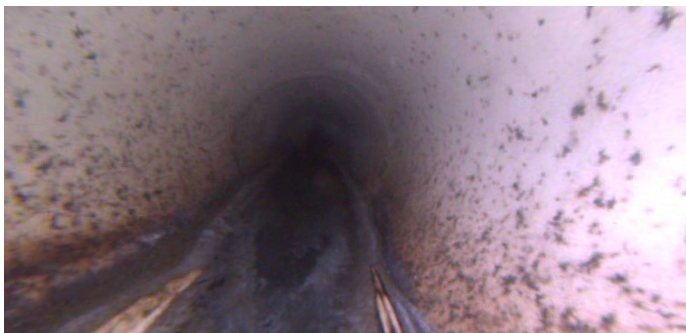
Code: **AMH**  
Description: **Manhole**

Distance (ft): **.0**  
Structural Grade: **0**  
O&M Grade: **0**  
Clock Start/From:  
Clock To:  
1st Value:  
2nd Value:  
Value Percent:  
Continuous Index:  
Within 8" of Joint: **NO**  
Remarks: **M-904-072**

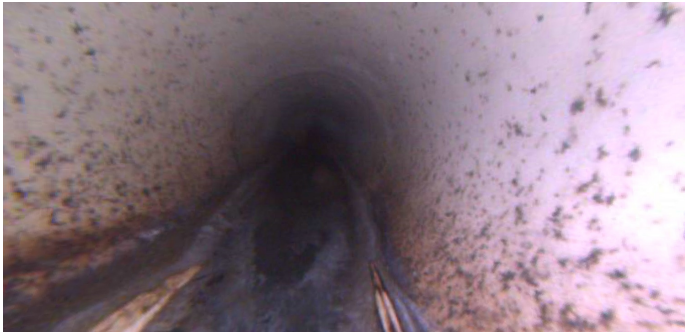
Code:	<b>MWL</b>
Description:	<b>Water Level</b>

Distance (ft):	<b>.0</b>
Structural Grade:	<b>0</b>
O&M Grade:	<b>0</b>
Clock Start/From:	
Clock To:	
1st Value:	
2nd Value:	
Value Percent:	<b>5.000</b>
Continuous Index:	
Within 8" of Joint:	<b>NO</b>
Remarks:

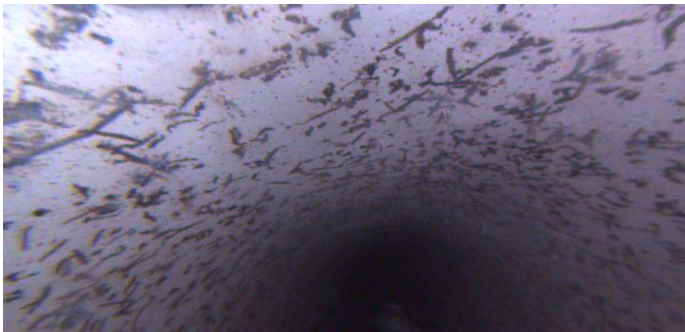
Code:	<b>MSA</b>
Description:	<b>Abandoned Survey</b>

Distance (ft):	<b>17.0</b>
Structural Grade:	<b>0</b>
O&M Grade:	<b>0</b>
Clock Start/From:	
Clock To:	
1st Value:	
2nd Value:	
Value Percent:	
Continuous Index:	
Within 8" of Joint:	<b>NO</b>
Remarks:	<b>DEBRIS UNDER WATER</b>
