Profile/Photo Observation Report

Street:	Shelby St.	Flow Control:	Not Controlled
City:	Hobart, IN	Year Renewed:	
Location:	Light Highway	Tape/Media #:	
Purpose:	Routine Assessment	Dia/Height:	8"
Use:	Sanitary	Material:	VCP
Drain Area:	NA	Lining:	
Category:	NA		
Comment:

Location Details:		Direction of Survey:	Downstream
US MH:	M-904-063	DS MH:	M-904-072
		Total Length Surveyed (ft):	287.1

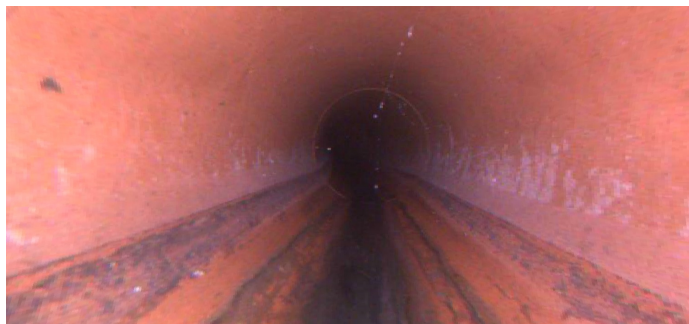
Code: **AMH**
Description: **Manhole**

Distance (ft): **.0**
Structural Grade: **0**
O&M Grade: **0**
Clock Start/From:
Clock To:
1st Value:
2nd Value:
Value Percent:
Continuous Index:
Within 8" of Joint: **NO**
Remarks: **M-904-063**

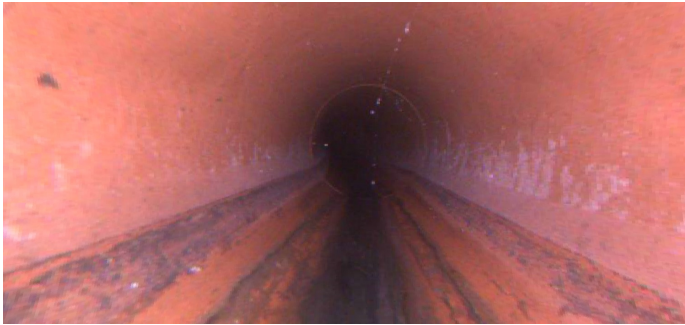
Code:	MWL
Description:	Water Level

Distance (ft):	.0
Structural Grade:	0
O&M Grade:	0
Clock Start/From:	
Clock To:	
1st Value:	
2nd Value:	
Value Percent:	5.000
Continuous Index:	
Within 8" of Joint:	NO
Remarks:

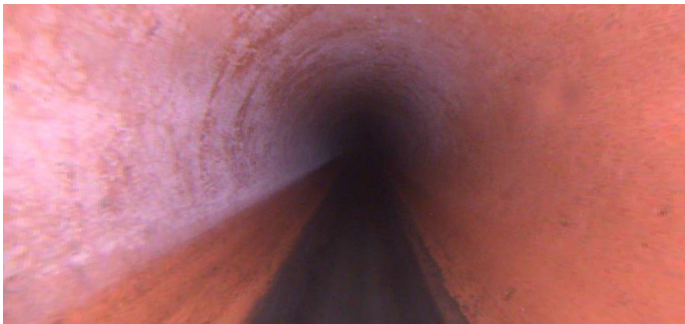
Code:	DAGS
Description:	Deposits Attached Grease

Distance (ft):	20.4
Structural Grade:	0
O&M Grade:	2
Clock Start/From:	7
Clock To:	5
1st Value:	
2nd Value:	
Value Percent:	5.000
Continuous Index:	S01
Within 8" of Joint:	YES
Remarks:	WANDER

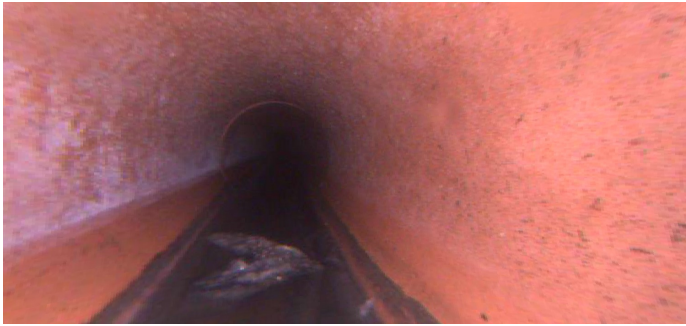
Code: **MWL**
Description: **Water Level**

Distance (ft): **41.4**
Structural Grade: **0**
O&M Grade: **0**
Clock Start/From:
Clock To:
1st Value:
2nd Value:
Value Percent: **10.000**
Continuous Index:
Within 8" of Joint: **NO**
Remarks:

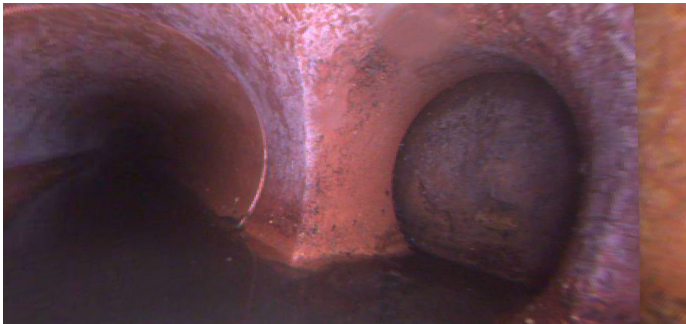
Code: **TFC**
Description: **Tap Factory Capped**

Distance (ft): **64.8**
Structural Grade: **0**
O&M Grade: **0**
Clock Start/From: **3**
Clock To:
1st Value: **6.000**
2nd Value:
Value Percent:
Continuous Index:
Within 8" of Joint:
Remarks:

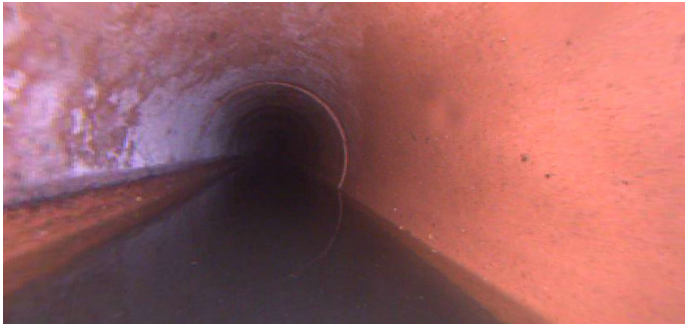
Code: **MWL**
Description: **Water Level**

Distance (ft): **69.5**
Structural Grade: **0**
O&M Grade: **0**
Clock Start/From:
Clock To:
1st Value:
2nd Value:
Value Percent: **15.000**
Continuous Index:
Within 8" of Joint: **NO**
Remarks:

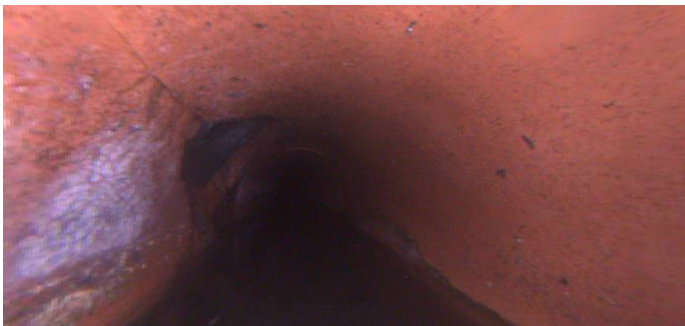
Code: **CL**
Description: **Crack Longitudinal**

Distance (ft): **113.8**
Structural Grade: **2**
O&M Grade: **0**
Clock Start/From: **10**
Clock To:
1st Value:
2nd Value:
Value Percent:
Continuous Index:
Within 8" of Joint:
Remarks:

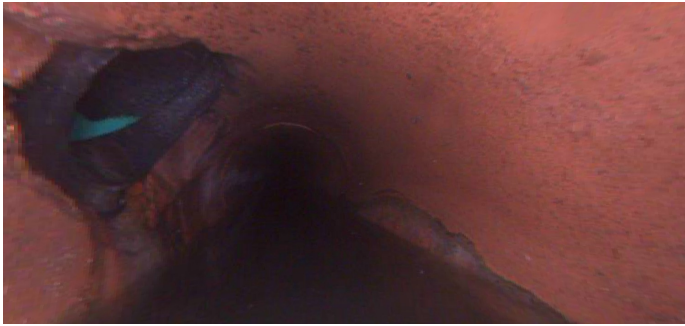
Code: **TB**
Description: **Tap Break-in**

Distance (ft): **114.2**
Structural Grade: **0**
O&M Grade: **0**
Clock Start/From: **10**
Clock To:
1st Value: **4.000**
2nd Value:
Value Percent:
Continuous Index:
Within 8" of Joint:
Remarks:

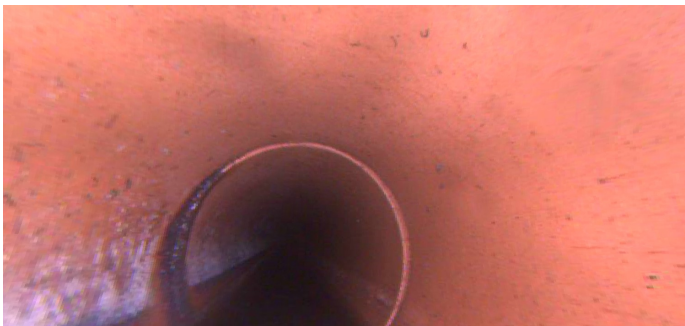
Code: **IS**
Description: **Infil Stain**

Distance (ft): **140.4**
Structural Grade: **0**
O&M Grade: **0**
Clock Start/From: **7**
Clock To: **10**
1st Value:
2nd Value:
Value Percent:
Continuous Index:
Within 8" of Joint: **YES**
Remarks:

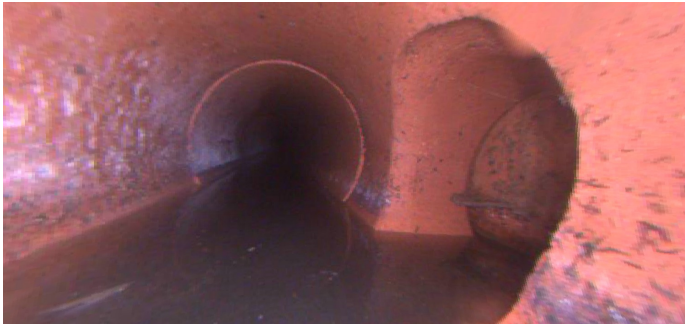
Code: **TFC**
Description: **Tap Factory Capped**

Distance (ft): **147.2**
Structural Grade: **0**
O&M Grade: **0**
Clock Start/From: **3**
Clock To:
1st Value: **4.000**
2nd Value:
Value Percent:
Continuous Index:
Within 8" of Joint:
Remarks:

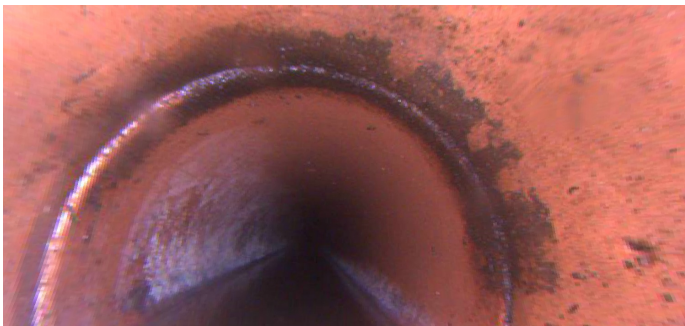
Code: **IS**
Description: **Infil Stain**

Distance (ft): **163.2**
Structural Grade: **0**
O&M Grade: **0**
Clock Start/From: **10**
Clock To: **3**
1st Value:
2nd Value:
Value Percent:
Continuous Index:
Within 8" of Joint: **YES**
Remarks:

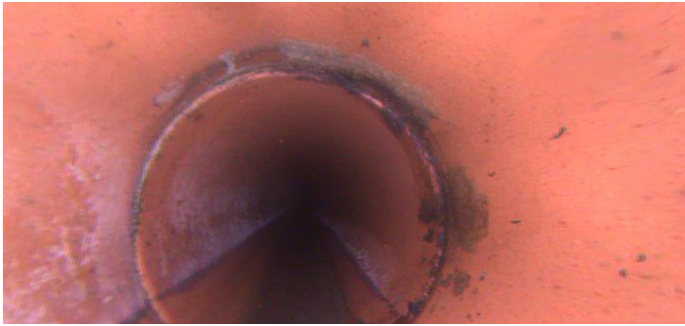
Code: **IS**
Description: **Infil Stain**

Distance (ft): **183.4**
Structural Grade: **0**
O&M Grade: **0**
Clock Start/From: **11**
Clock To: **5**
1st Value:
2nd Value:
Value Percent:
Continuous Index:
Within 8" of Joint: **YES**
Remarks:

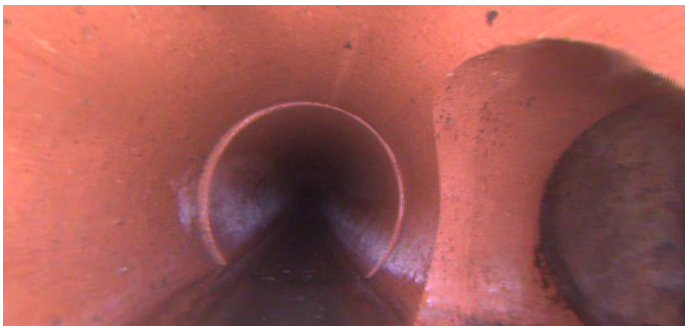
Code: **TFC**
Description: **Tap Factory Capped**

Distance (ft): **230.9**
Structural Grade: **0**
O&M Grade: **0**
Clock Start/From: **3**
Clock To:
1st Value: **6.000**
2nd Value:
Value Percent:
Continuous Index:
Within 8" of Joint:
Remarks:

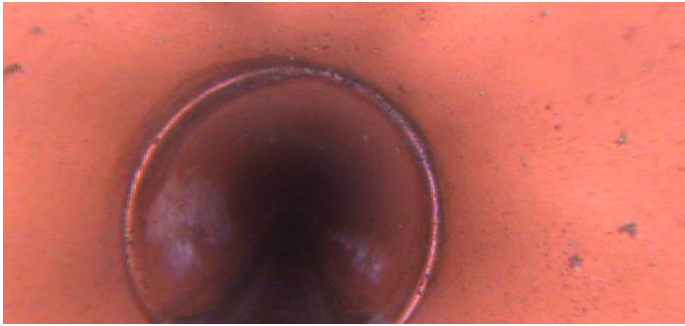
Code: **IS**
Description: **Infil Stain**

Distance (ft): **241.4**
Structural Grade: **0**
O&M Grade: **0**
Clock Start/From: **11**
Clock To: **4**
1st Value:
2nd Value:
Value Percent:
Continuous Index:
Within 8" of Joint: **YES**
Remarks:

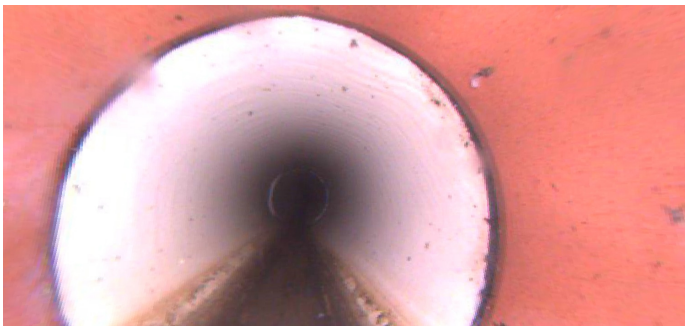
Code: **RPR**
Description: **Repair Point Pipe Replaced**

Distance (ft): **246.6**
Structural Grade: **0**
O&M Grade: **0**
Clock Start/From:
Clock To:
1st Value:
2nd Value:
Value Percent:
Continuous Index:
Within 8" of Joint: **NO**
Remarks: **PVC**

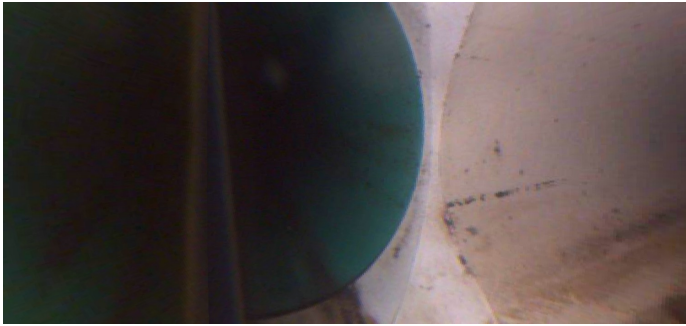
Code: **TF**
Description: **Tap Factory**

Distance (ft): **249.7**
Structural Grade: **0**
O&M Grade: **0**
Clock Start/From: **9**
Clock To:
1st Value: **4.000**
2nd Value:
Value Percent:
Continuous Index:
Within 8" of Joint:
Remarks:

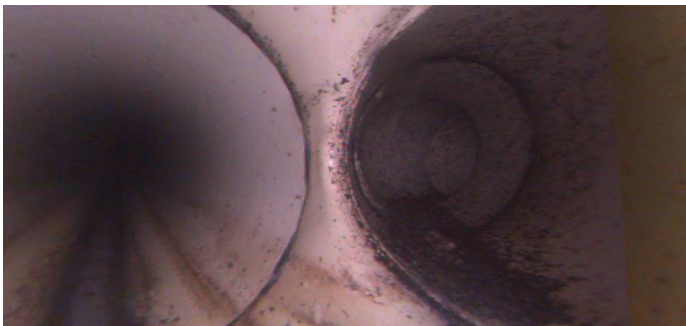
Code: **TF**
Description: **Tap Factory**

Distance (ft): **259.2**
Structural Grade: **0**
O&M Grade: **0**
Clock Start/From: **3**
Clock To:
1st Value: **4.000**
2nd Value:
Value Percent:
Continuous Index:
Within 8" of Joint:
Remarks:

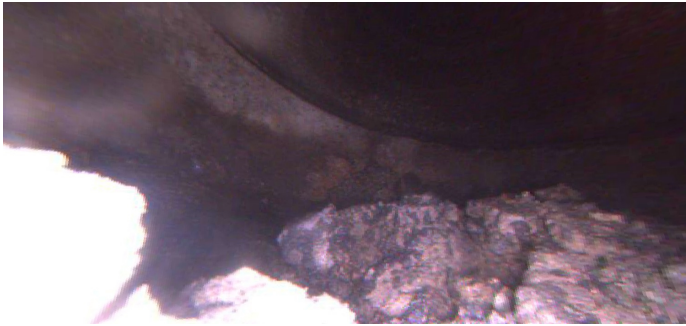
Code: **DAGS**
Description: **Deposits Attached Grease**

Distance (ft): **287.1**
Structural Grade: **0**
O&M Grade: **2**
Clock Start/From: **7**
Clock To: **5**
1st Value:
2nd Value:
Value Percent: **5.000**
Continuous Index: **F01**
Within 8" of Joint: **YES**
Remarks: **WANDER**

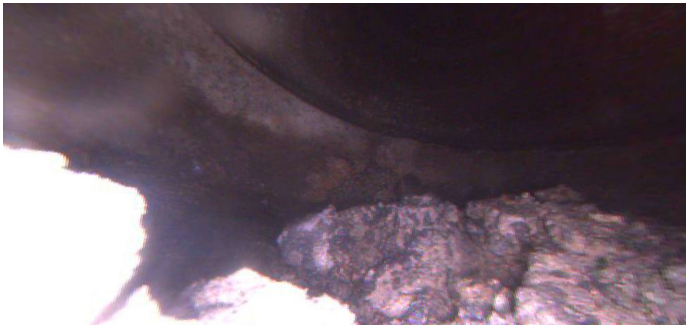
Code: **AMH**
Description: **Manhole**

Distance (ft): **287.1**
Structural Grade: **0**
O&M Grade: **0**
Clock Start/From:
Clock To:
1st Value:
2nd Value:
Value Percent:
Continuous Index:
Within 8" of Joint: **NO**
Remarks: **M-904-072**
