Profile/Photo Observation Report

Street:	E PEMBROKE DR E & N PEMBROKE	Flow Control:	Not Controlled
City:	Hobart, IN	Year Renewed:	
Location:	Other	Tape/Media #:	
Purpose:	Not Known	Dia/Height:	8"
Use:	Sanitary	Material:	PVC
Drain Area:	NA	Lining:	
Category:	NA		
Comment:

Location Details:		Direction of Survey:	Upstream
US MH:	M-904-066	DS MH:	M-904-065
		Total Length Surveyed (ft):	264.8

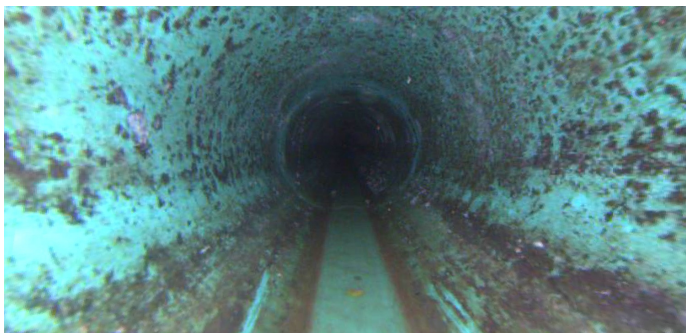
Code: **AMH**
Description: **Manhole**

Distance (ft): **.0**
Structural Grade: **0**
O&M Grade: **0**
Clock Start/From:
Clock To:
1st Value:
2nd Value:
Value Percent:
Continuous Index:
Within 8" of Joint: **NO**
Remarks: **M-904-065**

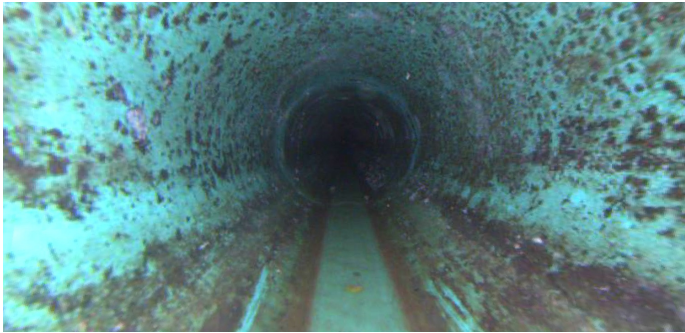
Code:	MWL
Description:	Water Level

Distance (ft):	.0
Structural Grade:	0
O&M Grade:	0
Clock Start/From:	
Clock To:	
1st Value:	
2nd Value:	
Value Percent:	5.000
Continuous Index:	
Within 8" of Joint:	NO
Remarks:

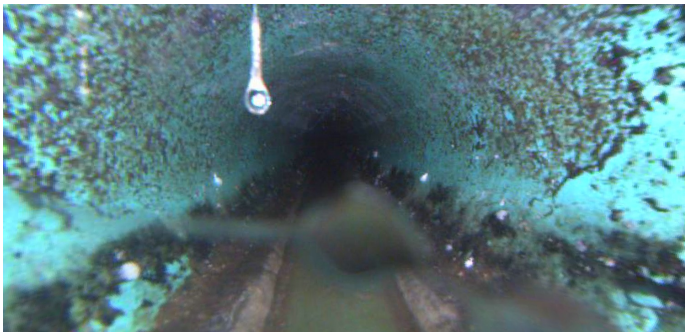
Code:	DAGS
Description:	Deposits Attached Grease

Distance (ft):	14.4
Structural Grade:	0
O&M Grade:	2
Clock Start/From:	8
Clock To:	4
1st Value:	
2nd Value:	
Value Percent:	5.000
Continuous Index:	S01
Within 8" of Joint:	NO
Remarks:

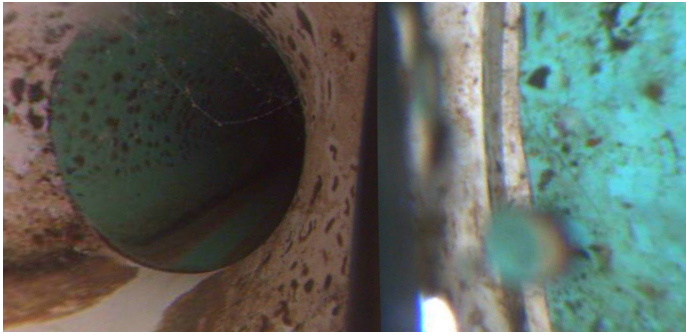
Code: **TF**
Description: **Tap Factory**

Distance (ft): **31.6**
Structural Grade: **0**
O&M Grade: **0**
Clock Start/From: **9**
Clock To:
1st Value: **4.000**
2nd Value:
Value Percent:
Continuous Index:
Within 8" of Joint:
Remarks:

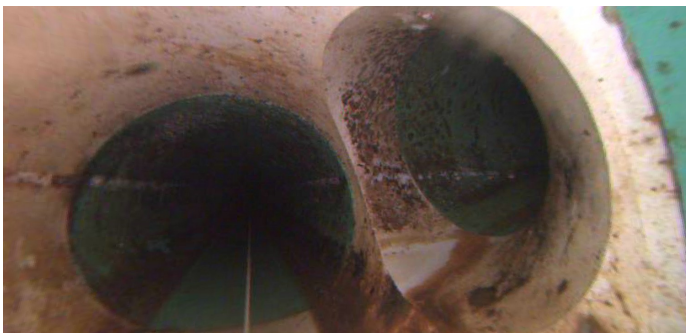
Code: **TFA**
Description: **Tap Factory Active**

Distance (ft): **93.5**
Structural Grade: **0**
O&M Grade: **0**
Clock Start/From: **9**
Clock To:
1st Value: **4.000**
2nd Value:
Value Percent:
Continuous Index:
Within 8" of Joint:
Remarks:

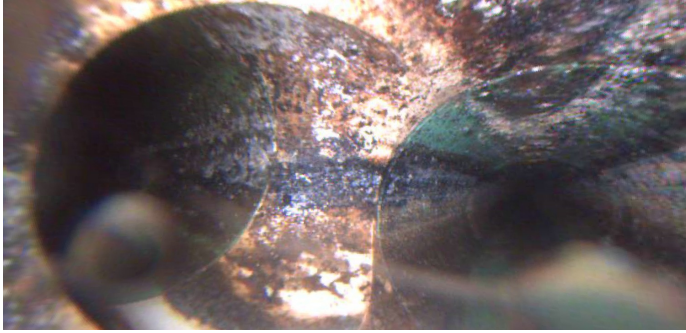
Code: **TF**
Description: **Tap Factory**

Distance (ft): **186.1**
Structural Grade: **0**
O&M Grade: **0**
Clock Start/From: **9**
Clock To:
1st Value: **4.000**
2nd Value:
Value Percent:
Continuous Index:
Within 8" of Joint:
Remarks:

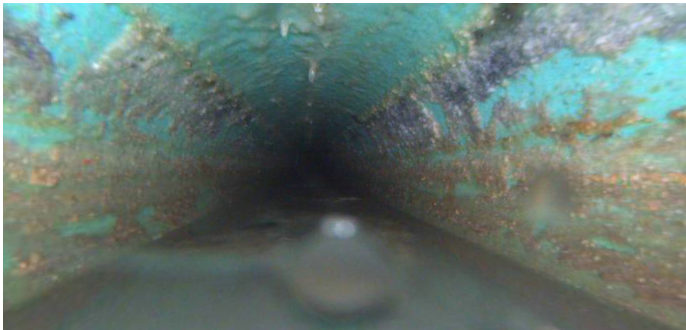
Code: **MWL**
Description: **Water Level**

Distance (ft): **196.9**
Structural Grade: **0**
O&M Grade: **0**
Clock Start/From:
Clock To:
1st Value:
2nd Value:
Value Percent: **30.000**
Continuous Index:
Within 8" of Joint: **NO**
Remarks:

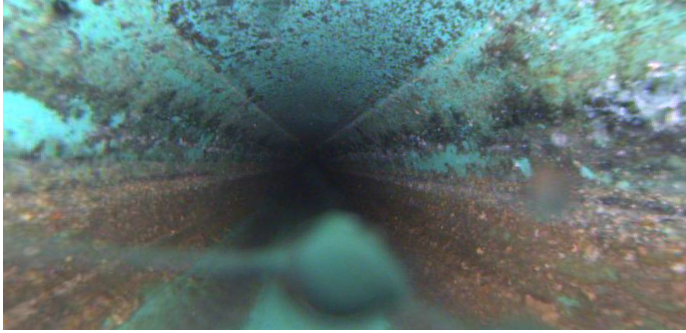
Code: **MWL**
Description: **Water Level**

Distance (ft): **218.2**
Structural Grade: **0**
O&M Grade: **0**
Clock Start/From:
Clock To:
1st Value:
2nd Value:
Value Percent: **5.000**
Continuous Index:
Within 8" of Joint: **NO**
Remarks:

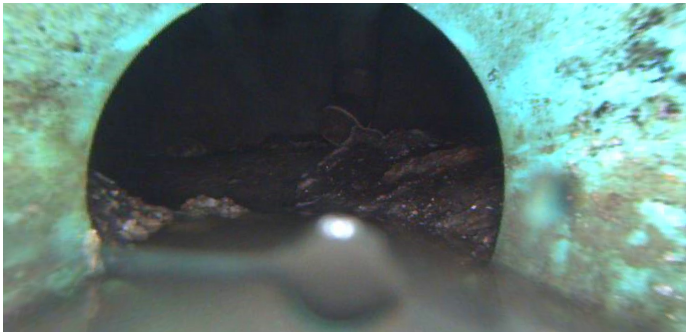
Code: **DAGS**
Description: **Deposits Attached Grease**

Distance (ft): **263.3**
Structural Grade: **0**
O&M Grade: **2**
Clock Start/From: **8**
Clock To: **4**
1st Value:
2nd Value:
Value Percent: **5.000**
Continuous Index: **F01**
Within 8" of Joint: **NO**
Remarks:

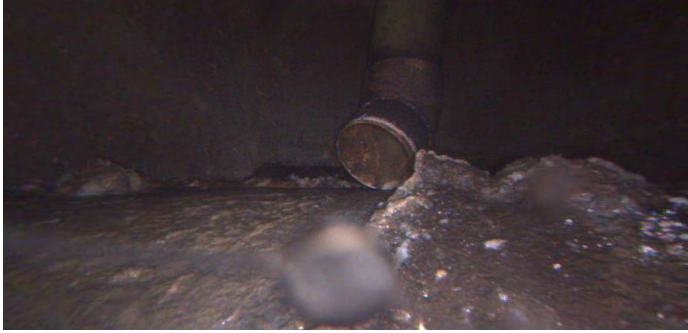
Code: **AMH**
Description: **Manhole**

Distance (ft): **264.8**
Structural Grade: **0**
O&M Grade: **0**
Clock Start/From:
Clock To:
1st Value:
2nd Value:
Value Percent:
Continuous Index:
Within 8" of Joint: **NO**
Remarks: **M-904-066**
