Profile/Photo Observation Report

Street:	N PEMBROKE DR E	Flow Control:	Not Controlled
City:	Hobart, IN	Year Renewed:	
Location:	Other	Tape/Media #:	
Purpose:	Not Known	Dia/Height:	8"
Use:	Sanitary	Material:	PVC
Drain Area:	NA	Lining:	
Category:	NA		
Comment:

Location Details:		Direction of Survey:	Downstream
US MH:	M-904-067	DS MH:	M-904-066
		Total Length Surveyed (ft):	317.0

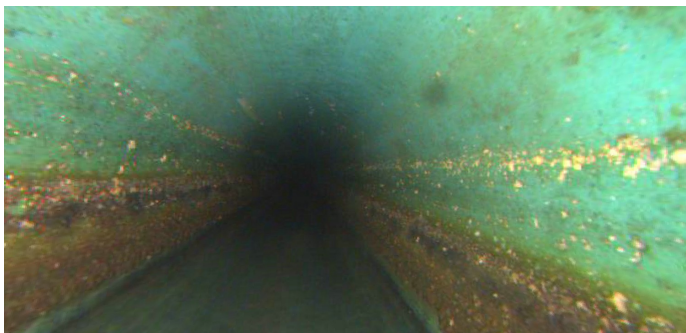
Code: **AMH**
Description: **Manhole**

Distance (ft): **.0**
Structural Grade: **0**
O&M Grade: **0**
Clock Start/From:
Clock To:
1st Value:
2nd Value:
Value Percent:
Continuous Index:
Within 8" of Joint: **NO**
Remarks: **M-904-067**

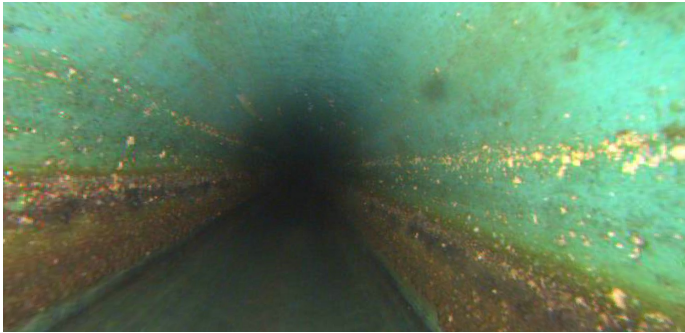
Code:	MWL
Description:	Water Level

Distance (ft):	.0
Structural Grade:	0
O&M Grade:	0
Clock Start/From:	
Clock To:	
1st Value:	
2nd Value:	
Value Percent:	10.000
Continuous Index:	
Within 8" of Joint:	NO
Remarks:

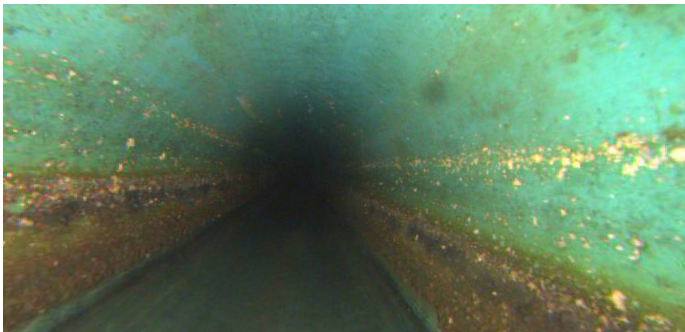
Code:	DAGS
Description:	Deposits Attached Grease

Distance (ft):	.0
Structural Grade:	0
O&M Grade:	2
Clock Start/From:	8
Clock To:	4
1st Value:	
2nd Value:	
Value Percent:	5.000
Continuous Index:	S01
Within 8" of Joint:	NO
Remarks:

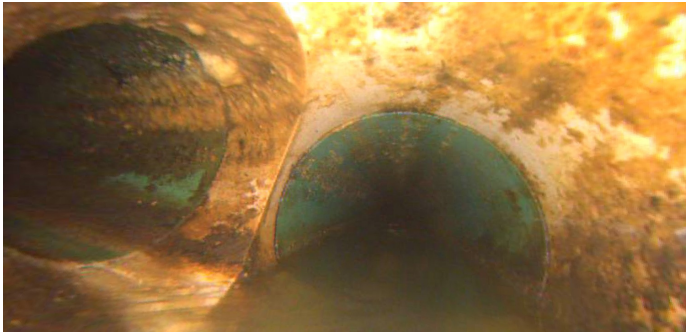
Code: **TFA**
Description: **Tap Factory Active**

Distance (ft): **51.7**
Structural Grade: **0**
O&M Grade: **0**
Clock Start/From: **9**
Clock To:
1st Value: **4.000**
2nd Value:
Value Percent:
Continuous Index:
Within 8" of Joint:
Remarks:

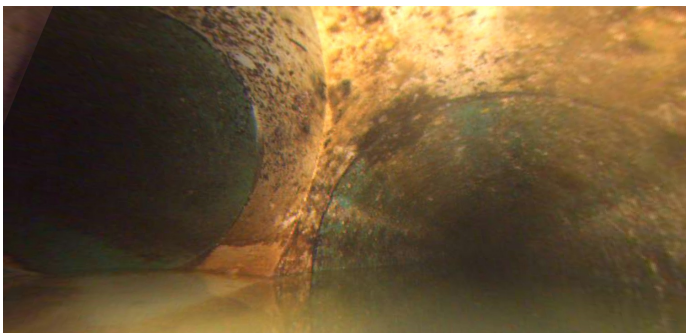
Code: **TFA**
Description: **Tap Factory Active**

Distance (ft): **140.5**
Structural Grade: **0**
O&M Grade: **0**
Clock Start/From: **9**
Clock To:
1st Value: **4.000**
2nd Value:
Value Percent:
Continuous Index:
Within 8" of Joint:
Remarks:

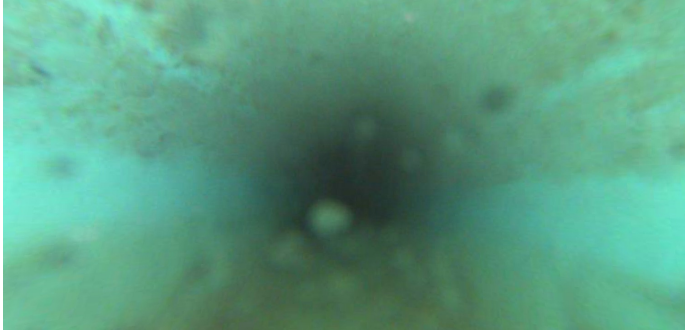
Code: **DAGS**
Description: **Deposits Attached Grease**

Distance (ft): **175.4**
Structural Grade: **0**
O&M Grade: **2**
Clock Start/From: **8**
Clock To: **4**
1st Value:
2nd Value:
Value Percent: **5.000**
Continuous Index: **F01**
Within 8" of Joint: **NO**
Remarks:

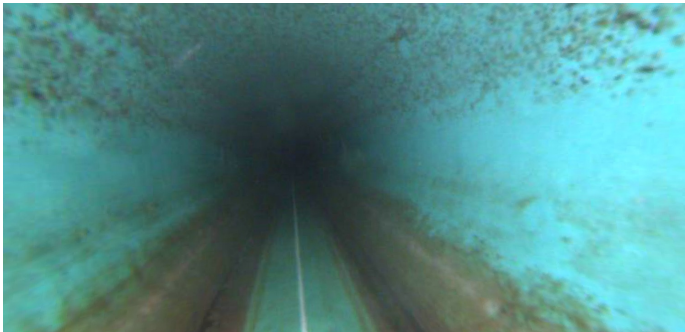
Code: **MGO**
Description: **General Observation**

Distance (ft): **175.4**
Structural Grade: **0**
O&M Grade: **0**
Clock Start/From:
Clock To:
1st Value:
2nd Value:
Value Percent:
Continuous Index:
Within 8" of Joint: **NO**
Remarks: **REAR CAMERA**

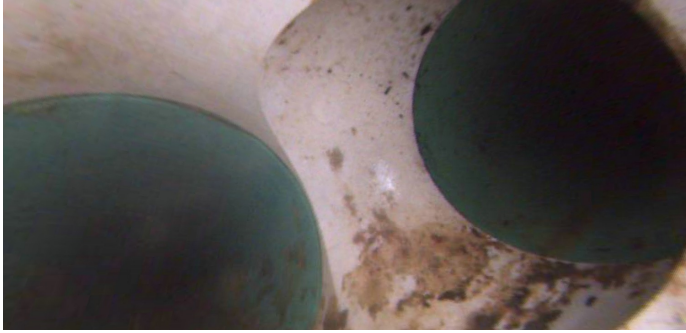
Code: **TF**
Description: **Tap Factory**

Distance (ft): **203.3**
Structural Grade: **0**
O&M Grade: **0**
Clock Start/From: **9**
Clock To:
1st Value: **4.000**
2nd Value:
Value Percent:
Continuous Index:
Within 8" of Joint:
Remarks:

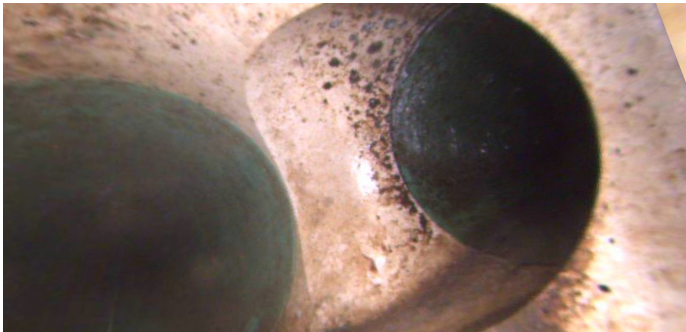
Code: **TFA**
Description: **Tap Factory Active**

Distance (ft): **262.6**
Structural Grade: **0**
O&M Grade: **0**
Clock Start/From: **9**
Clock To:
1st Value: **4.000**
2nd Value:
Value Percent:
Continuous Index:
Within 8" of Joint:
Remarks:

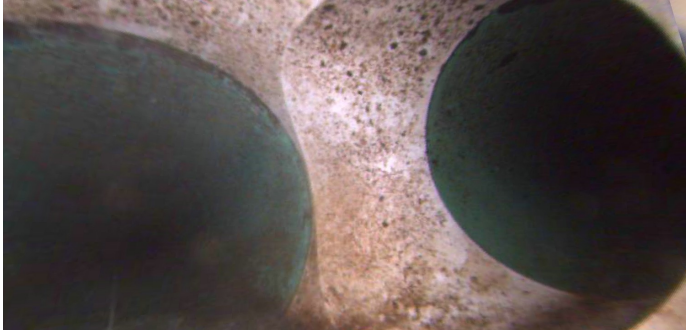
Code: **TFA**
Description: **Tap Factory Active**

Distance (ft): **302.9**
Structural Grade: **0**
O&M Grade: **0**
Clock Start/From: **9**
Clock To:
1st Value: **4.000**
2nd Value:
Value Percent:
Continuous Index:
Within 8" of Joint:
Remarks:

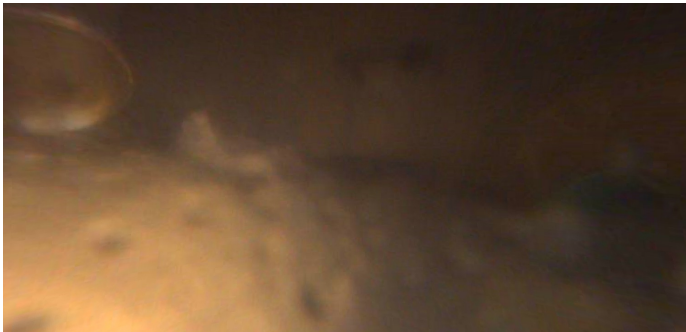
Code: **AMH**
Description: **Manhole**

Distance (ft): **317.0**
Structural Grade: **0**
O&M Grade: **0**
Clock Start/From:
Clock To:
1st Value:
2nd Value:
Value Percent:
Continuous Index:
Within 8" of Joint: **NO**
Remarks: **M-904-066**
