## Profile/Photo Observation Report

Street:	<b>N PEMBROKE DR E</b>	Flow Control:	<b>Not Controlled</b>
City:	<b>Hobart, IN</b>	Year Renewed:	
Location:	<b>Other</b>	Tape/Media #:	
Purpose:	<b>Not Known</b>	Dia/Height:	<b>8"</b>
Use:	<b>Sanitary</b>	Material:	<b>PVC</b>
Drain Area:	<b>NA</b>	Lining:	
Category:	<b>NA</b>		
Comment:

Location Details:		Direction of Survey:	<b>Upstream</b>
US MH:	<b>M-904-071</b>	DS MH:	<b>M-904-067</b>
		Total Length Surveyed (ft):	<b>110.5</b>

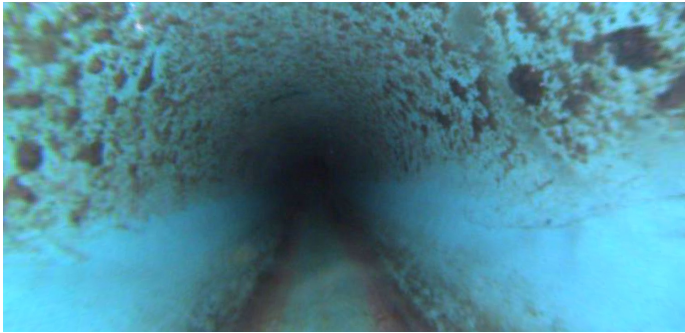
Code:	<b>MWL</b>
Description:	<b>Water Level</b>

Distance (ft):	<b>.0</b>
Structural Grade:	<b>0</b>
O&M Grade:	<b>0</b>
Clock Start/From:	
Clock To:	
1st Value:	
2nd Value:	
Value Percent:	<b>5.000</b>
Continuous Index:	
Within 8" of Joint:	<b>NO</b>
Remarks:

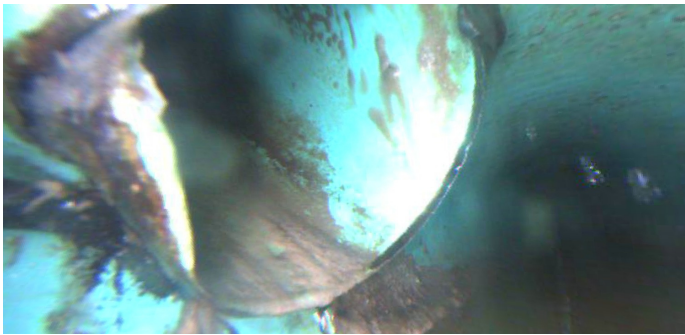
Code:	<b>TBI</b>
Description:	<b>Tap Break-in Intruding</b>

Distance (ft):	<b>12.7</b>
Structural Grade:	<b>0</b>
O&M Grade:	<b>2</b>
Clock Start/From:	<b>2</b>
Clock To:	
1st Value:	<b>4.000</b>
2nd Value:	<b>1.000</b>
Value Percent:	
Continuous Index:	
Within 8" of Joint:	
Remarks:	<b>active</b>

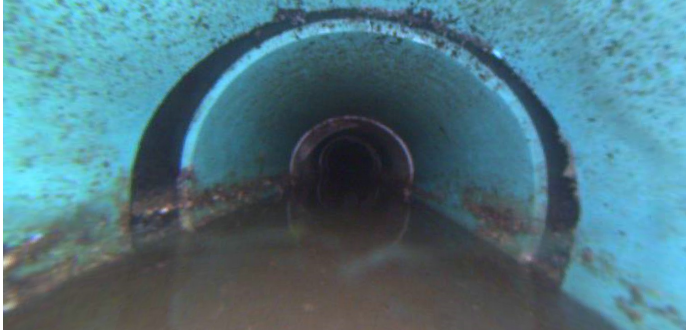
Code: **JSL**  
Description: **Joint Separated Large**

Distance (ft): **40.7**  
Structural Grade: **2**  
O&M Grade: **0**  
Clock Start/From:  
Clock To:  
1st Value:  
2nd Value:  
Value Percent:  
Continuous Index:  
Within 8" of Joint: **NO**  
Remarks:

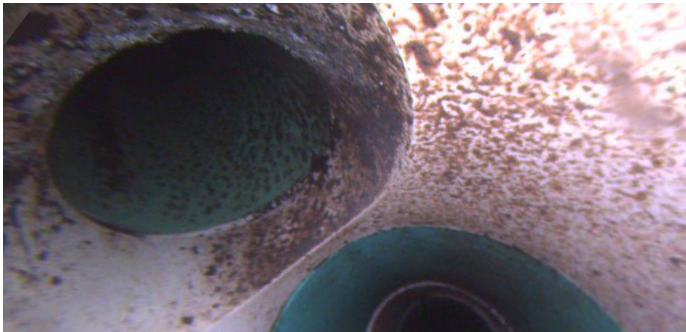
Code: **TF**  
Description: **Tap Factory**

Distance (ft): **42.4**  
Structural Grade: **0**  
O&M Grade: **0**  
Clock Start/From: **11**  
Clock To:  
1st Value: **4.000**  
2nd Value:  
Value Percent:  
Continuous Index:  
Within 8" of Joint:  
Remarks:

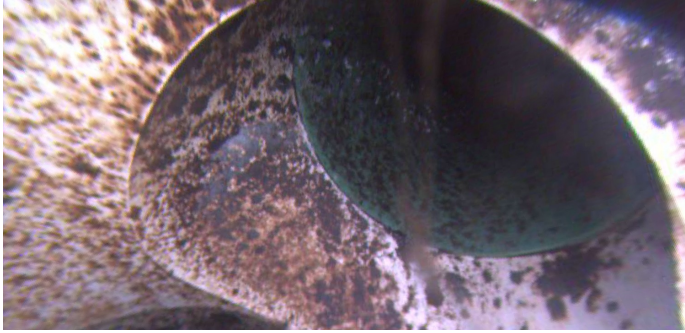
Code: **TF**  
Description: **Tap Factory**

Distance (ft): **44.0**  
Structural Grade: **0**  
O&M Grade: **0**  
Clock Start/From: **1**  
Clock To:  
1st Value: **4.000**  
2nd Value:  
Value Percent:  
Continuous Index:  
Within 8" of Joint:  
Remarks:

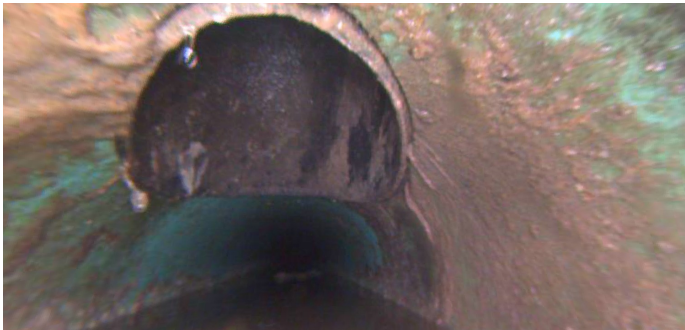
Code: **TBI**  
Description: **Tap Break-in Intruding**

Distance (ft): **101.3**  
Structural Grade: **0**  
O&M Grade: **2**  
Clock Start/From: **12**  
Clock To:  
1st Value: **4.000**  
2nd Value: **1.000**  
Value Percent:  
Continuous Index:  
Within 8" of Joint:  
Remarks:

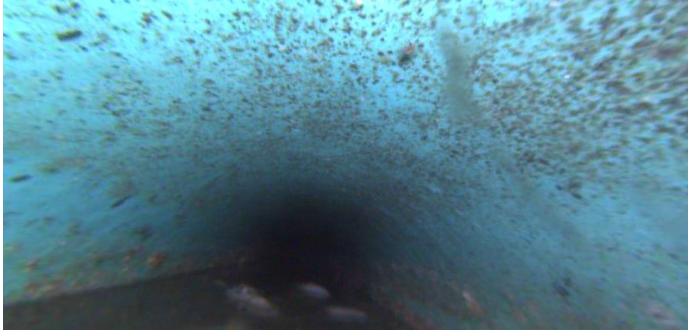
Code:	<b>MSA</b>
Description:	<b>Abandoned Survey</b>
Distance (ft):	<b>110.5</b>
Structural Grade:	<b>0</b>
O&M Grade:	<b>0</b>
Clock Start/From:	
Clock To:	
1st Value:	
2nd Value:	
Value Percent:	
Continuous Index:	
Within 8" of Joint:	<b>NO</b>
Remarks:	<b>debris under water</b>
