## Profile/Photo Observation Report

Street:	<b>N Pembroke Dr.</b>	Flow Control:	<b>Not Controlled</b>
City:	<b>Hobart, IN</b>	Year Renewed:	
Location:	<b>Other</b>	Tape/Media #:	
Purpose:	<b>Not Known</b>	Dia/Height:	<b>8"</b>
Use:	<b>Sanitary</b>	Material:	<b>PVC</b>
Drain Area:	<b>NA</b>	Lining:	
Category:	<b>NA</b>		
Comment:

Location Details:		Direction of Survey:	<b>Upstream</b>
US MH:	<b>M-904-071</b>	DS MH:	<b>M-904-067</b>
		Total Length Surveyed (ft):	<b>110.5</b>

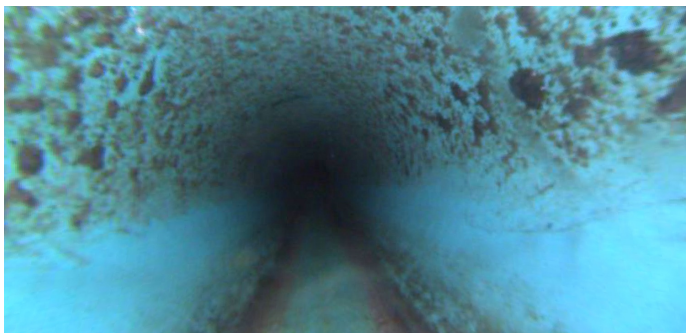
Code: **AMH**  
Description: **Manhole**

Distance (ft): **.0**  
Structural Grade: **0**  
O&M Grade: **0**  
Clock Start/From:  
Clock To:  
1st Value:  
2nd Value:  
Value Percent:  
Continuous Index:  
Within 8" of Joint: **NO**  
Remarks: **M-904-067**

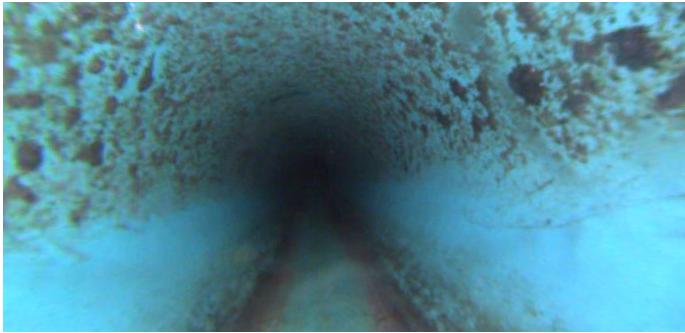
Code:	<b>MWL</b>
Description:	<b>Water Level</b>

Distance (ft):	<b>.0</b>
Structural Grade:	<b>0</b>
O&M Grade:	<b>0</b>
Clock Start/From:	
Clock To:	
1st Value:	
2nd Value:	
Value Percent:	<b>5.000</b>
Continuous Index:	
Within 8" of Joint:	<b>NO</b>
Remarks:

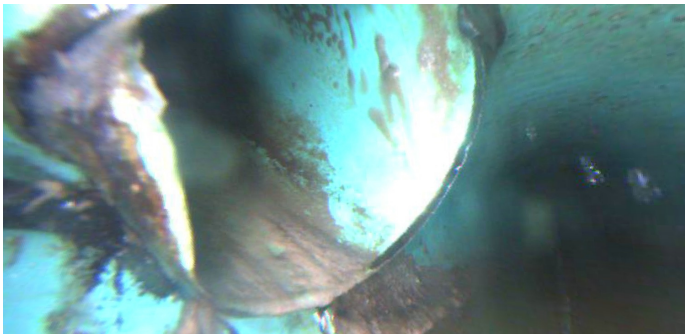
Code:	<b>TBI</b>
Description:	<b>Tap Break-in Intruding</b>

Distance (ft):	<b>12.7</b>
Structural Grade:	<b>0</b>
O&M Grade:	<b>2</b>
Clock Start/From:	<b>2</b>
Clock To:	
1st Value:	<b>4.000</b>
2nd Value:	<b>1.000</b>
Value Percent:	
Continuous Index:	
Within 8" of Joint:	
Remarks:	<b>active</b>

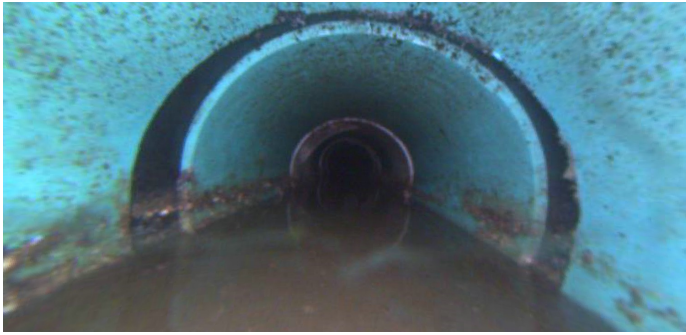
Code: **JSL**  
Description: **Joint Separated Large**

Distance (ft): **40.7**  
Structural Grade: **2**  
O&M Grade: **0**  
Clock Start/From:  
Clock To:  
1st Value:  
2nd Value:  
Value Percent:  
Continuous Index:  
Within 8" of Joint: **NO**  
Remarks:

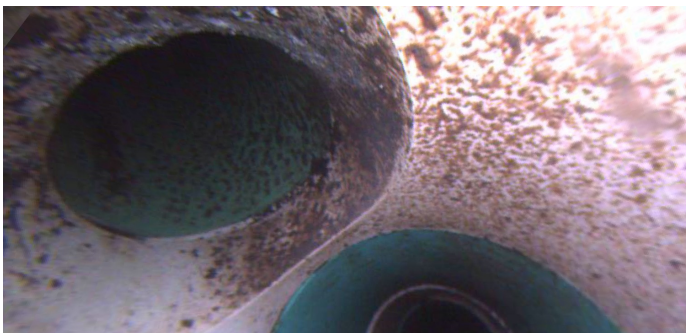
Code: **TF**  
Description: **Tap Factory**

Distance (ft): **42.4**  
Structural Grade: **0**  
O&M Grade: **0**  
Clock Start/From: **11**  
Clock To:  
1st Value: **4.000**  
2nd Value:  
Value Percent:  
Continuous Index:  
Within 8" of Joint:  
Remarks:

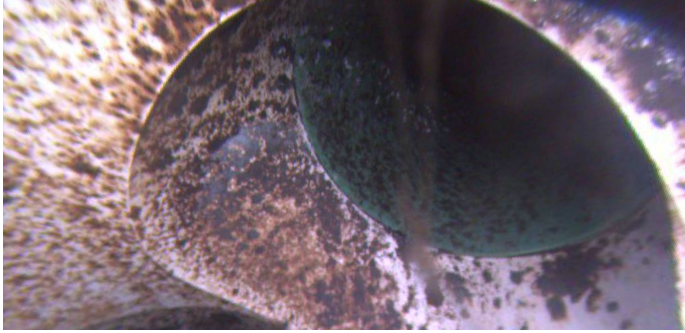
Code: **TF**  
Description: **Tap Factory**

Distance (ft): **44.0**  
Structural Grade: **0**  
O&M Grade: **0**  
Clock Start/From: **1**  
Clock To:  
1st Value: **4.000**  
2nd Value:  
Value Percent:  
Continuous Index:  
Within 8" of Joint:  
Remarks:

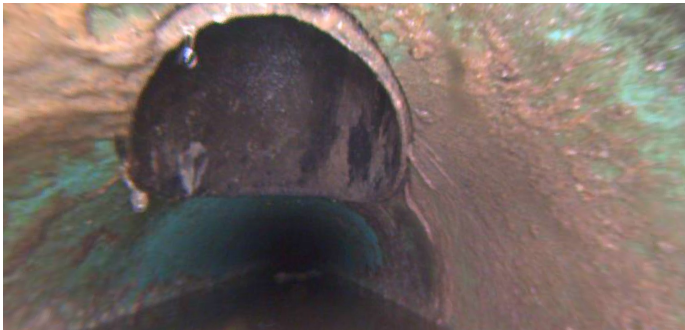
Code: **TBI**  
Description: **Tap Break-in Intruding**

Distance (ft): **101.3**  
Structural Grade: **0**  
O&M Grade: **2**  
Clock Start/From: **12**  
Clock To:  
1st Value: **4.000**  
2nd Value: **1.000**  
Value Percent:  
Continuous Index:  
Within 8" of Joint:  
Remarks:

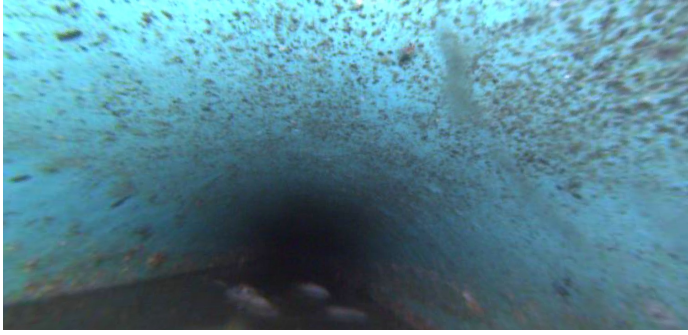
Code:	<b>MSA</b>
Description:	<b>Abandoned Survey</b>
Distance (ft):	<b>110.5</b>
Structural Grade:	<b>0</b>
O&M Grade:	<b>0</b>
Clock Start/From:	
Clock To:	
1st Value:	
2nd Value:	
Value Percent:	
Continuous Index:	
Within 8" of Joint:	<b>NO</b>
Remarks:	<b>debris under water</b>
