## Profile/Photo Observation Report

Street:	<b>East State Road 130</b>	Flow Control:	<b>Not Controlled</b>
City:	<b>Hobart, IN</b>	Year Renewed:	
Location:	<b>Yard</b>	Tape/Media #:	<b>DEP267</b>
Purpose:	<b>Routine Assessment</b>	Dia/Height:	<b>18"</b>
Use:	<b>Sanitary</b>	Material:	<b>PVC</b>
Drain Area:		Lining:	
Category:	<b>NA</b>		
Comment:	<b>5-21-2018</b>

Location Details:		Direction of Survey:	<b>Downstream</b>
US MH:	<b>M-905-001</b>	DS MH:	<b>M-1006-014</b>
		Total Length Surveyed (ft):	<b>32.6</b>

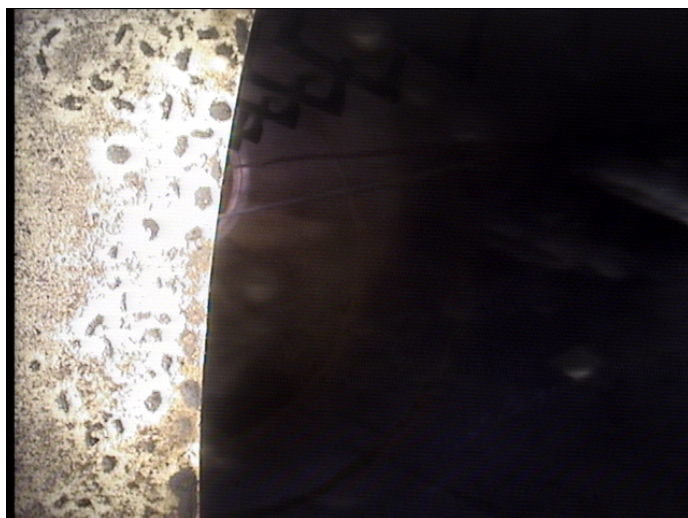
Code: **AMH**  
Description: **Manhole**

Distance (ft): **.0**  
Structural Grade: **0**  
O&M Grade: **0**  
Clock Start/From:  
Clock To:  
1st Value:  
2nd Value:  
Value Percent:  
Continuous Index:  
Within 8" of Joint: **NO**  
Remarks: **M-1006-014**

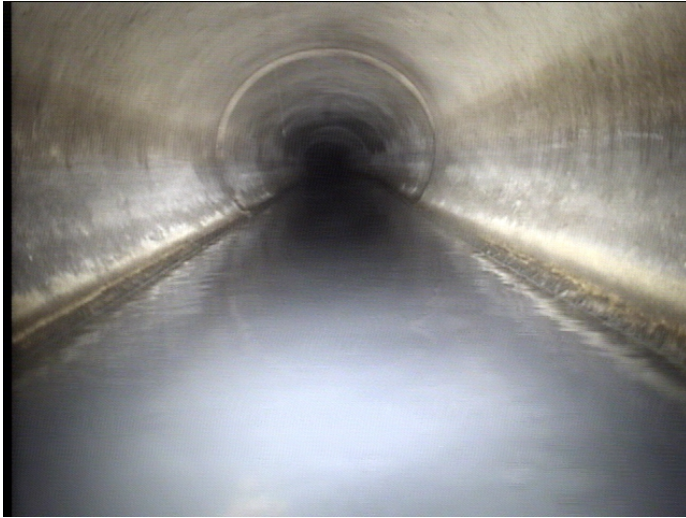
Code: **MWL**  
Description: **Water Level**

Distance (ft): **.0**  
Structural Grade: **0**  
O&M Grade: **0**  
Clock Start/From:  
Clock To:  
1st Value:  
2nd Value:  
Value Percent: **10.000**  
Continuous Index:  
Within 8" of Joint: **NO**  
Remarks:

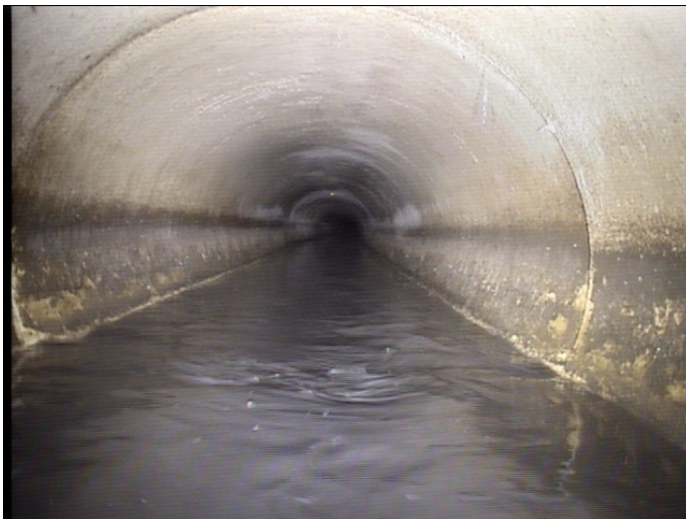
Code: **DSF**  
Description: **Deposits Settled Fine**

Distance (ft): **30.7**  
Structural Grade: **0**  
O&M Grade: **2**  
Clock Start/From: **4**  
Clock To: **8**  
1st Value:  
2nd Value:  
Value Percent: **10.000**  
Continuous Index:  
Within 8" of Joint: **NO**  
Remarks:

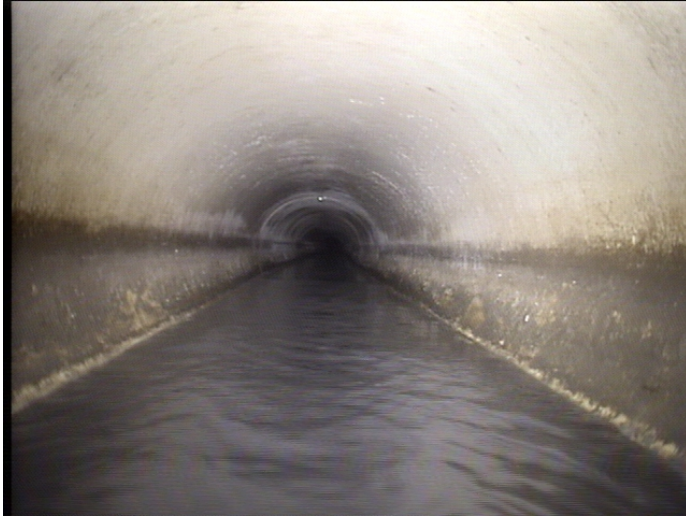
Code: **OBZ**  
Description: **Obstacle Other**

Distance (ft): **32.6**  
Structural Grade: **0**  
O&M Grade: **2**  
Clock Start/From: **5**  
Clock To: **7**  
1st Value:  
2nd Value:  
Value Percent: **10.000**  
Continuous Index:  
Within 8" of Joint: **NO**  
Remarks: **Debris**

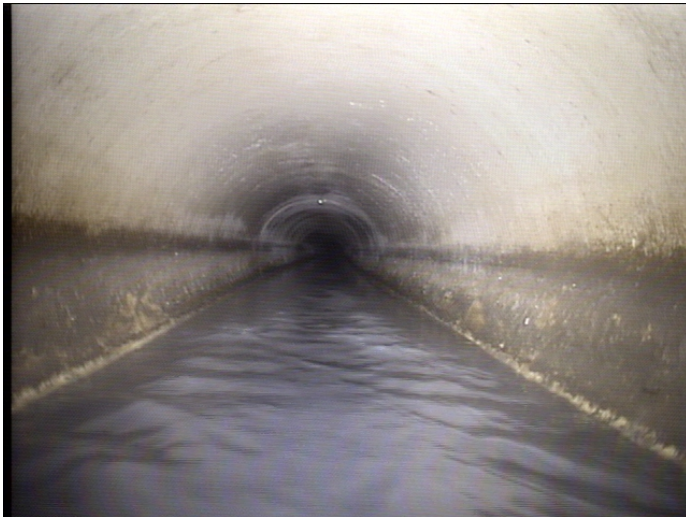
Code: **MSA**  
Description: **Abandoned Survey**

Distance (ft): **32.6**  
Structural Grade: **0**  
O&M Grade: **0**  
Clock Start/From:  
Clock To:  
1st Value:  
2nd Value:  
Value Percent:  
Continuous Index:  
Within 8" of Joint: **NO**  
Remarks: **Debris under flow**
