Profile/Photo Observation Report

Thursday, May 4, 2023

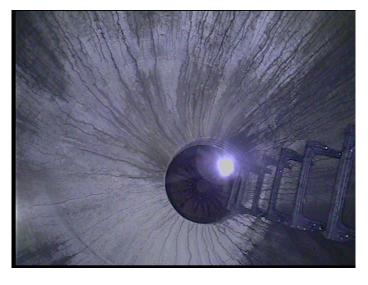
AMH

Description:	Manhole
Distance (ft):	.0
Structural Grade:	0
O&M Grade:	0
Clock Start/From:	
Clock To:	
1st Value:	
2nd Value:	
Value Percent:	
Continuous Index:	
Within 8" of Joint:	NO
Remarks:	M-905-003

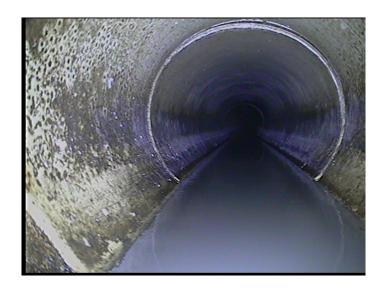
Code: MWL
Description: Water Level

Distance (ft): .0
Structural Grade: 0
O&M Grade: 0
Clock Start/From:
Clock To:

/alue Percent: **15.000**

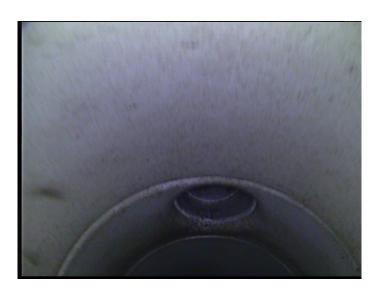
Code: **TF**

Description: Tap Factory

Distance (ft): 132.6
Structural Grade: 0
O&M Grade: 0
Clock Start/From: 12

1st Value: **4.000**

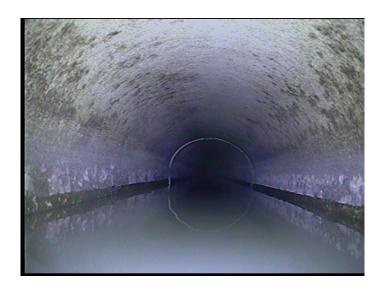
Code: **DSF**

Description: Deposits Settled Fine

Distance (ft): 179.1
Structural Grade: 0
O&M Grade: 3
Clock Start/From: 4
Clock To: 8

Value Percent: 15.000

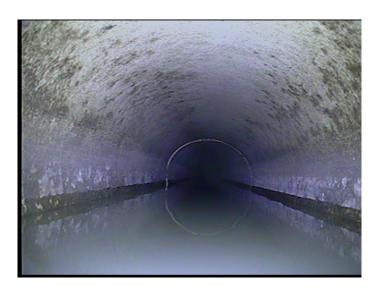
Code: MSA

Description: Abandoned Survey

Distance (ft): 179.1
Structural Grade: 0
O&M Grade: 0

Remarks: sediment
