## Profile/Photo Observation Report

Street:	<b>Sullivan Street</b>	Flow Control:	<b>Not Controlled</b>
City:	<b>Hobart, IN</b>	Year Renewed:	
Location:	<b>Light Highway</b>	Tape/Media #:	<b>DEP 606</b>
Purpose:	<b>Routine Assessment</b>	Dia/Height:	<b>18"</b>
Use:	<b>Sanitary</b>	Material:	<b>PVC</b>
Drain Area:		Lining:	
Category:	<b>NA</b>		
Comment:	<b>5-21-2018</b>

Location Details:		Direction of Survey:	<b>Upstream</b>
US MH:	<b>M-905-005</b>	DS MH:	<b>M-905-004</b>
		Total Length Surveyed (ft):	<b>95.8</b>

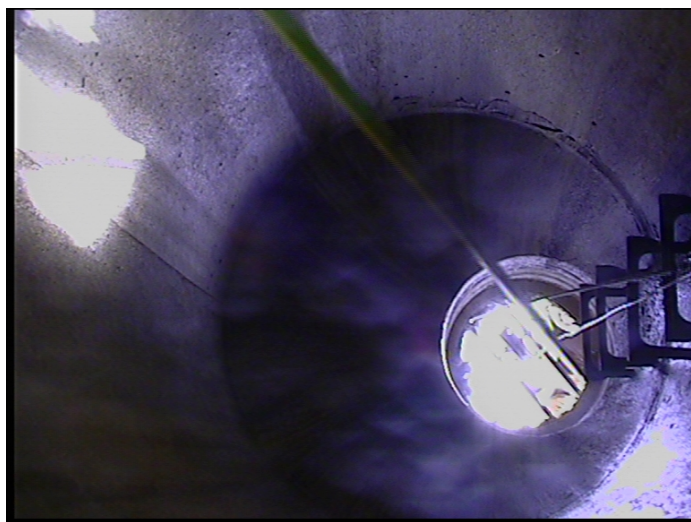
Code: **AMH**  
Description: **Manhole**

Distance (ft): **.0**  
Structural Grade: **0**  
O&M Grade: **0**  
Clock Start/From:  
Clock To:  
1st Value:  
2nd Value:  
Value Percent:  
Continuous Index:  
Within 8" of Joint: **NO**  
Remarks: **M-905-005**

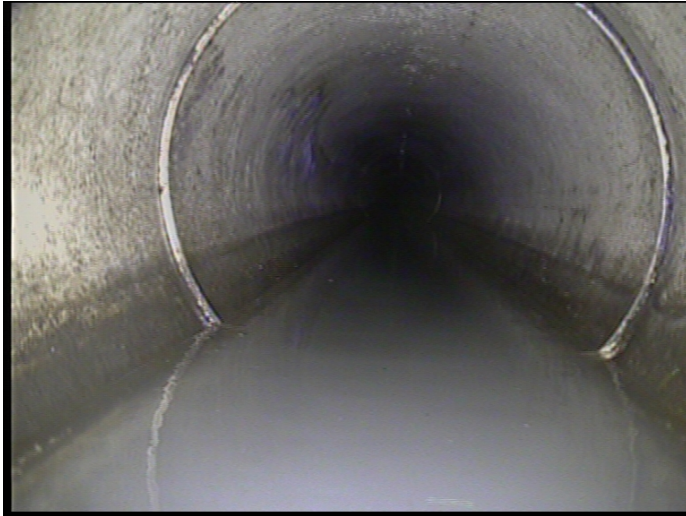
Code: **MWL**  
Description: **Water Level**

Distance (ft): **.0**  
Structural Grade: **0**  
O&M Grade: **0**  
Clock Start/From:  
Clock To:  
1st Value:  
2nd Value:  
Value Percent: **10.000**  
Continuous Index:  
Within 8" of Joint: **NO**  
Remarks:

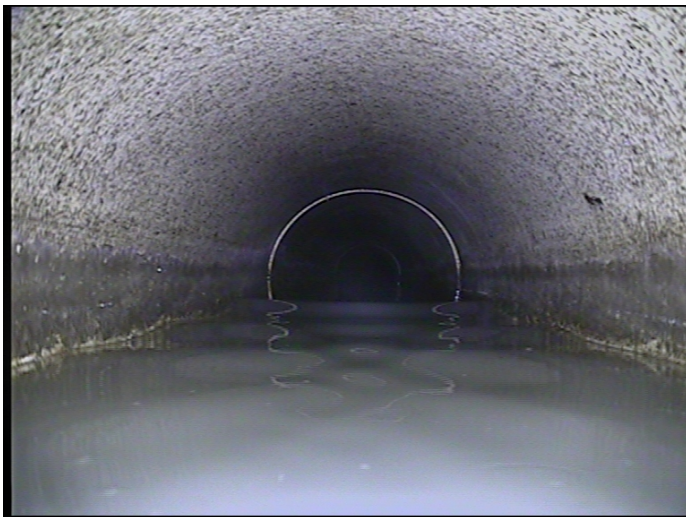
Code: **MSA**  
Description: **Abandoned Survey**

Distance (ft): **95.8**  
Structural Grade: **0**  
O&M Grade: **0**  
Clock Start/From:  
Clock To:  
1st Value:  
2nd Value:  
Value Percent:  
Continuous Index:  
Within 8" of Joint: **NO**  
Remarks: **underwater sediment/debris**
