Profile/Photo Observation Report

Date:	04/24/2018	Weather:		Coding:	PACP 6.0
Pipe Length (ft):	314.3	Owner:	NA	Pre Clean:	Not Known
P.O.#:		Surveyor:	Jen Costello	PSR:	P-905-006-005
Customer:		Clean Date:	01/01/1900	Shape:	C

Street:	SULLIVAN ST	Flow Control:	Not Controlled
City:	Hobart, IN	Year Renewed:	
Location:	Light Highway	Tape/Media #:	
Purpose:	Maintenance Related	Dia/Height:	10"
Use:	Sanitary	Material:	PVC
Drain Area:	NA	Lining:	Cured in Place
Category:	NA		
Comment:	Flow direction wrong.

Location Details:		Direction of Survey:	Upstream
US MH:	M-905-005	DS MH:	M-905-006
		Total Length Surveyed (ft):	314.0

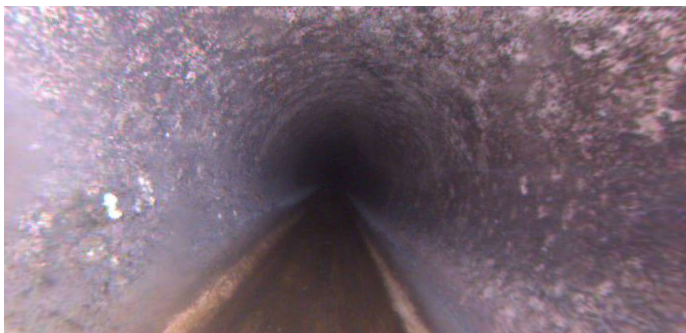
Code: **AMH**
Description: **Manhole**

Distance (ft): **.0**
Structural Grade: **0**
O&M Grade: **0**
Clock Start/From:
Clock To:
1st Value:
2nd Value:
Value Percent:
Continuous Index:
Within 8" of Joint: **NO**
Remarks: **M-905-006**

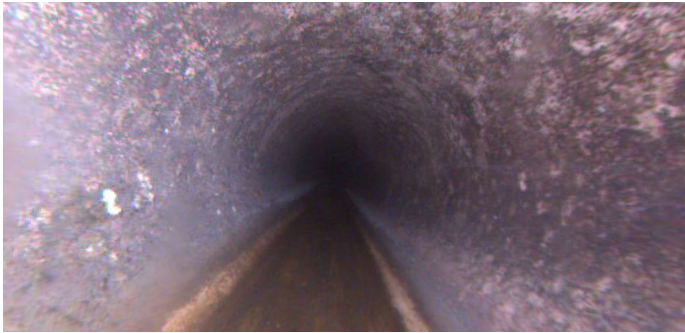
Code:	MWL
Description:	Water Level

Distance (ft):	.0
Structural Grade:	0
O&M Grade:	0
Clock Start/From:	
Clock To:	
1st Value:	
2nd Value:	
Value Percent:	5.000
Continuous Index:	
Within 8" of Joint:	NO
Remarks:

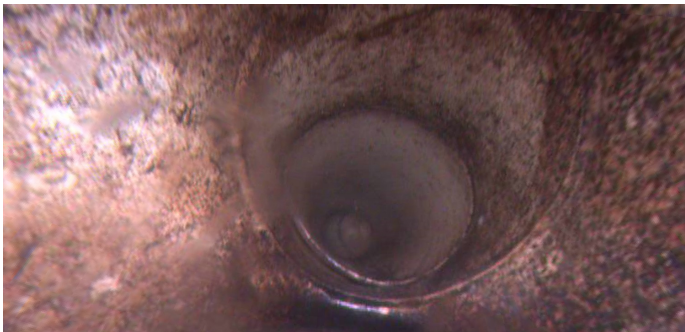
Code:	TF
Description:	Tap Factory

Distance (ft):	40.4
Structural Grade:	0
O&M Grade:	0
Clock Start/From:	11
Clock To:	
1st Value:	4.000
2nd Value:	
Value Percent:	
Continuous Index:	
Within 8" of Joint:	
Remarks:

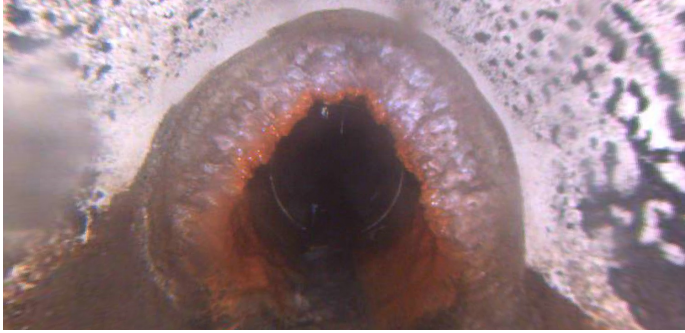
Code: **DAE**
Description: **Deposits Attached Encrustation**

Distance (ft): **98.9**
Structural Grade: **0**
O&M Grade: **3**
Clock Start/From: **8**
Clock To: **4**
1st Value:
2nd Value:
Value Percent: **20.000**
Continuous Index:
Within 8" of Joint: **YES**
Remarks:

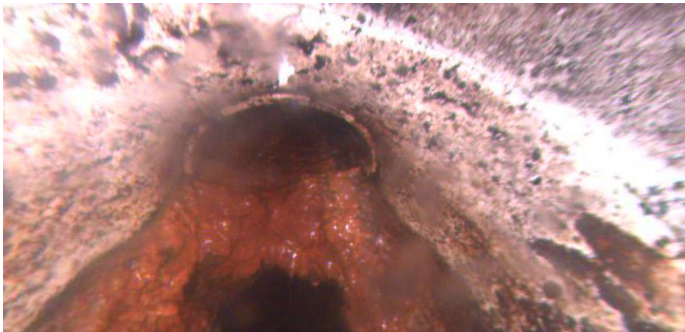
Code: **TFD**
Description: **Tap Factory Defective**

Distance (ft): **100.8**
Structural Grade: **0**
O&M Grade: **2**
Clock Start/From: **12**
Clock To:
1st Value: **4.000**
2nd Value:
Value Percent:
Continuous Index:
Within 8" of Joint:
Remarks: **dae**

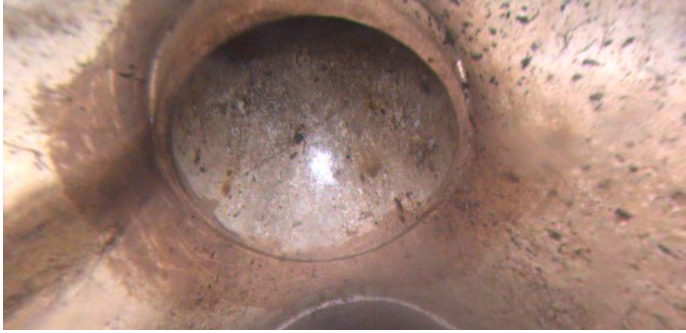
Code: **TF**
Description: **Tap Factory**

Distance (ft): **172.4**
Structural Grade: **0**
O&M Grade: **0**
Clock Start/From: **12**
Clock To:
1st Value: **4.000**
2nd Value:
Value Percent:
Continuous Index:
Within 8" of Joint:
Remarks:

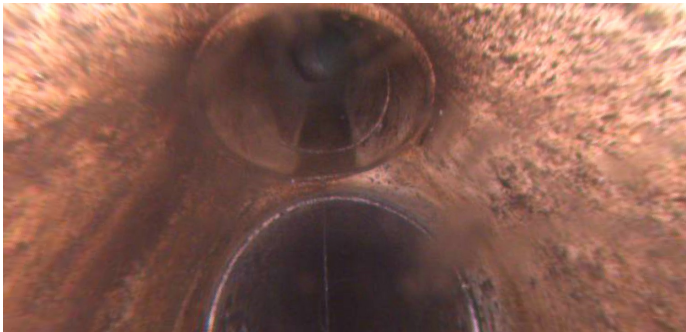
Code: **TFA**
Description: **Tap Factory Active**

Distance (ft): **278.3**
Structural Grade: **0**
O&M Grade: **0**
Clock Start/From: **12**
Clock To:
1st Value: **4.000**
2nd Value:
Value Percent:
Continuous Index:
Within 8" of Joint:
Remarks:

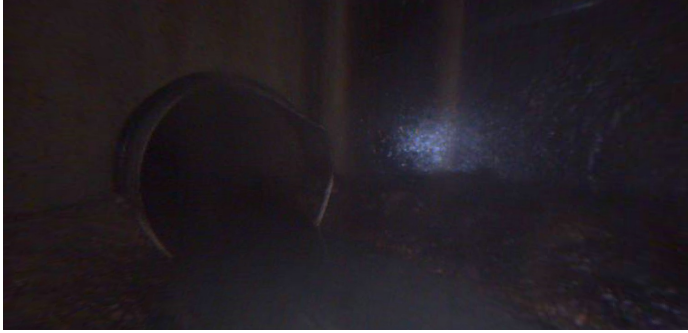
Code:	AMH
Description:	Manhole
Distance (ft):	314.0
Structural Grade:	0
O&M Grade:	0
Clock Start/From:	
Clock To:	
1st Value:	
2nd Value:	
Value Percent:	
Continuous Index:	
Within 8" of Joint:	NO
Remarks:	M-905-005
