## Profile/Photo Observation Report

Date:	<b>04/24/2018</b>	Weather:		Coding:	<b>PACP 6.0</b>
Pipe Length (ft):	<b>314.3</b>	Owner:	<b>NA</b>	Pre Clean:	<b>Not Known</b>
P.O.#:		Surveyor:	<b>Jen Costello</b>	PSR:	<b>P-905-006-005</b>
Customer:		Clean Date:	<b>01/01/1900</b>	Shape:	<b>C</b>

Street:	<b>Sullivan</b>	Flow Control:	<b>Not Controlled</b>
City:	<b>Hobart, IN</b>	Year Renewed:	
Location:	<b>Light Highway</b>	Tape/Media #:	
Purpose:	<b>Maintenance Related</b>	Dia/Height:	<b>10"</b>
Use:	<b>Sanitary</b>	Material:	<b>PVC</b>
Drain Area:	<b>NA</b>	Lining:	<b>Cured in Place</b>
Category:	<b>NA</b>		
Comment:	<b>Flow direction wrong.</b>

Location Details:		Direction of Survey:	<b>Upstream</b>
US MH:	<b>M-905-005</b>	DS MH:	<b>M-905-006</b>
		Total Length Surveyed (ft):	<b>314.0</b>

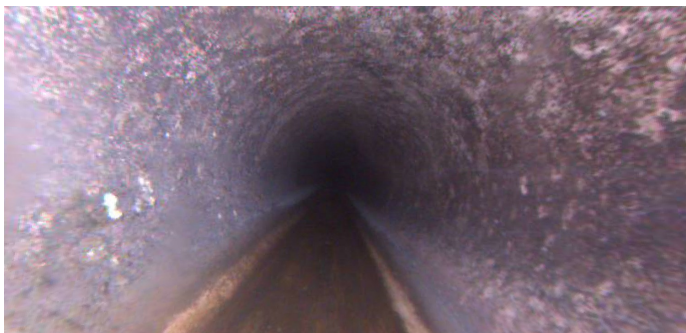
Code: **AMH**  
Description: **Manhole**

Distance (ft): **.0**  
Structural Grade: **0**  
O&M Grade: **0**  
Clock Start/From:  
Clock To:  
1st Value:  
2nd Value:  
Value Percent:  
Continuous Index:  
Within 8" of Joint: **NO**  
Remarks: **M-905-006**

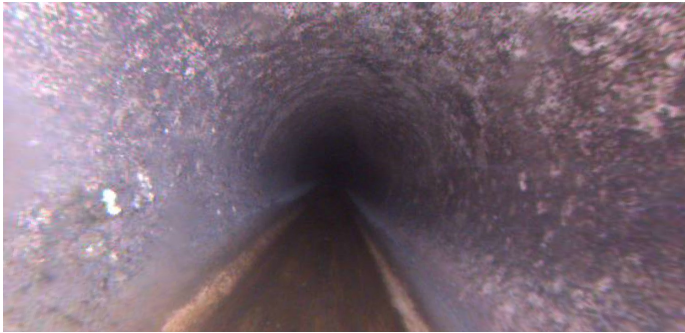
Code:	<b>MWL</b>
Description:	<b>Water Level</b>

Distance (ft):	<b>.0</b>
Structural Grade:	<b>0</b>
O&M Grade:	<b>0</b>
Clock Start/From:	
Clock To:	
1st Value:	
2nd Value:	
Value Percent:	<b>5.000</b>
Continuous Index:	
Within 8" of Joint:	<b>NO</b>
Remarks:

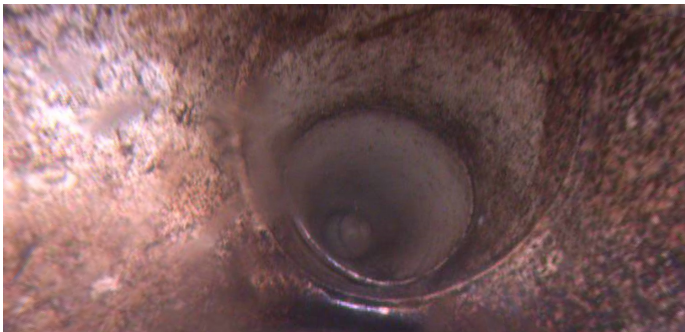
Code:	<b>TF</b>
Description:	<b>Tap Factory</b>

Distance (ft):	<b>40.4</b>
Structural Grade:	<b>0</b>
O&M Grade:	<b>0</b>
Clock Start/From:	<b>11</b>
Clock To:	
1st Value:	<b>4.000</b>
2nd Value:	
Value Percent:	
Continuous Index:	
Within 8" of Joint:	
Remarks:

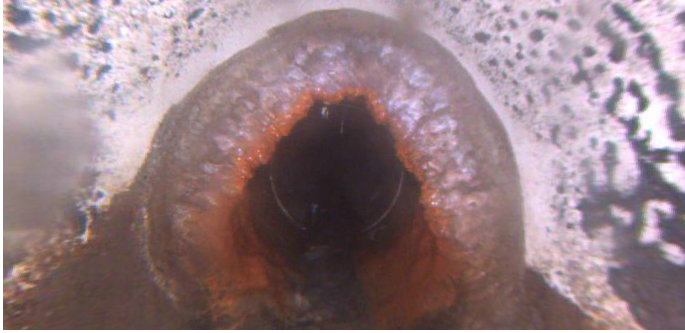
Code: **DAE**  
Description: **Deposits Attached Encrustation**

Distance (ft): **98.9**  
Structural Grade: **0**  
O&M Grade: **3**  
Clock Start/From: **8**  
Clock To: **4**  
1st Value:  
2nd Value:  
Value Percent: **20.000**  
Continuous Index:  
Within 8" of Joint: **YES**  
Remarks:

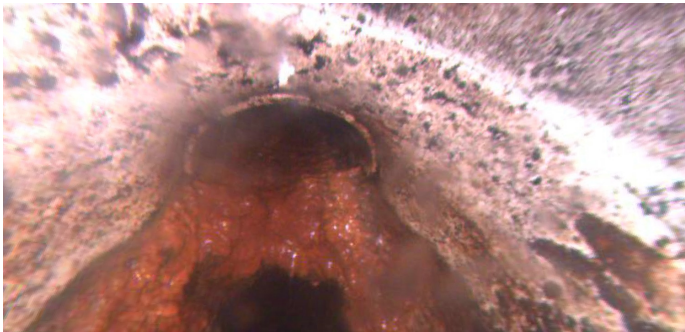
Code: **TFD**  
Description: **Tap Factory Defective**

Distance (ft): **100.8**  
Structural Grade: **0**  
O&M Grade: **2**  
Clock Start/From: **12**  
Clock To:  
1st Value: **4.000**  
2nd Value:  
Value Percent:  
Continuous Index:  
Within 8" of Joint:  
Remarks: **dae**

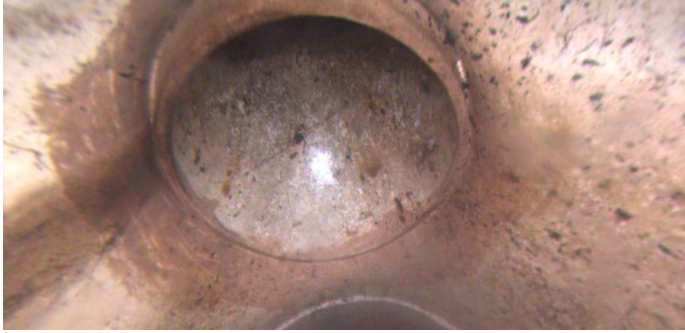
Code: **TF**  
Description: **Tap Factory**

Distance (ft): **172.4**  
Structural Grade: **0**  
O&M Grade: **0**  
Clock Start/From: **12**  
Clock To:  
1st Value: **4.000**  
2nd Value:  
Value Percent:  
Continuous Index:  
Within 8" of Joint:  
Remarks:

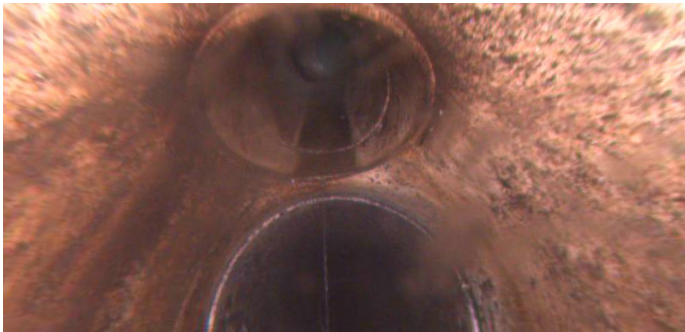
Code: **TFA**  
Description: **Tap Factory Active**

Distance (ft): **278.3**  
Structural Grade: **0**  
O&M Grade: **0**  
Clock Start/From: **12**  
Clock To:  
1st Value: **4.000**  
2nd Value:  
Value Percent:  
Continuous Index:  
Within 8" of Joint:  
Remarks:

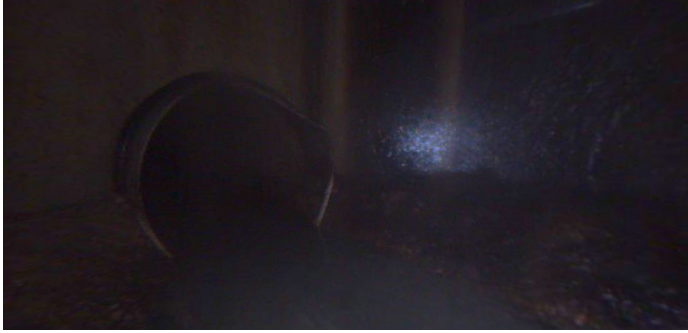
Code:	<b>AMH</b>
Description:	<b>Manhole</b>
Distance (ft):	<b>314.0</b>
Structural Grade:	<b>0</b>
O&M Grade:	<b>0</b>
Clock Start/From:	
Clock To:	
1st Value:	
2nd Value:	
Value Percent:	
Continuous Index:	
Within 8" of Joint:	<b>NO</b>
Remarks:	<b>M-905-005</b>
