## Profile/Photo Observation Report

Street:	<b>SULLIVAN ST</b>	Flow Control:	<b>Not Controlled</b>
City:	<b>Hobart, IN</b>	Year Renewed:	
Location:	<b>Light Highway</b>	Tape/Media #:	
Purpose:	<b>Maintenance Related</b>	Dia/Height:	<b>10"</b>
Use:	<b>Sanitary</b>	Material:	<b>PVC</b>
Drain Area:	<b>NA</b>	Lining:	<b>Cured in Place</b>
Category:	<b>NA</b>		
Comment:

Location Details:		Direction of Survey:	<b>Downstream</b>
US MH:	<b>M-905-006</b>	DS MH:	<b>M-905-007</b>
		Total Length Surveyed (ft):	<b>4.7</b>

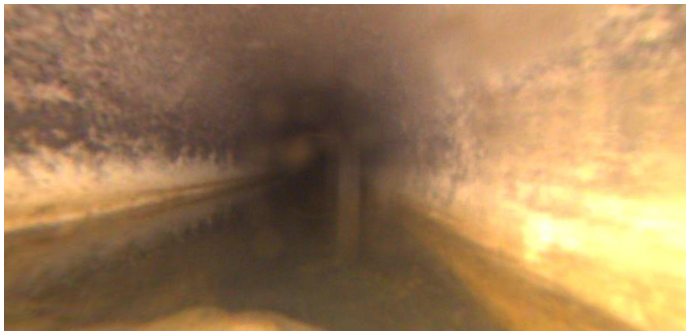
Code: **AMH**  
Description: **Manhole**

Distance (ft): **.0**  
Structural Grade: **0**  
O&M Grade: **0**  
Clock Start/From:  
Clock To:  
1st Value:  
2nd Value:  
Value Percent:  
Continuous Index:  
Within 8" of Joint: **NO**  
Remarks: **M-905-006**

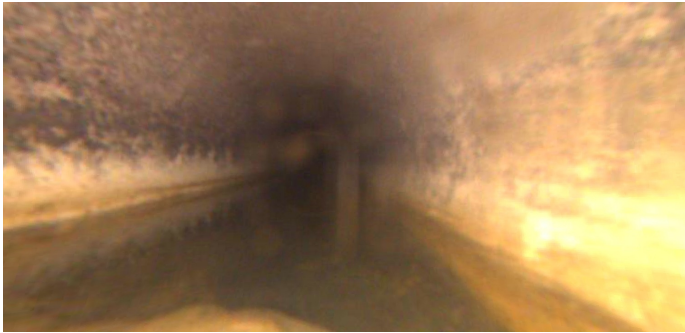
Code:	<b>MWL</b>
Description:	<b>Water Level</b>

Distance (ft):	<b>.0</b>
Structural Grade:	<b>0</b>
O&M Grade:	<b>0</b>
Clock Start/From:	
Clock To:	
1st Value:	
2nd Value:	
Value Percent:	<b>30.000</b>
Continuous Index:	
Within 8" of Joint:	<b>NO</b>
Remarks:

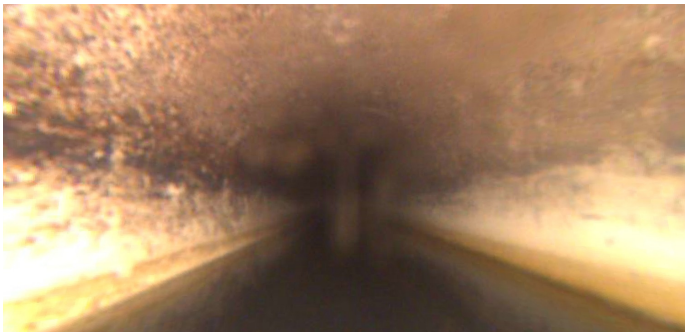
Code:	<b>MSA</b>
Description:	<b>Abandoned Survey</b>

Distance (ft):	<b>4.7</b>
Structural Grade:	<b>0</b>
O&M Grade:	<b>0</b>
Clock Start/From:	
Clock To:	
1st Value:	
2nd Value:	
Value Percent:	
Continuous Index:	
Within 8" of Joint:	<b>NO</b>
Remarks:	<b>DEBRIS UNDER WATER</b>
