Profile/Photo Observation Report

Street:	SULLIVAN ST	Flow Control:	Not Controlled
City:	Hobart, IN	Year Renewed:	
Location:	Light Highway	Tape/Media #:	
Purpose:	Maintenance Related	Dia/Height:	10"
Use:	Sanitary	Material:	PVC
Drain Area:	NA	Lining:	Cured in Place
Category:	NA		
Comment:	Flow direction wrong. Reverse setup. Debris at 81'.		
Location Details:		Direction of Survey:	Upstream
US MH:	M-905-006	DS MH:	M-905-007
		Total Length Surveyed (ft):	83.2

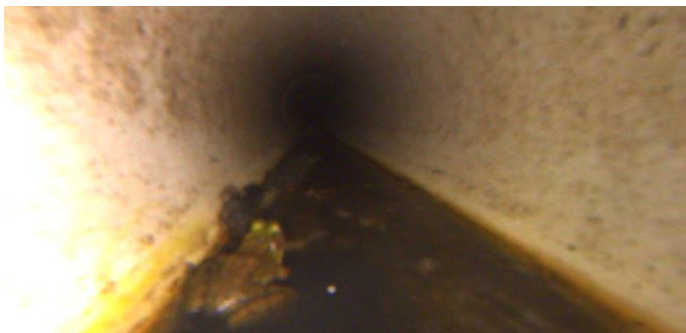
Code: **AMH**
Description: **Manhole**

Distance (ft): **.0**
Structural Grade: **0**
O&M Grade: **0**
Clock Start/From:
Clock To:
1st Value:
2nd Value:
Value Percent:
Continuous Index:
Within 8" of Joint: **NO**
Remarks: **M-905-007**

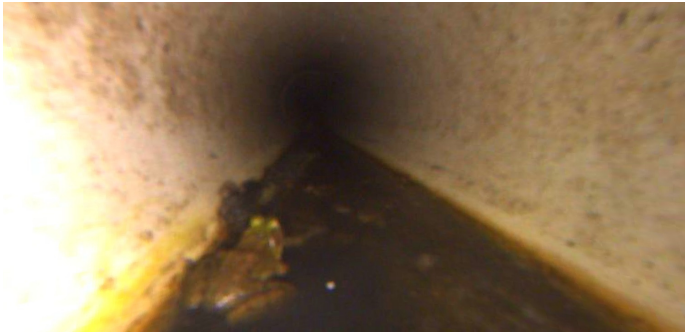
Code:	MWL
Description:	Water Level

Distance (ft):	.0
Structural Grade:	0
O&M Grade:	0
Clock Start/From:	
Clock To:	
1st Value:	
2nd Value:	
Value Percent:	5.000
Continuous Index:	
Within 8" of Joint:	NO
Remarks:

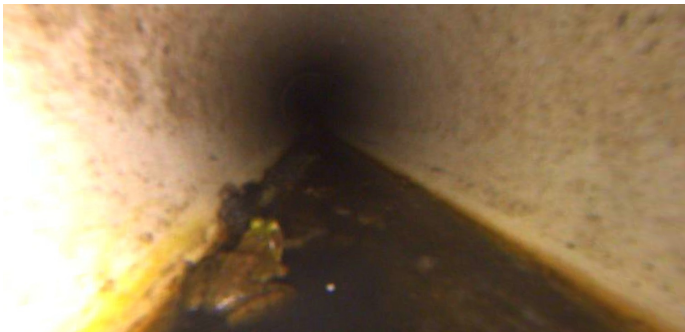
Code:	VZ
Description:	Vermin Other

Distance (ft):	.0
Structural Grade:	0
O&M Grade:	1
Clock Start/From:	
Clock To:	
1st Value:	1.000
2nd Value:	
Value Percent:	
Continuous Index:	
Within 8" of Joint:	
Remarks:	Frog

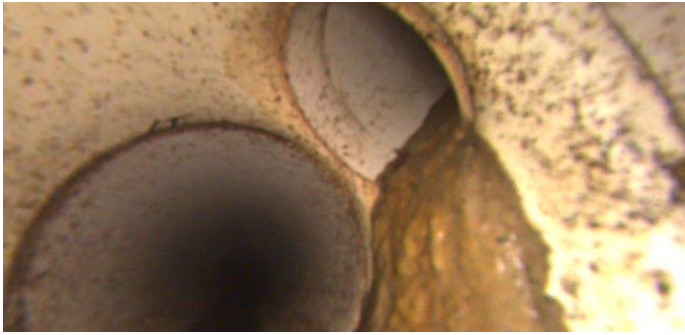
Code: **TFD**
Description: **Tap Factory Defective**

Distance (ft): **72.9**
Structural Grade: **0**
O&M Grade: **2**
Clock Start/From: **2**
Clock To:
1st Value: **4.000**
2nd Value:
Value Percent:
Continuous Index:
Within 8" of Joint:
Remarks: **dae**

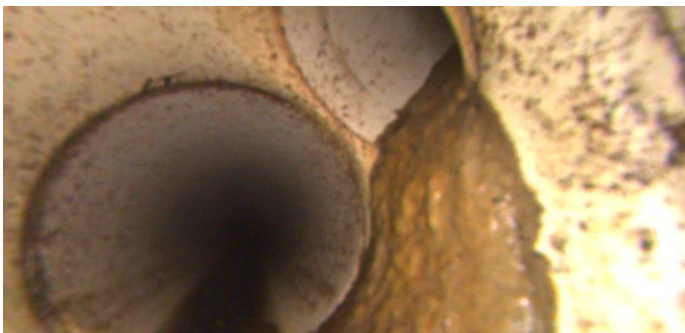
Code: **DAE**
Description: **Deposits Attached Encrustation**

Distance (ft): **72.9**
Structural Grade: **0**
O&M Grade: **2**
Clock Start/From: **1**
Clock To: **4**
1st Value:
2nd Value:
Value Percent: **5.000**
Continuous Index:
Within 8" of Joint: **NO**
Remarks:

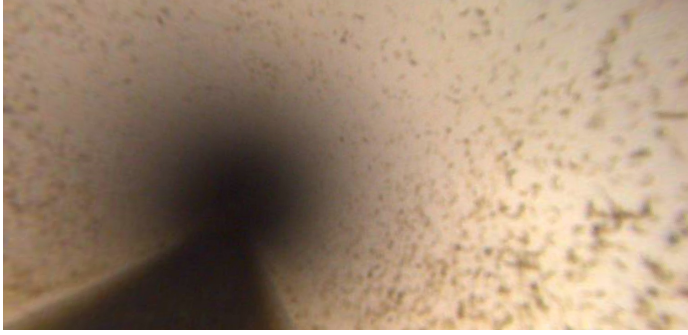
Code:	MSA
Description:	Abandoned Survey
Distance (ft):	83.2
Structural Grade:	0
O&M Grade:	0
Clock Start/From:	
Clock To:	
1st Value:	
2nd Value:	
Value Percent:	
Continuous Index:	
Within 8" of Joint:	NO
Remarks:	debris
