## Profile/Photo Observation Report

Date:	<b>04/24/2018</b>	Weather:		Coding:	<b>PACP 6.0</b>
Pipe Length (ft):	<b>310.2</b>	Owner:	<b>NA</b>	Pre Clean:	<b>Not Known</b>
P.O.#:		Surveyor:	<b>Jen Costello</b>	PSR:	<b>P-905-007-006</b>
Customer:		Clean Date:	<b>01/01/1900</b>	Shape:	<b>C</b>

Street:	<b>Sullivan</b>	Flow Control:	<b>Not Controlled</b>
City:	<b>Hobart, IN</b>	Year Renewed:	
Location:	<b>Light Highway</b>	Tape/Media #:	
Purpose:	<b>Maintenance Related</b>	Dia/Height:	<b>10"</b>
Use:	<b>Sanitary</b>	Material:	<b>PVC</b>
Drain Area:	<b>NA</b>	Lining:	<b>Cured in Place</b>
Category:	<b>NA</b>		
Comment:	<b>Flow direction wrong. Reverse setup. Debris at 81'.</b>		
Location Details:		Direction of Survey:	<b>Upstream</b>
US MH:	<b>M-905-006</b>	DS MH:	<b>M-905-007</b>
		Total Length Surveyed (ft):	<b>83.2</b>

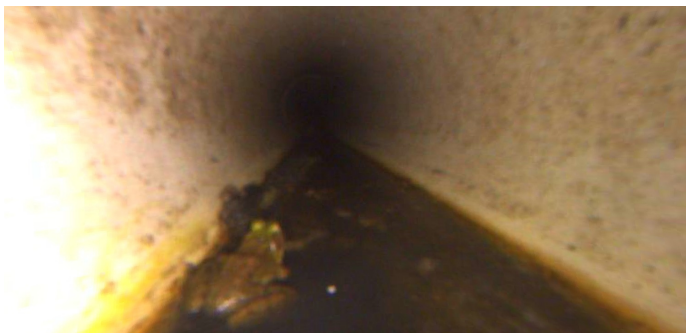
Code: **AMH**  
Description: **Manhole**

Distance (ft): **.0**  
Structural Grade: **0**  
O&M Grade: **0**  
Clock Start/From:  
Clock To:  
1st Value:  
2nd Value:  
Value Percent:  
Continuous Index:  
Within 8" of Joint: **NO**  
Remarks: **M-905-007**

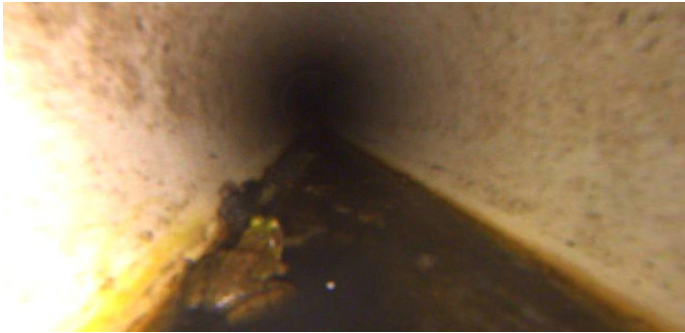
Code:	<b>MWL</b>
Description:	<b>Water Level</b>

Distance (ft):	<b>.0</b>
Structural Grade:	<b>0</b>
O&M Grade:	<b>0</b>
Clock Start/From:	
Clock To:	
1st Value:	
2nd Value:	
Value Percent:	<b>5.000</b>
Continuous Index:	
Within 8" of Joint:	<b>NO</b>
Remarks:

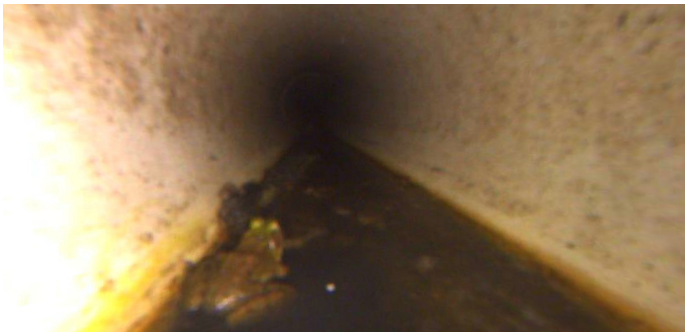
Code:	<b>VZ</b>
Description:	<b>Vermin Other</b>

Distance (ft):	<b>.0</b>
Structural Grade:	<b>0</b>
O&M Grade:	<b>1</b>
Clock Start/From:	
Clock To:	
1st Value:	<b>1.000</b>
2nd Value:	
Value Percent:	
Continuous Index:	
Within 8" of Joint:	
Remarks:	<b>Frog</b>

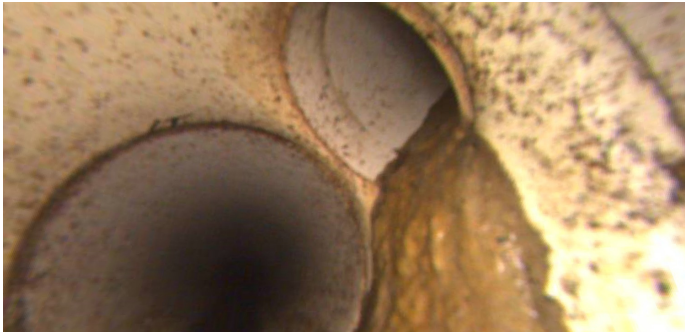
Code: **TFD**  
Description: **Tap Factory Defective**

Distance (ft): **72.9**  
Structural Grade: **0**  
O&M Grade: **2**  
Clock Start/From: **2**  
Clock To:  
1st Value: **4.000**  
2nd Value:  
Value Percent:  
Continuous Index:  
Within 8" of Joint:  
Remarks: **dae**

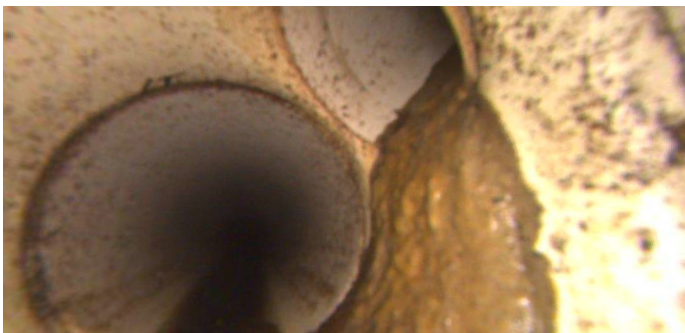
Code: **DAE**  
Description: **Deposits Attached Encrustation**

Distance (ft): **72.9**  
Structural Grade: **0**  
O&M Grade: **2**  
Clock Start/From: **1**  
Clock To: **4**  
1st Value:  
2nd Value:  
Value Percent: **5.000**  
Continuous Index:  
Within 8" of Joint: **NO**  
Remarks:

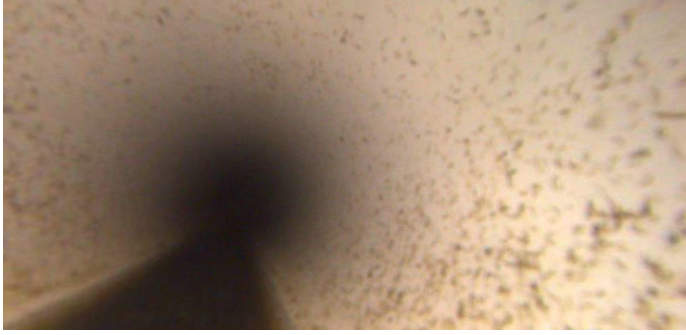
Code:	<b>MSA</b>
Description:	<b>Abandoned Survey</b>
Distance (ft):	<b>83.2</b>
Structural Grade:	<b>0</b>
O&M Grade:	<b>0</b>
Clock Start/From:	
Clock To:	
1st Value:	
2nd Value:	
Value Percent:	
Continuous Index:	
Within 8" of Joint:	<b>NO</b>
Remarks:	<b>debris</b>
