Profile/Photo Observation Report

| Street: | SULLIVAN ST | Flow Control: | Not Controlled |
| City: | Hobart, IN | Year Renewed: | |

| US MH: | M-905-007 | DS MH: | M-905-008 |

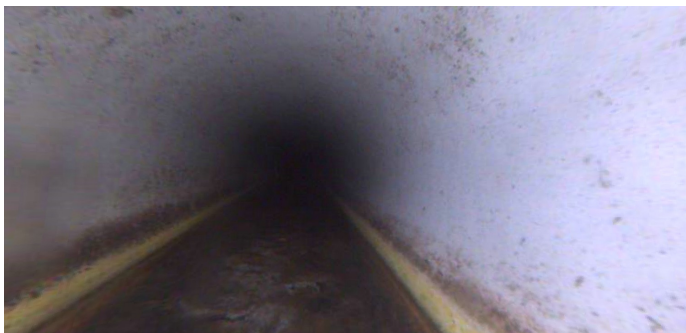
Code: **AMH**
Description: **Manhole**

Distance (ft): **.0**
Structural Grade: **0**
O&M Grade: **0**
Clock Start/From:
Clock To:
1st Value:
2nd Value:
Value Percent:
Continuous Index:
Within 8" of Joint: **NO**
Remarks: **M-905-007**

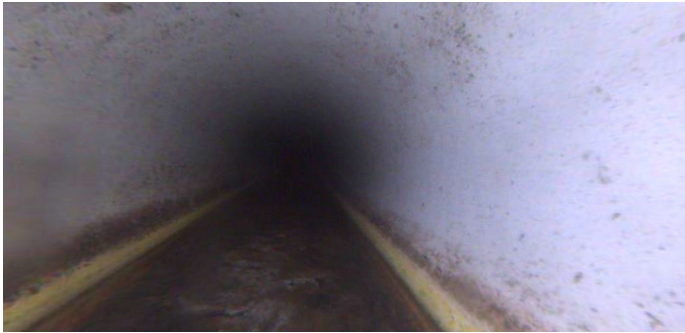
| Code: | MWL |
| Description: | Water Level |

| Value Percent: | 10.000 |

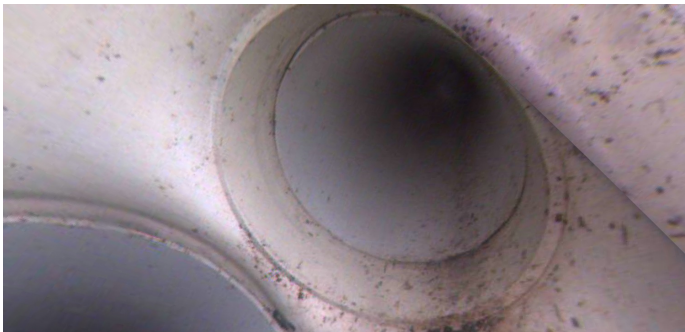
| Code: | TF |
| Description: | Tap Factory |

| Distance (ft): | 22.6 |

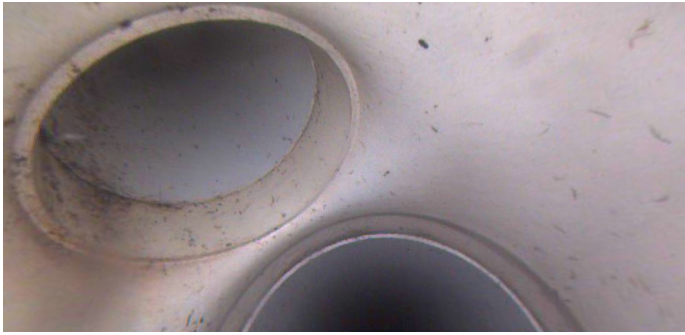
Code: **TF**
Description: **Tap Factory**

Distance (ft): **25.3**
Structural Grade: **0**
O&M Grade: **0**
Clock Start/From: **11**
Clock To:
1st Value: **4.000**
2nd Value:
Value Percent:
Continuous Index:
Within 8" of Joint:
Remarks:

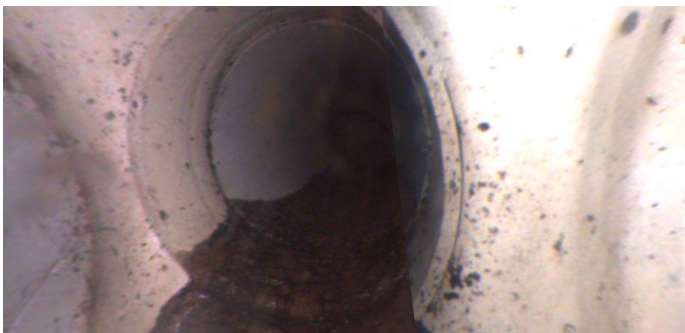
Code: **TF**
Description: **Tap Factory**

Distance (ft): **54.7**
Structural Grade: **0**
O&M Grade: **0**
Clock Start/From: **10**
Clock To:
1st Value: **4.000**
2nd Value:
Value Percent:
Continuous Index:
Within 8" of Joint:
Remarks:

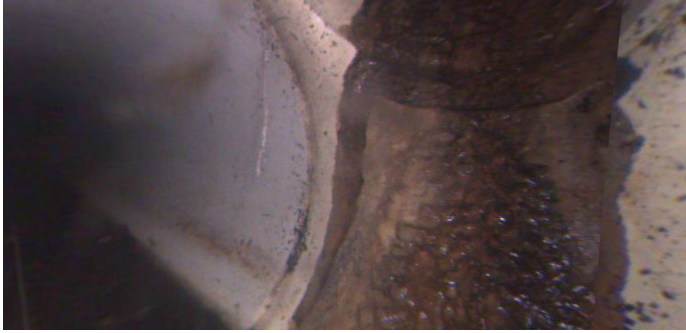
| | Position | Code | Observation | Video (sec) | Grade |
|--|---|---|---|---|---|
| | 54.7 | DAE | Deposits Attached Encrustation | 180 | M 2 |

Code: **DAE**
Description: **Deposits Attached Encrustation**

Distance (ft): **54.7**
Structural Grade: **0**
O&M Grade: **2**
Clock Start/From: **8**
Clock To: **10**
1st Value:
2nd Value:
Value Percent: **5.000**
Continuous Index:
Within 8" of Joint: **NO**
Remarks:

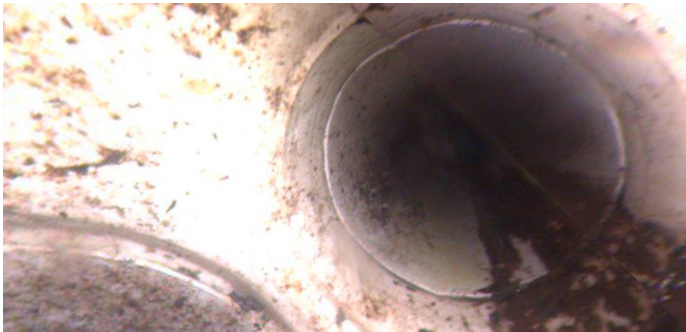
Code: **TF**
Description: **Tap Factory**

Distance (ft): **142.2**
Structural Grade: **0**
O&M Grade: **0**
Clock Start/From: **1**
Clock To:
1st Value: **4.000**
2nd Value:
Value Percent:
Continuous Index:
Within 8" of Joint:
Remarks:

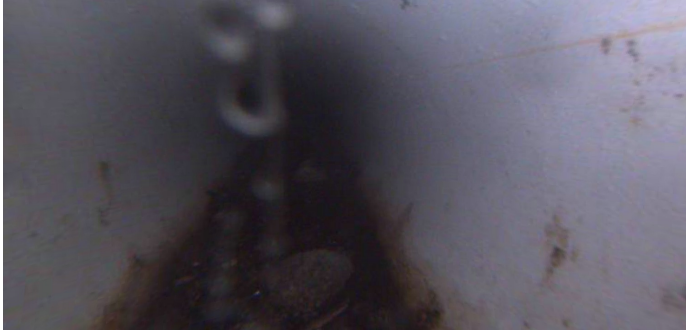
| Comment: | Debris at 207'. | | |

| | Position | Code | Observation | Video (sec) | Grade |
|--|---|---|---|---|---|
| | 206.8 | DSF | Deposits Settled Fine | 510 | M 2 |

Code: **DSF**
Description: **Deposits Settled Fine**

Distance (ft): **206.8**
Structural Grade: **0**
O&M Grade: **2**
Clock Start/From: **5**
Clock To: **7**
1st Value:
2nd Value:
Value Percent: **10.000**
Continuous Index:
Within 8" of Joint: **NO**
Remarks:

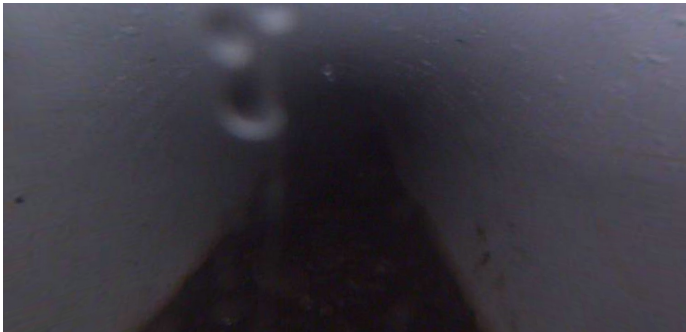
Code: **MSA**
Description: **Abandoned Survey**

Distance (ft): **208.6**
Structural Grade: **0**
O&M Grade: **0**
Clock Start/From:
Clock To:
1st Value:
2nd Value:
Value Percent:
Continuous Index:
Within 8" of Joint: **NO**
Remarks: **dsf**
