## Profile/Photo Observation Report

Date:	<b>01/14/2023</b>	Weather:		Coding:	<b>PACP 7.0</b>
Pipe Length (ft):	<b>98.7</b>	Owner:	<b>City of Hobart</b>	Pre Clean:	<b>Heavy Cleaning</b>
P.O.#:	<b>YES502259</b>	Surveyor:	<b>S. Bucklin</b>	PSR:	<b>M-905-008-M-905-009</b>
Customer:	<b>City of Hobart</b>	Clean Date:	<b>10/15/2022</b>	Shape:	<b>C</b>

Street:	<b>Sullivan Street</b>	Flow Control:	<b>Not Controlled</b>
City:	<b>Hobart, IN</b>	Year Renewed:	
Location:	<b>Levee Pump Station</b>	Tape/Media #:	
Purpose:	<b>Routine Assessment</b>	Dia/Height:	<b>10"</b>
Use:	<b>Sanitary Sewage Pipe</b>	Material:	<b>PVC</b>
Drain Area:		Lining:	<b>None</b>
Category:	<b>NA</b>

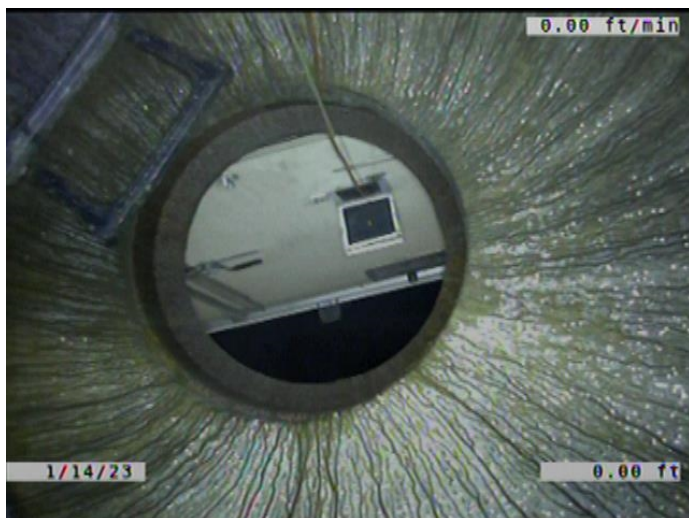
Code: **AMH**  
Description: **Manhole**

Distance (ft): **.0**  
Structural Grade: **0**  
O&M Grade: **0**  
Clock Start/From:  
Clock To:  
1st Value:  
2nd Value:  
Value Percent:  
Continuous Index:  
Within 8" of Joint: **NO**  
Remarks: **M-905-008**

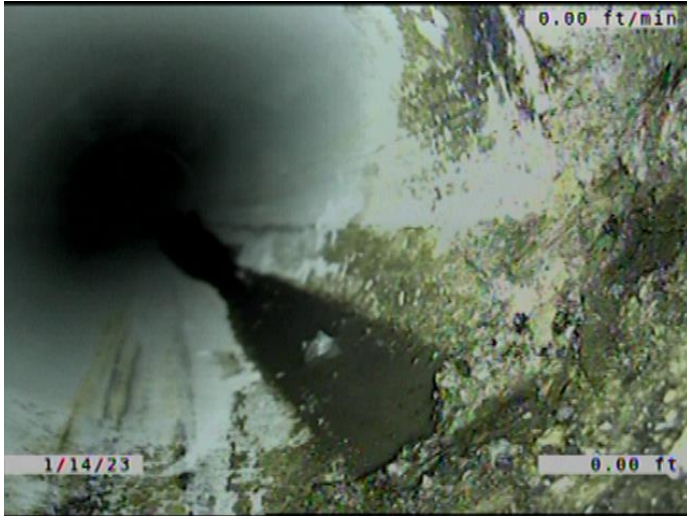
Code: **MWL**  
Description: **Miscellaneous Water Level**

Distance (ft): **.0**  
Structural Grade: **0**  
O&M Grade: **0**  
Clock Start/From:  
Clock To:  
1st Value:  
2nd Value:  
Value Percent: **5.000**  
Continuous Index:  
Within 8" of Joint: **NO**  
Remarks:

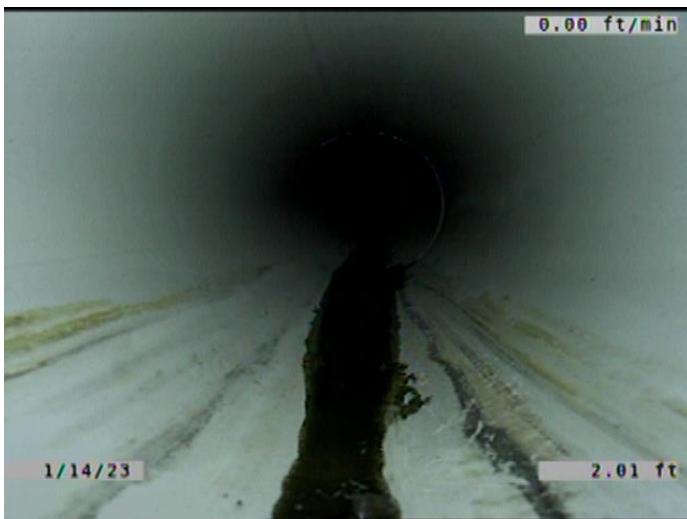
Code: **DSF**  
Description: **Deposits Settled Fine**

Distance (ft): **2.0**  
Structural Grade: **0**  
O&M Grade: **2**  
Clock Start/From: **5**  
Clock To: **7**  
1st Value:  
2nd Value:  
Value Percent: **5.000**  
Continuous Index: **S01**  
Within 8" of Joint: **YES**  
Remarks:

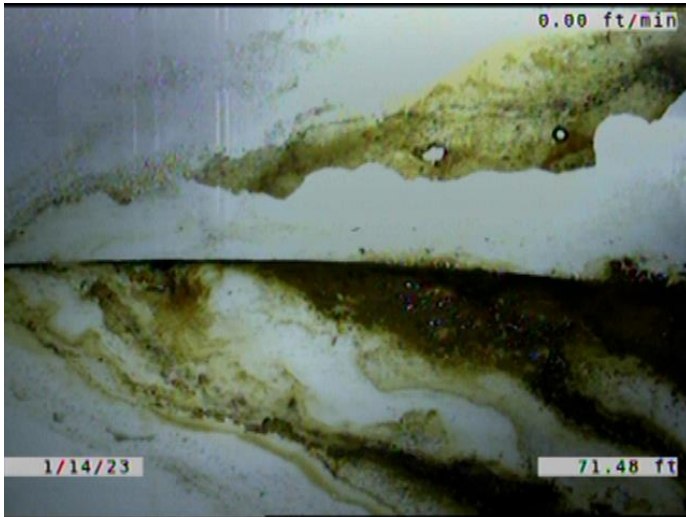
Code: **DAE**  
 Description: **Deposits Attached Encrustation**

Distance (ft): **71.5**  
 Structural Grade: **0**  
 O&M Grade: **2**  
 Clock Start/From: **1**  
 Clock To: **5**  
 1st Value:  
 2nd Value:  
 Value Percent: **5.000**  
 Continuous Index:  
 Within 8" of Joint: **YES**  
 Remarks:

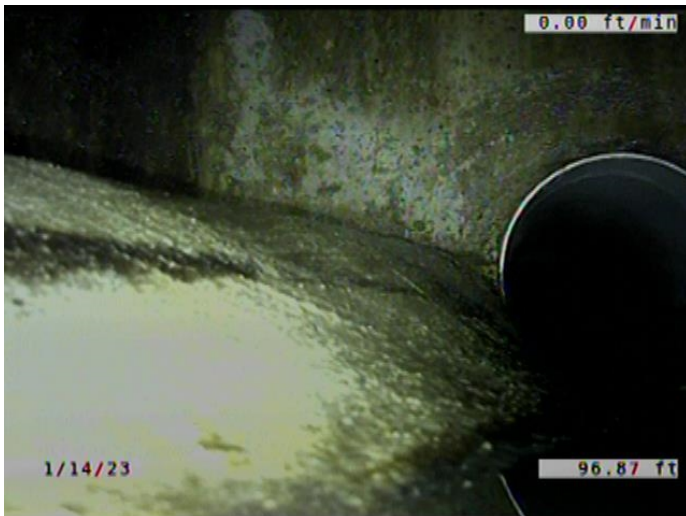
Code: **DSF**  
 Description: **Deposits Settled Fine**

Distance (ft): **96.9**  
 Structural Grade: **0**  
 O&M Grade: **2**  
 Clock Start/From: **5**  
 Clock To: **7**  
 1st Value:  
 2nd Value:  
 Value Percent: **5.000**  
 Continuous Index: **F01**  
 Within 8" of Joint: **YES**  
 Remarks:

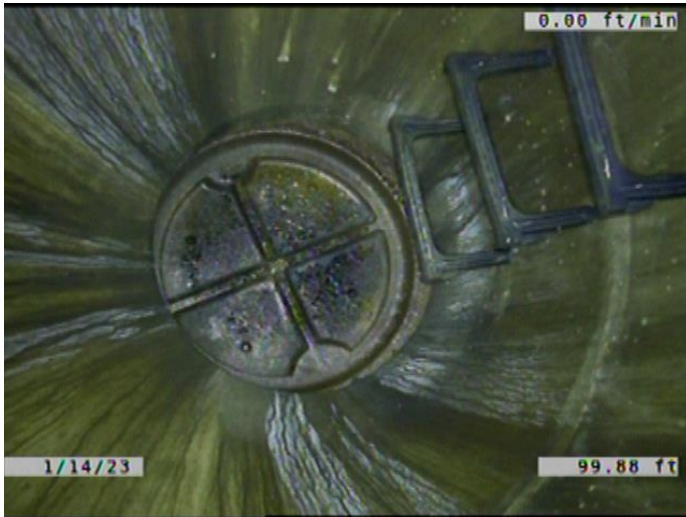
Code:	<b>AMH</b>
Description:	<b>Manhole</b>
Distance (ft):	<b>99.9</b>
Structural Grade:	<b>0</b>
O&M Grade:	<b>0</b>
Clock Start/From:	
Clock To:	
1st Value:	
2nd Value:	
Value Percent:	
Continuous Index:	
Within 8" of Joint:	<b>NO</b>
Remarks:	<b>M-905-009</b>
