Profile/Photo Observation Report

Street:	Sullivan Street	Flow Control:	
City:	Hobart, IN	Year Renewed:	
Location:	Light Highway	Tape/Media #:	904
Purpose:	Routine Assessment	Dia/Height:	10"
Use:	Sanitary	Material:	PVC
Drain Area:		Lining:	
Category:	NA		
Comment:

Location Details:		Direction of Survey:	Downstream
US MH:	M-905-8	DS MH:	M-905-9
		Total Length Surveyed (ft):	4.1

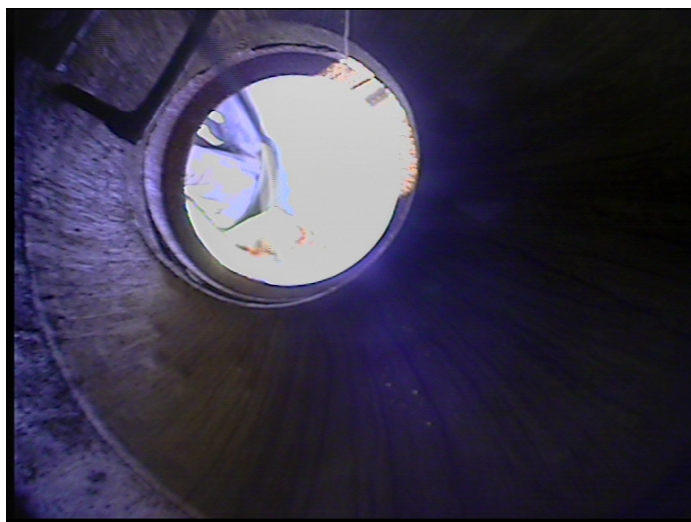
Code: **AMH**
Description: **Manhole**

Distance (ft): **.0**
Structural Grade: **0**
O&M Grade: **0**
Clock Start/From:
Clock To:
1st Value:
2nd Value:
Value Percent:
Continuous Index:
Within 8" of Joint: **NO**
Remarks: **M-905-8**

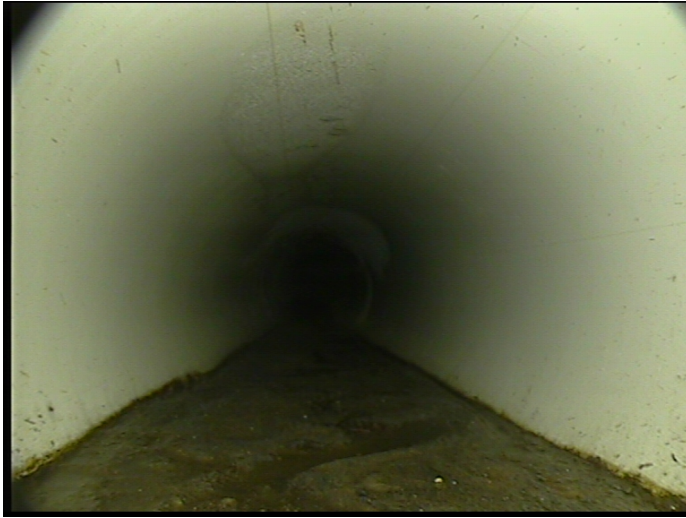
Code: **MWL**
Description: **Water Level**

Distance (ft): **.0**
Structural Grade: **0**
O&M Grade: **0**
Clock Start/From:
Clock To:
1st Value:
2nd Value:
Value Percent: **5.000**
Continuous Index:
Within 8" of Joint: **NO**
Remarks:

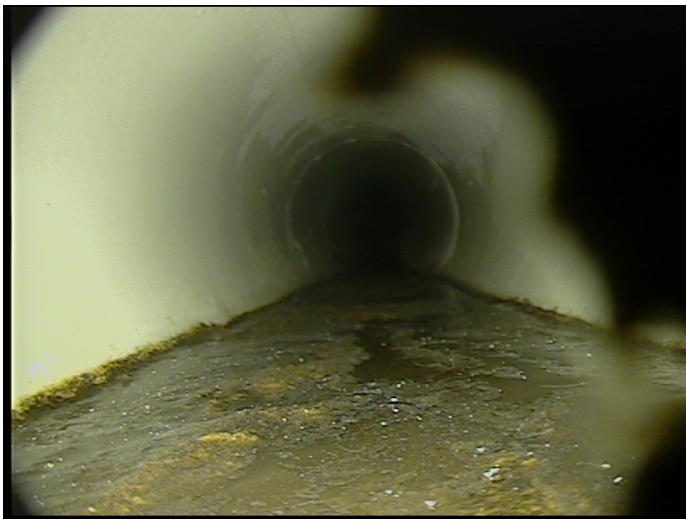
Code: **DSF**
Description: **Deposits Settled Fine**

Distance (ft): **4.1**
Structural Grade: **0**
O&M Grade: **3**
Clock Start/From: **4**
Clock To: **8**
1st Value:
2nd Value:
Value Percent: **15.000**
Continuous Index:
Within 8" of Joint: **NO**
Remarks:

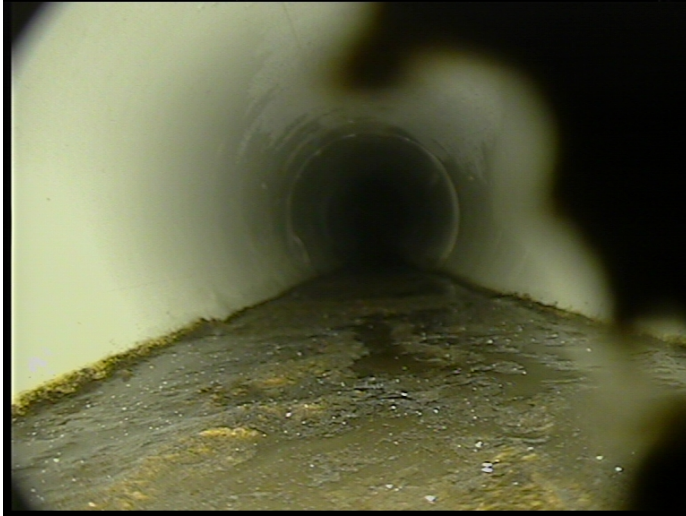
Code:	MSA
Description:	Abandoned Survey
Distance (ft):	4.1
Structural Grade:	0
O&M Grade:	0
Clock Start/From:	
Clock To:	
1st Value:	
2nd Value:	
Value Percent:	
Continuous Index:	
Within 8" of Joint:	NO
Remarks:	Can not pass through sediment
