## Profile/Photo Observation Report

Street:	<b>Sullivan Street</b>	Flow Control:	<b>Not Controlled</b>
City:	<b>Hobart, IN</b>	Year Renewed:	
Location:	<b>Light Highway</b>	Tape/Media #:	<b>905</b>
Purpose:	<b>Reversal</b>	Dia/Height:	<b>10"</b>
Use:	<b>Sanitary</b>	Material:	<b>PVC</b>
Drain Area:		Lining:	
Category:	<b>NA</b>		
Comment:			
Location Details:		Direction of Survey:	<b>Upstream</b>
US MH:	<b>M-905-8</b>	DS MH:	<b>M-905-9</b>
		Total Length Surveyed (ft):	<b>.1</b>

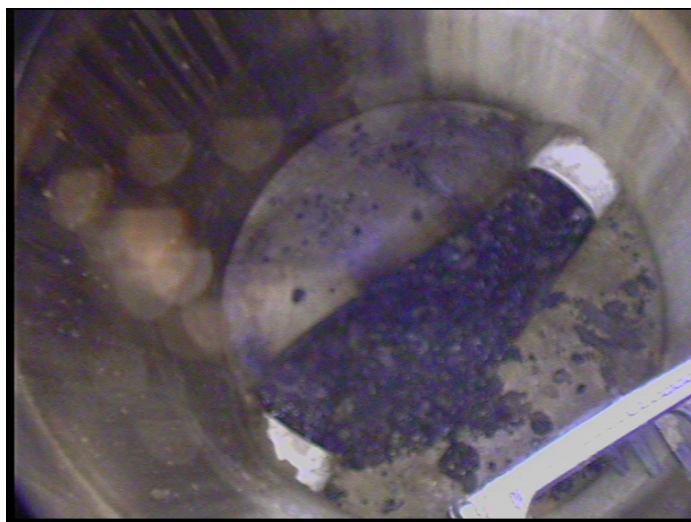
Code: **AMH**  
Description: **Manhole**

Distance (ft): **.0**  
Structural Grade: **0**  
O&M Grade: **0**  
Clock Start/From:  
Clock To:  
1st Value:  
2nd Value:  
Value Percent:  
Continuous Index:  
Within 8" of Joint: **NO**  
Remarks: **M-905-9**

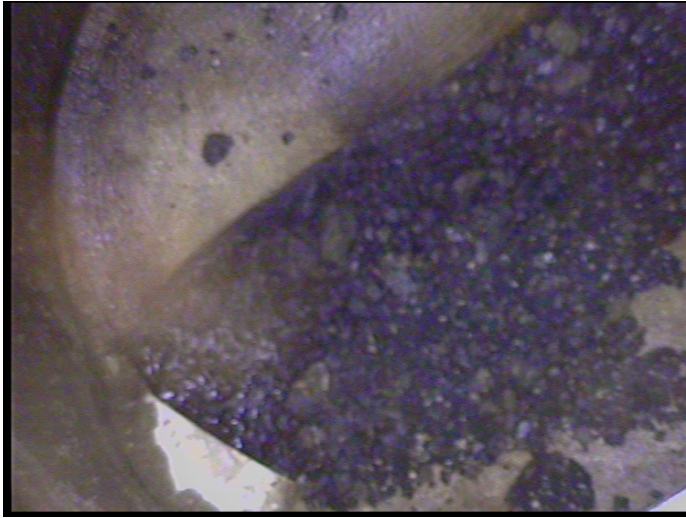
Code: **MWL**  
Description: **Water Level**

Distance (ft): **.0**  
Structural Grade: **0**  
O&M Grade: **0**  
Clock Start/From:  
Clock To:  
1st Value:  
2nd Value:  
Value Percent: **0.000**  
Continuous Index:  
Within 8" of Joint: **NO**  
Remarks:

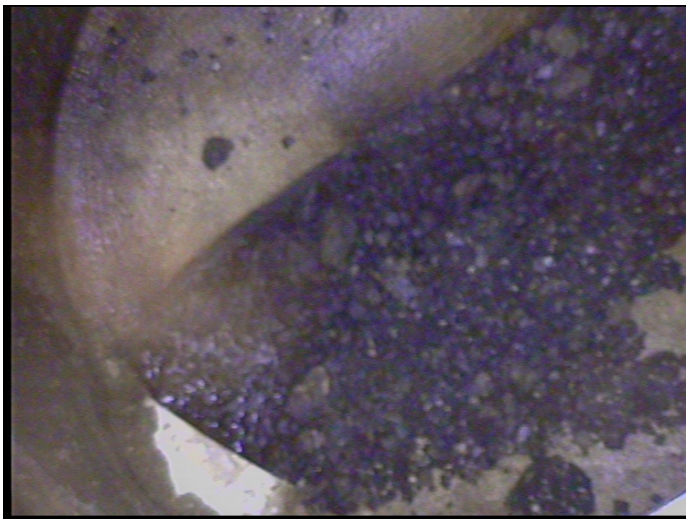
Code: **DSGV**  
Description: **Deposits Settled Gravel**

Distance (ft): **.0**  
Structural Grade: **0**  
O&M Grade: **3**  
Clock Start/From: **4**  
Clock To: **8**  
1st Value:  
2nd Value:  
Value Percent: **20.000**  
Continuous Index:  
Within 8" of Joint: **NO**  
Remarks:

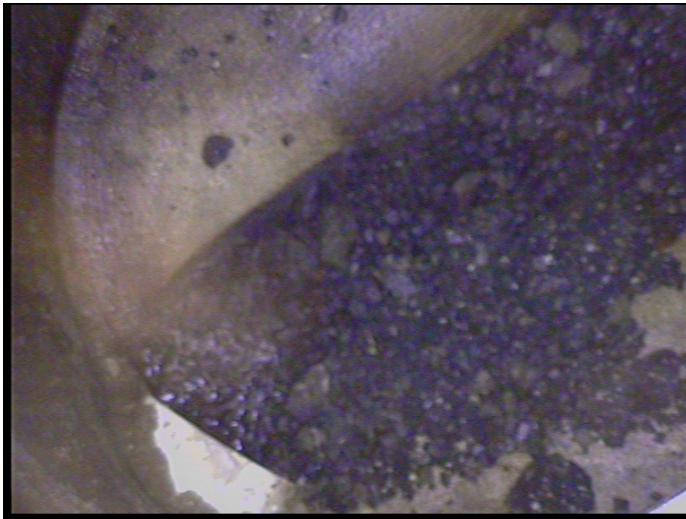
Code:	<b>MSA</b>
Description:	<b>Abandoned Survey</b>
Distance (ft):	<b>.0</b>
Structural Grade:	<b>0</b>
O&M Grade:	<b>0</b>
Clock Start/From:	
Clock To:	
1st Value:	
2nd Value:	
Value Percent:	
Continuous Index:	
Within 8" of Joint:	<b>NO</b>
Remarks:	<b>Debris in pipe entrance</b>
