Profile/Photo Observation Report

Date:	02/03/2023	Weather:		Coding:	PACP 7.0
Pipe Length (ft):	357.0	Owner:	City of Hobart	Pre Clean:	No Pre-Cleaning
P.O.#:	YES502259	Surveyor:	S. Bucklin	PSR:	P-905-010-011
Customer:	City of Hobart	Clean Date:		Shape:	C

Street:	South Shelby Street	Flow Control:	Not Controlled
City:	Hobart, IN	Year Renewed:	
Location:	Local rural streets with light traffic, t	Tape/Media #:	
Purpose:	Routine Assessment	Dia/Height:	18"
Use:	Sanitary Sewage Pipe	Material:	PVC
Drain Area:		Lining:	None
Category:	NA		
Comment:			
Location Details:		Direction of Survey:	Upstream
US MH:	M-905-011	DS MH:	M-905-010
		Total Length Surveyed (ft):	355.9

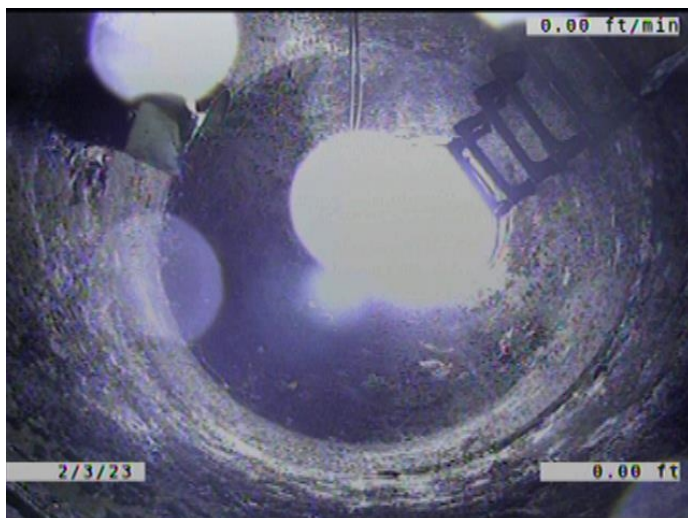
Code: **AMH**
 Description: **Manhole**

Distance (ft): **.0**
 Structural Grade: **0**
 O&M Grade: **0**
 Clock Start/From:
 Clock To:
 1st Value:
 2nd Value:
 Value Percent:
 Continuous Index:
 Within 8" of Joint: **NO**
 Remarks: **M-905-010**

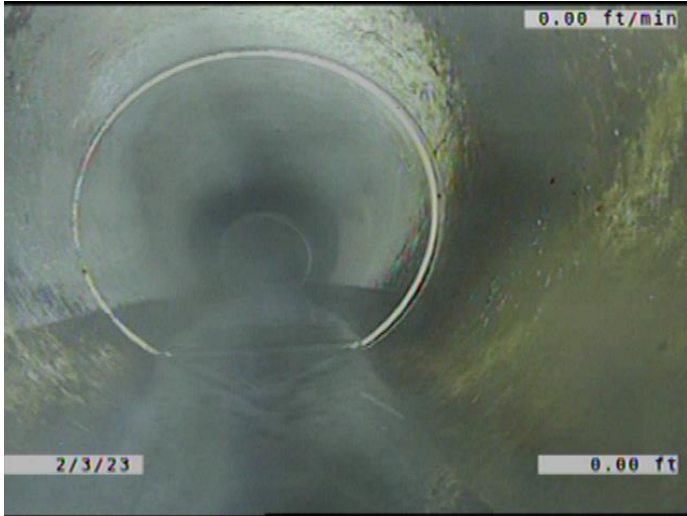
Code: **MWL**
Description: **Miscellaneous Water Level**

Distance (ft): **.0**
Structural Grade: **0**
O&M Grade: **0**
Clock Start/From:
Clock To:
1st Value:
2nd Value:
Value Percent: **10.000**
Continuous Index:
Within 8" of Joint: **NO**
Remarks:

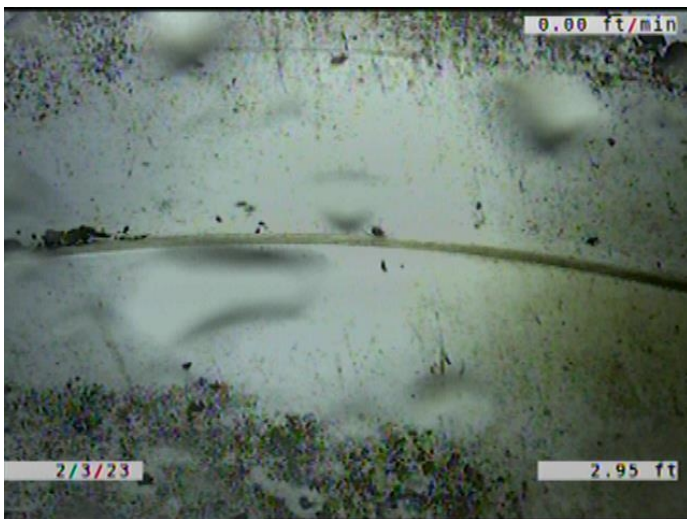
Code: **JAM**
Description: **Joint Angular Medium**

Distance (ft): **2.9**
Structural Grade: **3**
O&M Grade: **0**
Clock Start/From:
Clock To:
1st Value:
2nd Value:
Value Percent:
Continuous Index:
Within 8" of Joint: **NO**
Remarks:

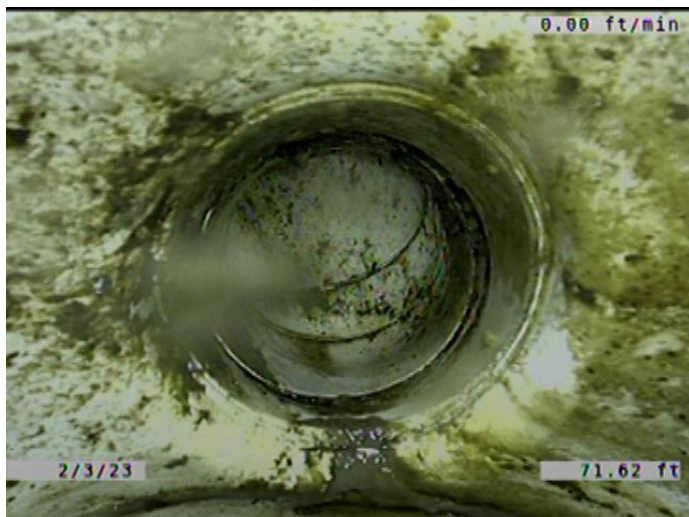
Code: **TF**
Description: **Tap Factory**

Distance (ft): **71.6**
Structural Grade: **0**
O&M Grade: **0**
Clock Start/From: **12**
Clock To:
1st Value: **6.000**
2nd Value:
Value Percent:
Continuous Index:
Within 8" of Joint: **YES**
Remarks: **CONSTANTLY DRIPPING WATER.**

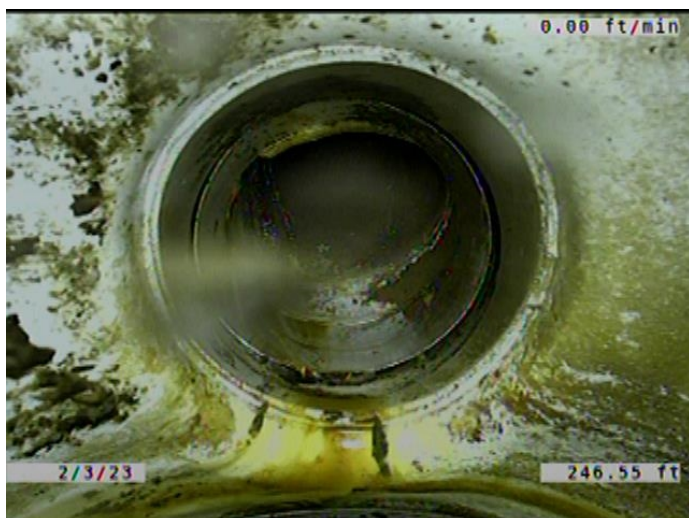
Code: **TF**
Description: **Tap Factory**

Distance (ft): **246.5**
Structural Grade: **0**
O&M Grade: **0**
Clock Start/From: **12**
Clock To:
1st Value: **6.000**
2nd Value:
Value Percent:
Continuous Index:
Within 8" of Joint: **YES**
Remarks: **CONSTANTLY RUNNING WATER.**

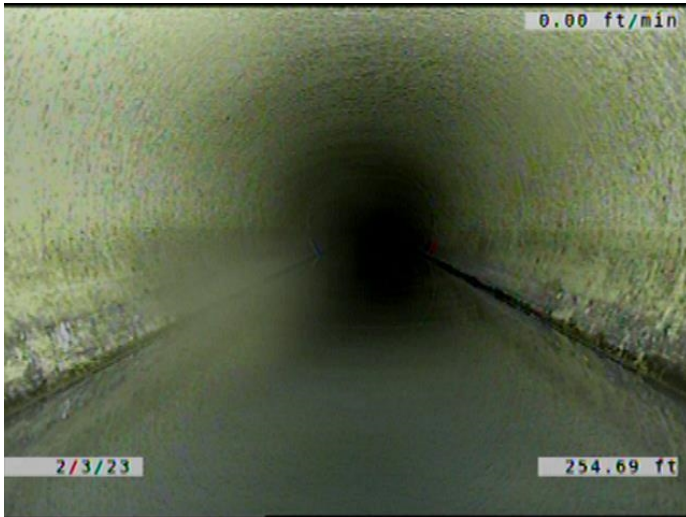
Code: **MWLS**
Description: **Miscellaneous Water Level Sag**

Distance (ft): **254.7**
Structural Grade: **2**
O&M Grade: **0**
Clock Start/From:
Clock To:
1st Value:
2nd Value:
Value Percent: **20.000**
Continuous Index: **S01**
Within 8" of Joint: **NO**
Remarks:

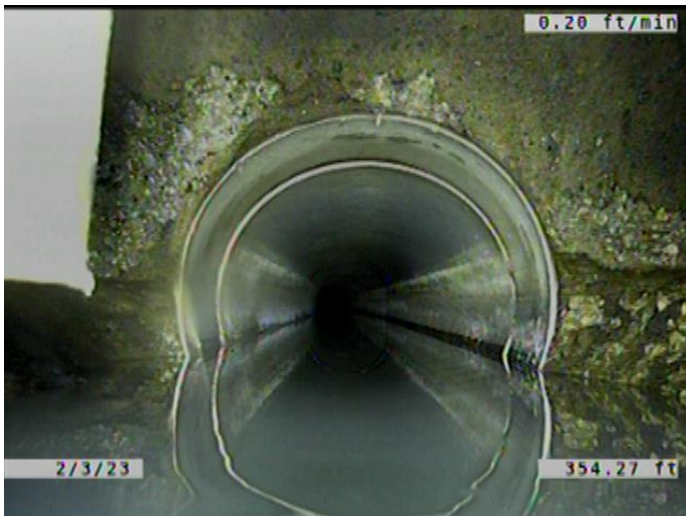
Code: **MWLS**
Description: **Miscellaneous Water Level Sag**

Distance (ft): **354.3**
Structural Grade: **2**
O&M Grade: **0**
Clock Start/From:
Clock To:
1st Value:
2nd Value:
Value Percent: **20.000**
Continuous Index: **F01**
Within 8" of Joint: **NO**
Remarks:

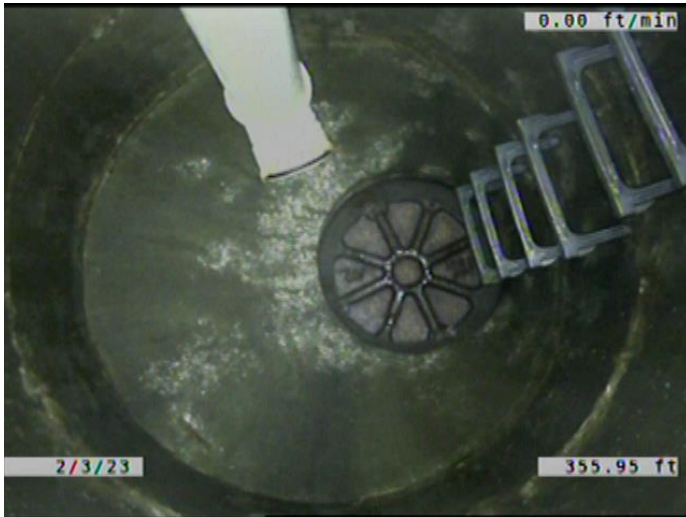
Code:	AMH
Description:	Manhole
Distance (ft):	355.9
Structural Grade:	0
O&M Grade:	0
Clock Start/From:	
Clock To:	
1st Value:	
2nd Value:	
Value Percent:	
Continuous Index:	
Within 8" of Joint:	NO
Remarks:	M-905-011
