Profile/Photo Observation Report

| City: | Hobart, IN | Year Renewed: | |

| US MH: | M-905-011 | DS MH: | M-905-033 |

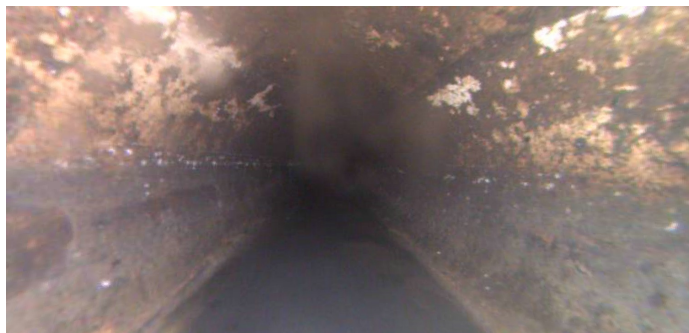
Code: **AMH**
Description: **Manhole**

Distance (ft): **.0**
Structural Grade: **0**
O&M Grade: **0**
Clock Start/From:
Clock To:
1st Value:
2nd Value:
Value Percent:
Continuous Index:
Within 8" of Joint: **NO**
Remarks: **M-905-033**

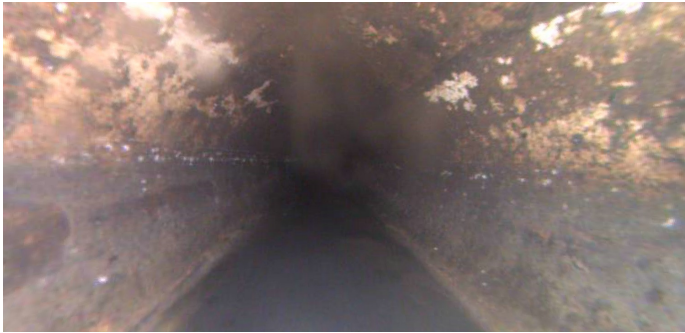
| Code: | MWL |
| Description: | Water Level |

| Value Percent: | 10.000 |

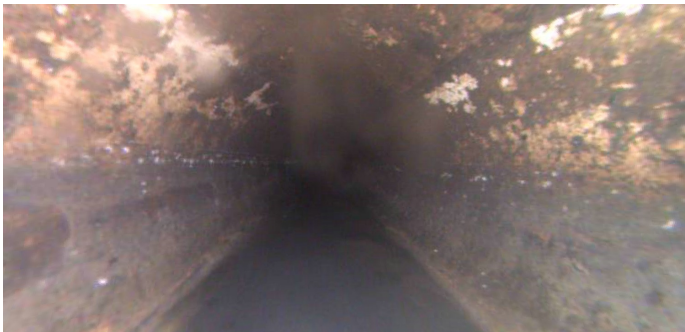
| | Position | Code | Observation | Video (sec) | Grade |
|--|---|---|---|---|---|
| | .0 | DAGS(S01) | Deposits Attached Grease | 33 | M 2 |

| Code: | DAGS |
| Description: | Deposits Attached Grease |

| O&M Grade: | 2 |
| Clock Start/From: | 8 |
| Clock To: | 4 |
| Value Percent: | 5.000 |

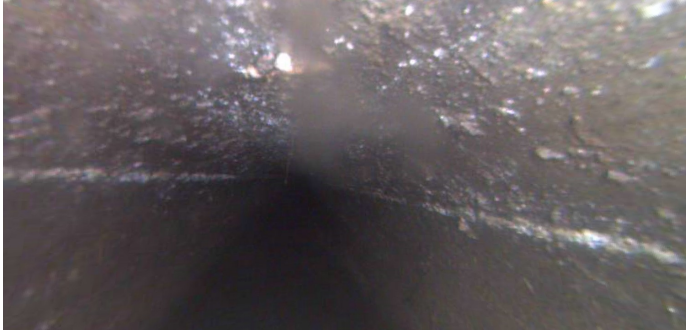
| | Position | Code | Observation | Video (sec) | Grade |
|--|---|---|---|---|---|
| | 23.3 | DAGS(F01) | Deposits Attached Grease | 91 | M 2 |

Code: **DAGS**
Description: **Deposits Attached Grease**

Distance (ft): **23.3**
Structural Grade: **0**
O&M Grade: **2**
Clock Start/From: **8**
Clock To: **4**
1st Value:
2nd Value:
Value Percent: **5.000**
Continuous Index: **F01**
Within 8" of Joint: **NO**
Remarks:

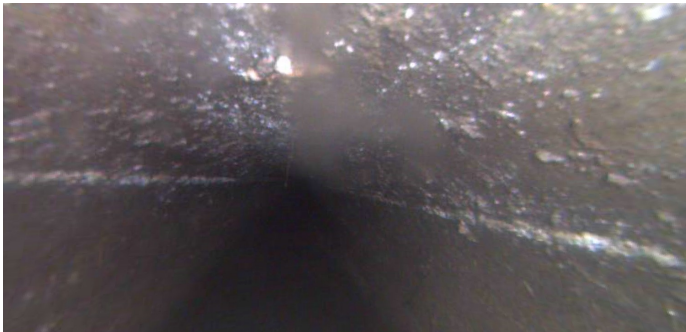
Code: **MSA**
Description: **Abandoned Survey**

Distance (ft): **23.3**
Structural Grade: **0**
O&M Grade: **0**
Clock Start/From:
Clock To:
1st Value:
2nd Value:
Value Percent:
Continuous Index:
Within 8" of Joint: **NO**
Remarks: **dags**
