Profile/Photo Observation Report

Date:	04/24/2018	Weather:		Coding:	PACP 6.0
Pipe Length (ft):	368.5	Owner:	NA	Pre Clean:	Not Known
P.O.#:		Surveyor:	Jen Costello	PSR:	P-905-033-011
Customer:		Clean Date:	01/01/1900	Shape:	C

Street:	S SHELBY ST	Flow Control:	Not Controlled
City:	Hobart, IN	Year Renewed:	
Location:	Light Highway	Tape/Media #:	
Purpose:	Maintenance Related	Dia/Height:	8"
Use:	Sanitary	Material:	PVC
Drain Area:	NA	Lining:	Cured in Place
Category:	NA		
Comment:	Debris at 3'.

Location Details:		Direction of Survey:	Upstream
US MH:	M-905-011	DS MH:	M-905-033
		Total Length Surveyed (ft):	5.3

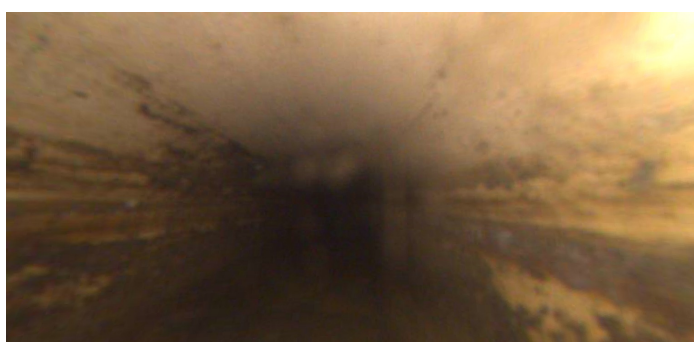
Code: **AMH**
Description: **Manhole**

Distance (ft): **.0**
Structural Grade: **0**
O&M Grade: **0**
Clock Start/From:
Clock To:
1st Value:
2nd Value:
Value Percent:
Continuous Index:
Within 8" of Joint: **NO**
Remarks: **M-905-033**

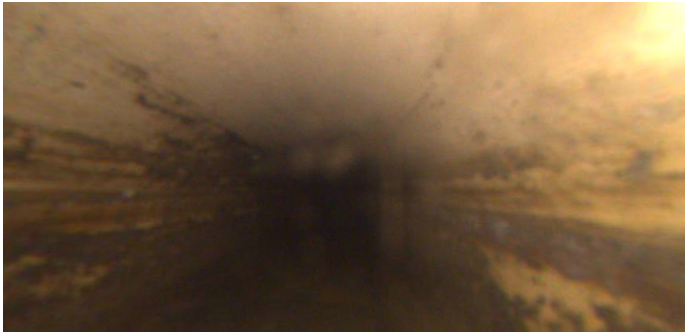
Code:	MWL
Description:	Water Level

Distance (ft):	.0
Structural Grade:	0
O&M Grade:	0
Clock Start/From:	
Clock To:	
1st Value:	
2nd Value:	
Value Percent:	10.000
Continuous Index:	
Within 8" of Joint:	NO
Remarks:

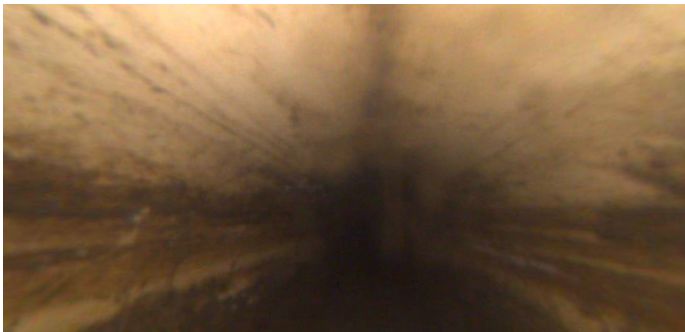
Code:	MSA
Description:	Abandoned Survey

Distance (ft):	5.3
Structural Grade:	0
O&M Grade:	0
Clock Start/From:	
Clock To:	
1st Value:	
2nd Value:	
Value Percent:	
Continuous Index:	
Within 8" of Joint:	NO
Remarks:	debris under water
