Profile/Photo Observation Report

Date:	04/24/2018	Weather:		Coding:	PACP 6.0
Pipe Length (ft):	368.5	Owner:	NA	Pre Clean:	Not Known
P.O.#:		Surveyor:	Jen Costello	PSR:	P-905-033-011
Customer:		Clean Date:	01/01/1900	Shape:	C

Street:	130	Flow Control:	Not Controlled
City:	Hobart, IN	Year Renewed:	
Location:	Light Highway	Tape/Media #:	
Purpose:	Maintenance Related	Dia/Height:	8"
Use:	Sanitary	Material:	PVC
Drain Area:	NA	Lining:	Cured in Place
Category:	NA		
Comment:	Debris at 3'.

Location Details:		Direction of Survey:	Upstream
US MH:	M-905-011	DS MH:	M-905-033
		Total Length Surveyed (ft):	5.3

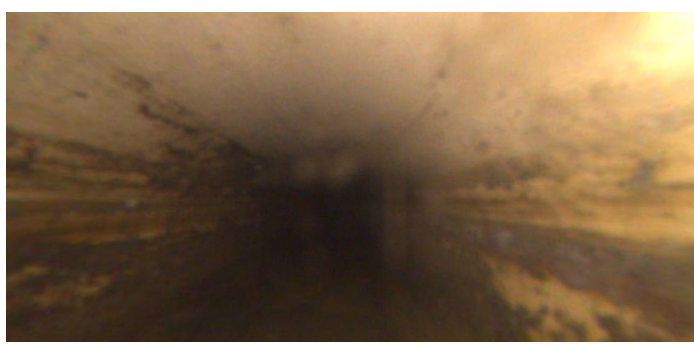
Code: **AMH**
Description: **Manhole**

Distance (ft): **.0**
Structural Grade: **0**
O&M Grade: **0**
Clock Start/From:
Clock To:
1st Value:
2nd Value:
Value Percent:
Continuous Index:
Within 8" of Joint: **NO**
Remarks: **M-905-033**

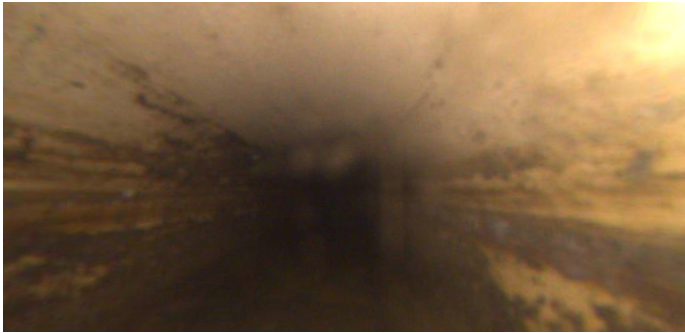
Code:	MWL
Description:	Water Level

Distance (ft):	.0
Structural Grade:	0
O&M Grade:	0
Clock Start/From:	
Clock To:	
1st Value:	
2nd Value:	
Value Percent:	10.000
Continuous Index:	
Within 8" of Joint:	NO
Remarks:

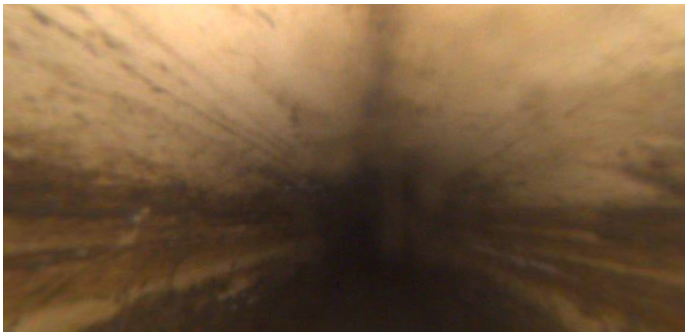
Code:	MSA
Description:	Abandoned Survey

Distance (ft):	5.3
Structural Grade:	0
O&M Grade:	0
Clock Start/From:	
Clock To:	
1st Value:	
2nd Value:	
Value Percent:	
Continuous Index:	
Within 8" of Joint:	NO
Remarks:	debris under water
