Profile/Photo Observation Report

Date:	04/24/2018	Weather:		Coding:	PACP 6.0
Pipe Length (ft):	368.5	Owner:	NA	Pre Clean:	Not Known
P.O.#:		Surveyor:	Jen Costello	PSR:	P-905-033-011
Customer:		Clean Date:	01/01/1900	Shape:	C

Street:	S SHELBY ST	Flow Control:	Not Controlled
City:	Hobart, IN	Year Renewed:	
Location:	Light Highway	Tape/Media #:	
Purpose:	Maintenance Related	Dia/Height:	8"
Use:	Sanitary	Material:	PVC
Drain Area:	NA	Lining:	Cured in Place
Category:	NA		
Comment:	Redeployment.

Location Details:		Direction of Survey:	Upstream
US MH:	M-905-011	DS MH:	M-905-033
		Total Length Surveyed (ft):	390.3

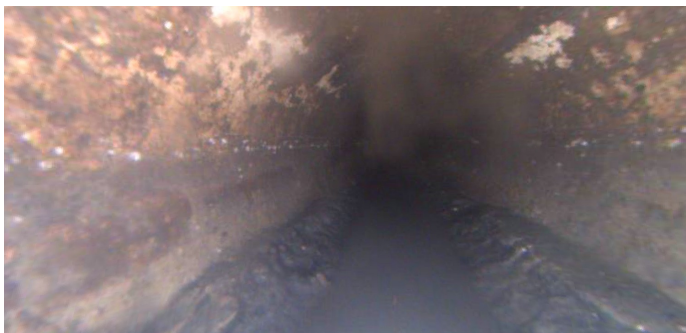
Code: **AMH**
Description: **Manhole**

Distance (ft): **.0**
Structural Grade: **0**
O&M Grade: **0**
Clock Start/From:
Clock To:
1st Value:
2nd Value:
Value Percent:
Continuous Index:
Within 8" of Joint: **NO**
Remarks: **M-905-033**

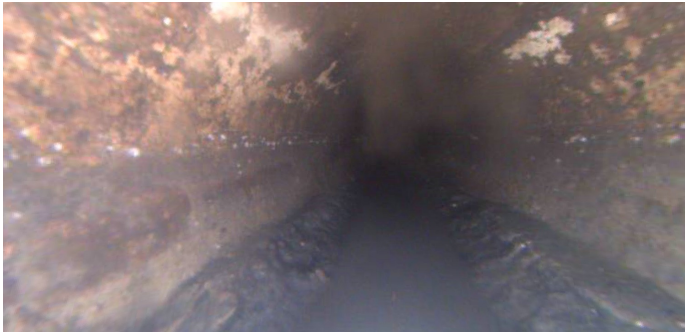
Code:	MWL
Description:	Water Level

Distance (ft):	.0
Structural Grade:	0
O&M Grade:	0
Clock Start/From:	
Clock To:	
1st Value:	
2nd Value:	
Value Percent:	10.000
Continuous Index:	
Within 8" of Joint:	NO
Remarks:

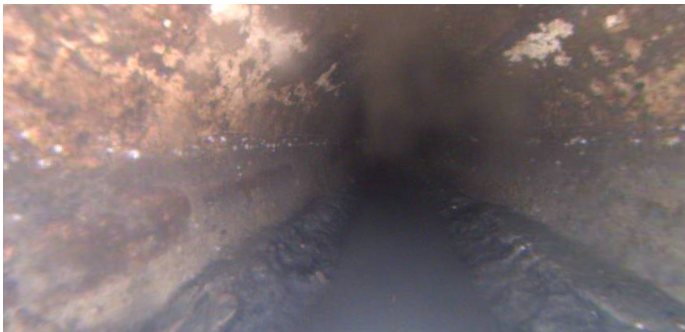
Code:	DAGS
Description:	Deposits Attached Grease

Distance (ft):	.0
Structural Grade:	0
O&M Grade:	2
Clock Start/From:	7
Clock To:	5
1st Value:	
2nd Value:	
Value Percent:	10.000
Continuous Index:	S01
Within 8" of Joint:	NO
Remarks:

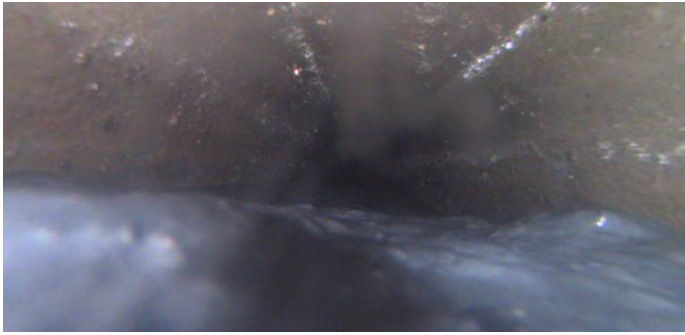
Code: **MWL**
Description: **Water Level**

Distance (ft): **27.7**
Structural Grade: **0**
O&M Grade: **0**
Clock Start/From:
Clock To:
1st Value:
2nd Value:
Value Percent: **40.000**
Continuous Index:
Within 8" of Joint: **NO**
Remarks:

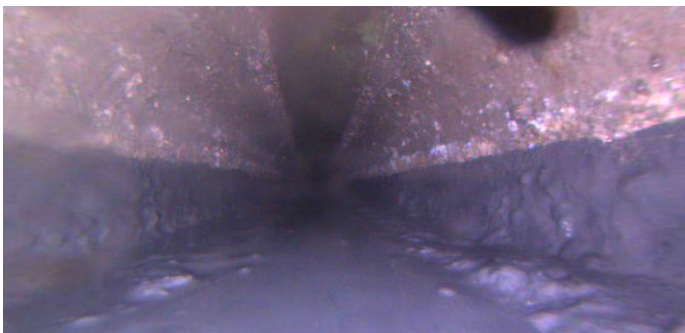
Code: **MGO**
Description: **General Observation**

Distance (ft): **37.2**
Structural Grade: **0**
O&M Grade: **0**
Clock Start/From:
Clock To:
1st Value:
2nd Value:
Value Percent:
Continuous Index:
Within 8" of Joint: **NO**
Remarks: **rear camera**

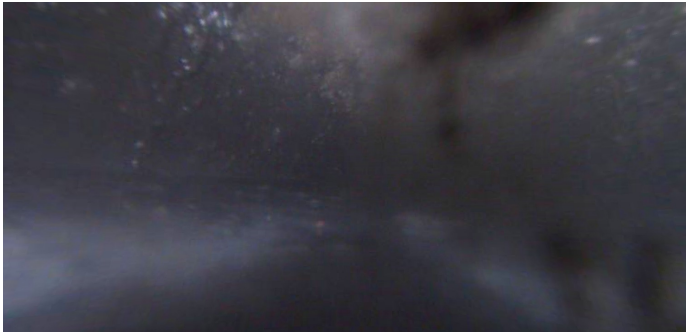
Code: **MCU**
Description: **Camera Underwater**

Distance (ft): **218.7**
Structural Grade: **0**
O&M Grade: **4**
Clock Start/From:
Clock To:
1st Value:
2nd Value:
Value Percent:
Continuous Index: **F02**
Within 8" of Joint: **NO**
Remarks:

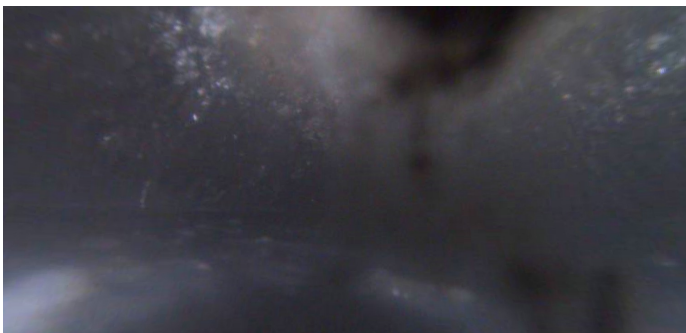
Code: **DAGS**
Description: **Deposits Attached Grease**

Distance (ft): **220.3**
Structural Grade: **0**
O&M Grade: **2**
Clock Start/From: **8**
Clock To: **4**
1st Value:
2nd Value:
Value Percent: **10.000**
Continuous Index: **S03**
Within 8" of Joint: **NO**
Remarks:

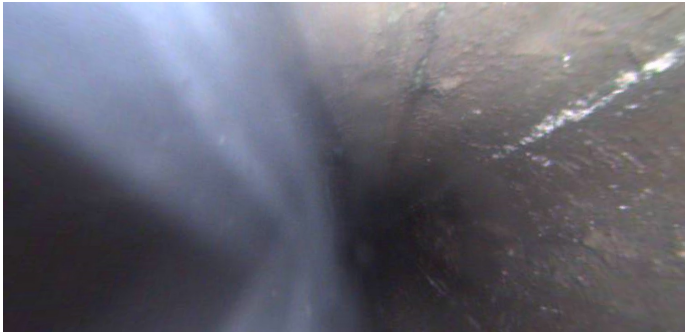
Code: **DAGS**
Description: **Deposits Attached Grease**

Distance (ft): **309.3**
Structural Grade: **0**
O&M Grade: **2**
Clock Start/From: **8**
Clock To: **4**
1st Value:
2nd Value:
Value Percent: **10.000**
Continuous Index: **F03**
Within 8" of Joint: **NO**
Remarks:

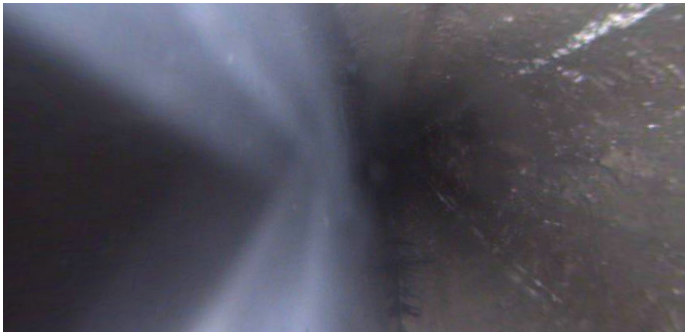
Code: **MSA**
Description: **Abandoned Survey**

Distance (ft): **309.3**
Structural Grade: **0**
O&M Grade: **0**
Clock Start/From:
Clock To:
1st Value:
2nd Value:
Value Percent:
Continuous Index:
Within 8" of Joint: **NO**
Remarks: **overturned, footage increases**
