## Profile/Photo Observation Report

Date:	<b>04/24/2018</b>	Weather:		Coding:	<b>PACP 6.0</b>
Pipe Length (ft):	<b>368.5</b>	Owner:	<b>NA</b>	Pre Clean:	<b>Not Known</b>
P.O.#:		Surveyor:	<b>Jen Costello</b>	PSR:	<b>P-905-033-011</b>
Customer:		Clean Date:	<b>01/01/1900</b>	Shape:	<b>C</b>

Location Details:		Direction of Survey:	<b>Upstream</b>
US MH:	<b>M-905-011</b>	DS MH:	<b>M-905-033</b>
		Total Length Surveyed (ft):	<b>390.3</b>

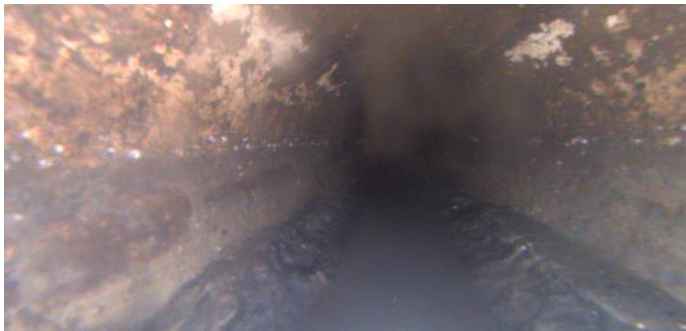
Code: **AMH**  
Description: **Manhole**

Distance (ft): **.0**  
Structural Grade: **0**  
O&M Grade: **0**  
Clock Start/From:  
Clock To:  
1st Value:  
2nd Value:  
Value Percent:  
Continuous Index:  
Within 8" of Joint: **NO**  
Remarks: **M-905-033**

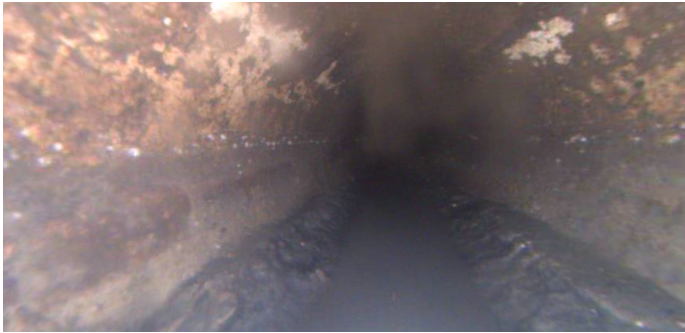
Code:	<b>MWL</b>
Description:	<b>Water Level</b>

Distance (ft):	<b>.0</b>
Structural Grade:	<b>0</b>
O&M Grade:	<b>0</b>
Clock Start/From:	
Clock To:	
1st Value:	
2nd Value:	
Value Percent:	<b>10.000</b>
Continuous Index:	
Within 8" of Joint:	<b>NO</b>
Remarks:

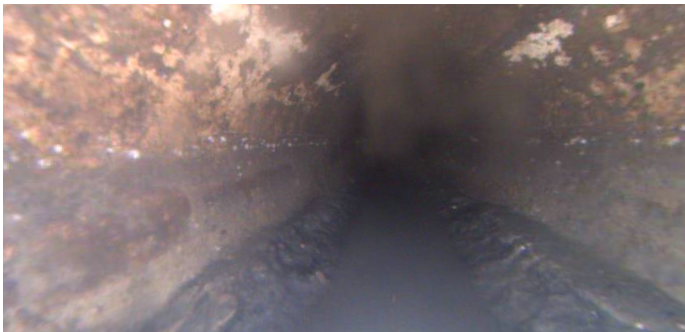
Code:	<b>DAGS</b>
Description:	<b>Deposits Attached Grease</b>

Distance (ft):	<b>.0</b>
Structural Grade:	<b>0</b>
O&M Grade:	<b>2</b>
Clock Start/From:	<b>7</b>
Clock To:	<b>5</b>
1st Value:	
2nd Value:	
Value Percent:	<b>10.000</b>
Continuous Index:	<b>S01</b>
Within 8" of Joint:	<b>NO</b>
Remarks:

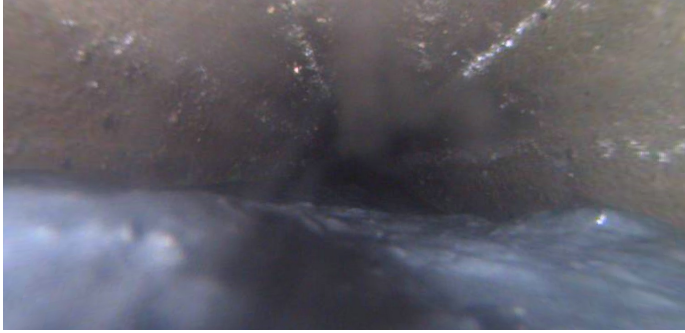
Code: **MWL**  
Description: **Water Level**

Distance (ft): **27.7**  
Structural Grade: **0**  
O&M Grade: **0**  
Clock Start/From:  
Clock To:  
1st Value:  
2nd Value:  
Value Percent: **40.000**  
Continuous Index:  
Within 8" of Joint: **NO**  
Remarks:

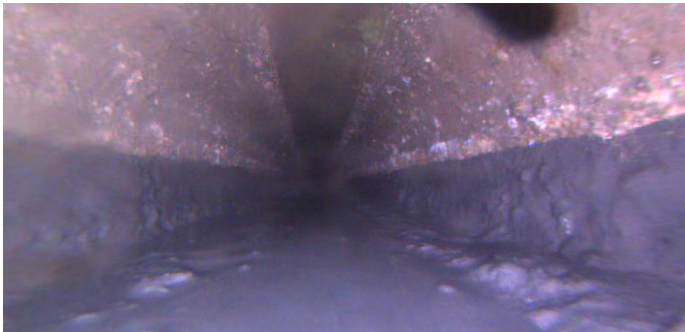
Code: **MGO**  
Description: **General Observation**

Distance (ft): **37.2**  
Structural Grade: **0**  
O&M Grade: **0**  
Clock Start/From:  
Clock To:  
1st Value:  
2nd Value:  
Value Percent:  
Continuous Index:  
Within 8" of Joint: **NO**  
Remarks: **rear camera**

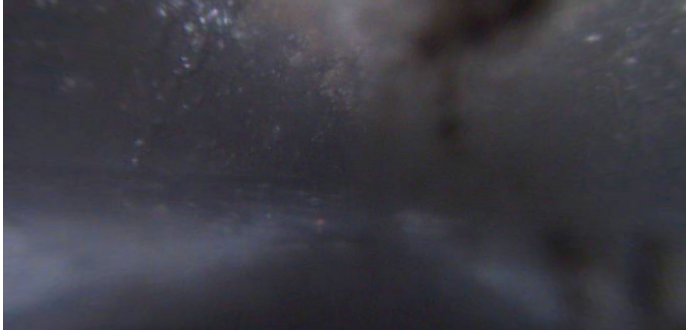
Code: **MCU**  
Description: **Camera Underwater**

Distance (ft): **218.7**  
Structural Grade: **0**  
O&M Grade: **4**  
Clock Start/From:  
Clock To:  
1st Value:  
2nd Value:  
Value Percent:  
Continuous Index: **F02**  
Within 8" of Joint: **NO**  
Remarks:

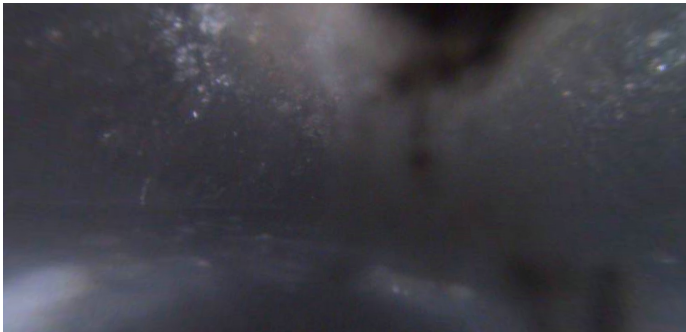
Code: **DAGS**  
Description: **Deposits Attached Grease**

Distance (ft): **220.3**  
Structural Grade: **0**  
O&M Grade: **2**  
Clock Start/From: **8**  
Clock To: **4**  
1st Value:  
2nd Value:  
Value Percent: **10.000**  
Continuous Index: **S03**  
Within 8" of Joint: **NO**  
Remarks:

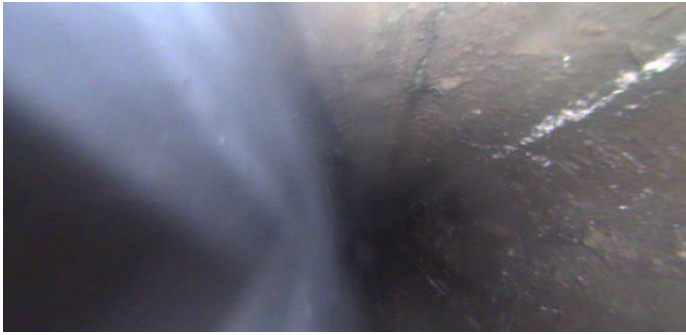
Code: **DAGS**  
Description: **Deposits Attached Grease**

Distance (ft): **309.3**  
Structural Grade: **0**  
O&M Grade: **2**  
Clock Start/From: **8**  
Clock To: **4**  
1st Value:  
2nd Value:  
Value Percent: **10.000**  
Continuous Index: **F03**  
Within 8" of Joint: **NO**  
Remarks:

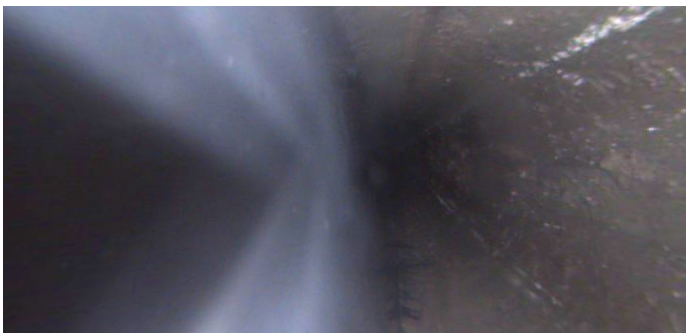
Code: **MSA**  
Description: **Abandoned Survey**

Distance (ft): **309.3**  
Structural Grade: **0**  
O&M Grade: **0**  
Clock Start/From:  
Clock To:  
1st Value:  
2nd Value:  
Value Percent:  
Continuous Index:  
Within 8" of Joint: **NO**  
Remarks: **overturned, footage increases**
