Profile/Photo Observation Report

| Date: | 05/06/2018 | Weather: | | Coding: | PACP 6.0 |

| US MH: | M-905-012 | DS MH: | M-905-011 |

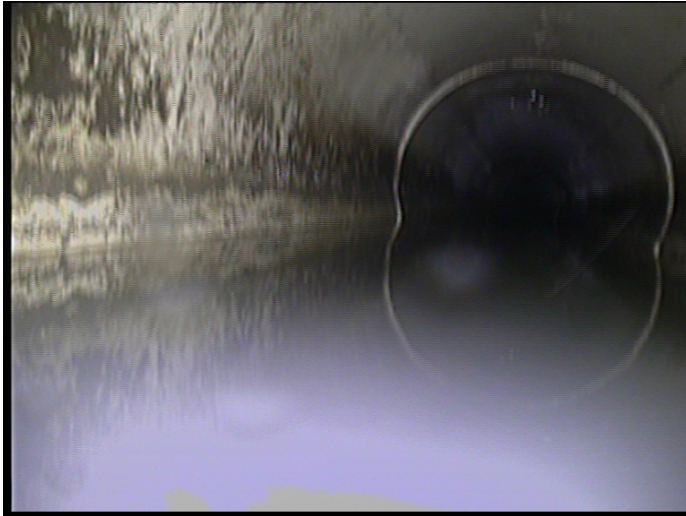
| Code: | AMH |
| Description: | Manhole |
| Distance (ft): | .0 |
| Remarks: | M-905-012 |

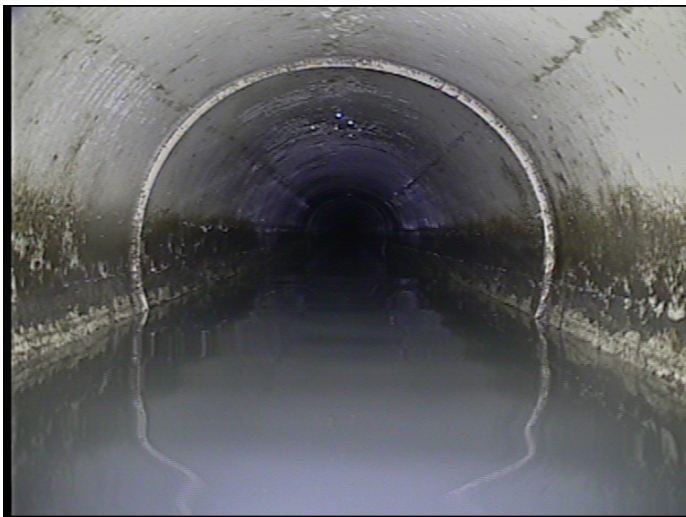
Code: **MWL**
Description: **Water Level**

Distance (ft): **.0**
Structural Grade: **0**
O&M Grade: **0**
Clock Start/From:
Clock To:
1st Value:
2nd Value:
Value Percent: **15.000**
Continuous Index:
Within 8" of Joint: **NO**
Remarks:

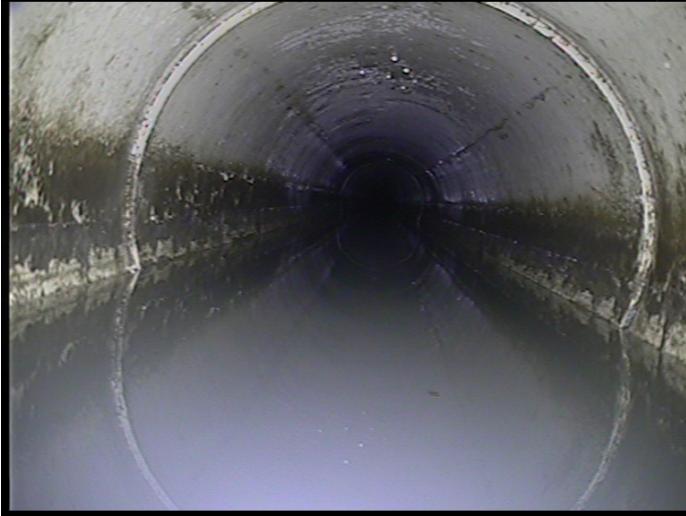
Code: **DSF**
Description: **Deposits Settled Fine**

Distance (ft): **1.5**
Structural Grade: **0**
O&M Grade: **3**
Clock Start/From: **4**
Clock To: **8**
1st Value:
2nd Value:
Value Percent: **15.000**
Continuous Index:
Within 8" of Joint: **NO**
Remarks: **under water sediment**
