Profile/Photo Observation Report

Date:	02/03/2023	Weather:		Coding:	PACP 7.0
Pipe Length (ft):	339.0	Owner:	City of Hobart	Pre Clean:	No Pre-Cleaning
P.O.#:	YES502259	Surveyor:	S. Bucklin	PSR:	P-905-011-012
Customer:	City of Hobart	Clean Date:		Shape:	C

Street:	South Shelby Street	Flow Control:	Not Controlled
City:	Hobart, IN	Year Renewed:	
Location:	Local rural streets with light traffic, t	Tape/Media #:	
Purpose:	Routine Assessment	Dia/Height:	18"
Use:	Sanitary Sewage Pipe	Material:	PVC
Drain Area:		Lining:	None
Category:	NA		
Comment:			
Location Details:		Direction of Survey:	Downstream
US MH:	M-905-012	DS MH:	M-905-011
		Total Length Surveyed (ft):	150.0

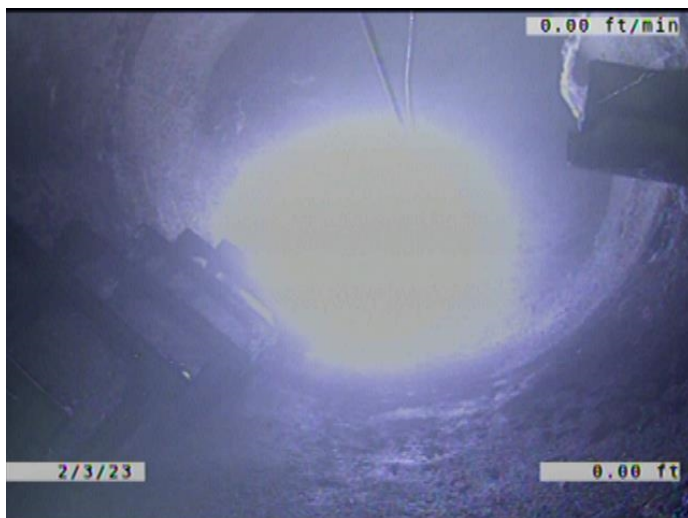
Code: **AMH**
Description: **Manhole**

Distance (ft): **.0**
Structural Grade: **0**
O&M Grade: **0**
Clock Start/From:
Clock To:
1st Value:
2nd Value:
Value Percent:
Continuous Index:
Within 8" of Joint: **NO**
Remarks: **M-905-012**

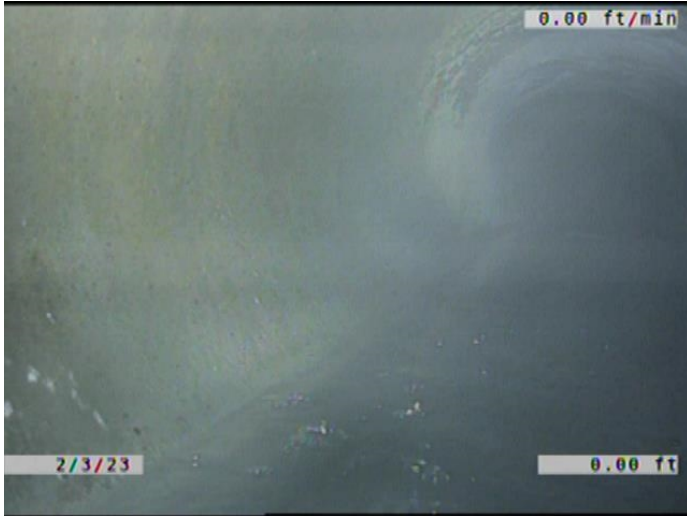
Code:	MWL
Description:	Miscellaneous Water Level
Distance (ft):	.0
Structural Grade:	0
O&M Grade:	0
Clock Start/From:	
Clock To:	
1st Value:	
2nd Value:	
Value Percent:	20.000
Continuous Index:	
Within 8" of Joint:	NO
Remarks:

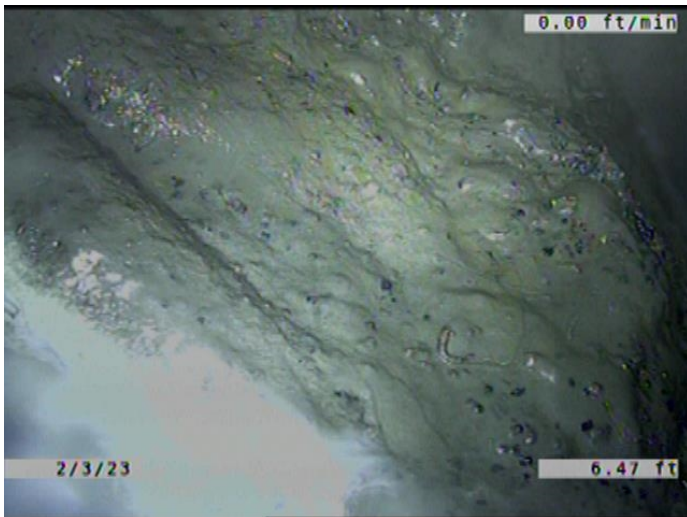
Code:	DAR
Description:	Deposits Attached Ragging
Distance (ft):	6.5
Structural Grade:	0
O&M Grade:	3
Clock Start/From:	4
Clock To:	8
1st Value:	
2nd Value:	
Value Percent:	15.000
Continuous Index:	
Within 8" of Joint:	NO
Remarks:

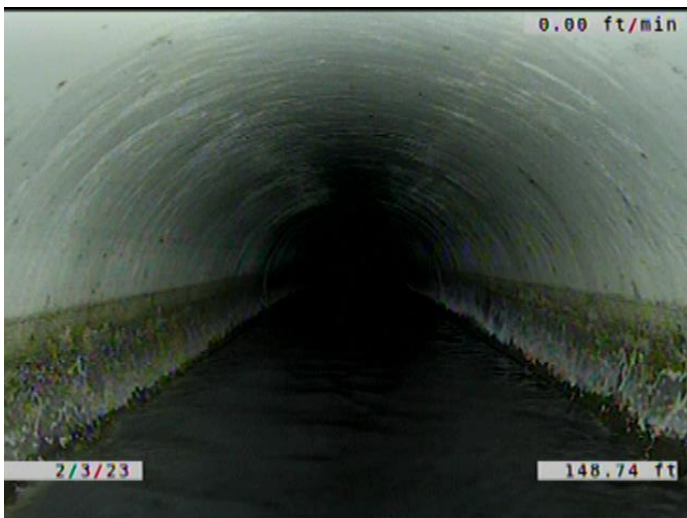
Code: **DSF**
Description: **Deposits Settled Fine**

Distance (ft): **148.7**
Structural Grade: **0**
O&M Grade: **3**
Clock Start/From: **4**
Clock To: **8**
1st Value:
2nd Value:
Value Percent: **15.000**
Continuous Index: **F01**
Within 8" of Joint: **YES**
Remarks:

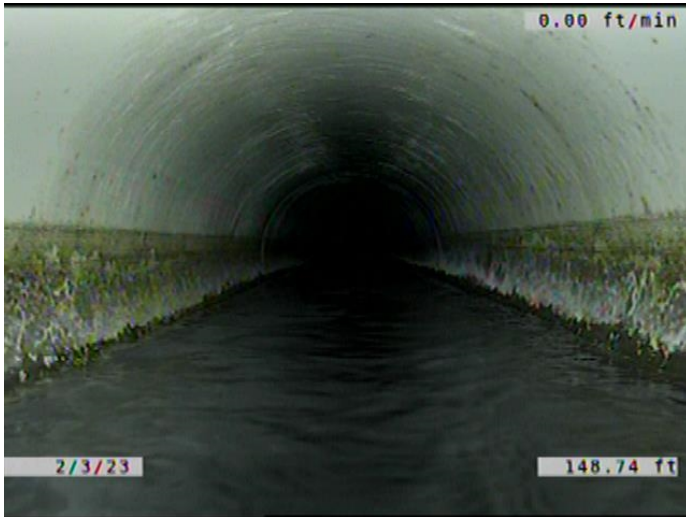
Code: **MGO**
Description: **Miscellaneous General Observation**

Distance (ft): **148.7**
Structural Grade: **0**
O&M Grade: **0**
Clock Start/From:
Clock To:
1st Value:
2nd Value:
Value Percent:
Continuous Index:
Within 8" of Joint: **NO**
Remarks: **Deposits likely increase.**

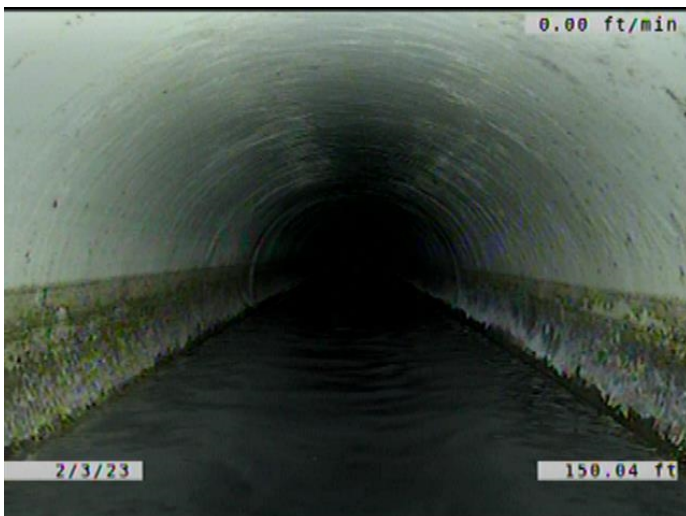
Code: **MSA**
Description: **Miscellaneous Survey Abandoned**

Distance (ft): **150.0**
Structural Grade: **0**
O&M Grade: **0**
Clock Start/From:
Clock To:
1st Value:
2nd Value:
Value Percent:
Continuous Index:
Within 8" of Joint: **NO**
Remarks: **CAMERA CANT MAKE IT PAST DEBRIS.**
