## Profile/Photo Observation Report

Date:	<b>05/06/2018</b>	Weather:		Coding:	<b>PACP 6.0</b>
Pipe Length (ft):		Owner:	<b>City of Hobart</b>	Pre Clean:	<b>No Pre-Cleaning</b>
P.O.#:	<b>601</b>	Surveyor:	<b>M. Pielacha</b>	PSR:	<b>P-905-012-013</b>
Customer:	<b>City of Hobart</b>	Clean Date:		Shape:	<b>C</b>

Street:	<b>Off State Road 130</b>	Flow Control:	<b>Not Controlled</b>
City:	<b>Hobart, IN</b>	Year Renewed:	
Location:	<b>Sidewalk</b>	Tape/Media #:	<b>DEP 601</b>
Purpose:	<b>Routine Assessment</b>	Dia/Height:	<b>18"</b>
Use:	<b>Sanitary</b>	Material:	<b>PVC</b>
Drain Area:		Lining:	
Category:	<b>NA</b>		
Comment:	<b>5-21-2018</b>		
Location Details:		Direction of Survey:	<b>Downstream</b>
US MH:	<b>M-905-012</b>	DS MH:	<b>M-905-013</b>
		Total Length Surveyed (ft):	<b>5.7</b>

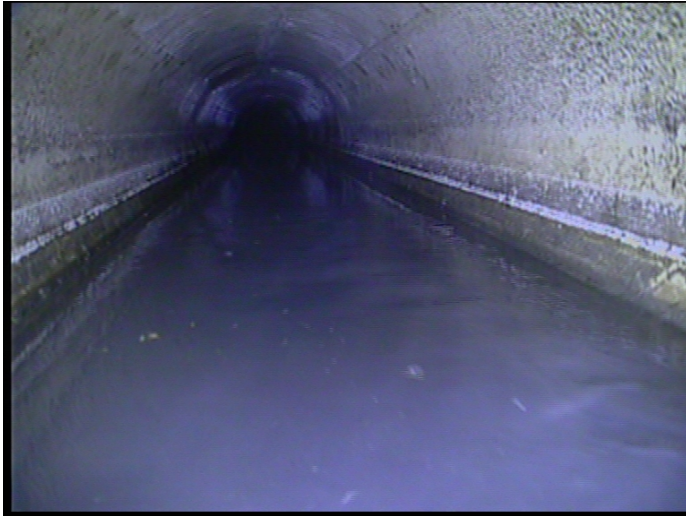
Code:	AMH
Description:	Manhole
Distance (ft):	.0
Structural Grade:	0
O&M Grade:	0
Clock Start/From:	
Clock To:	
1st Value:	
2nd Value:	
Value Percent:	
Continuous Index:	
Within 8" of Joint:	NO
Remarks:	M-905-012

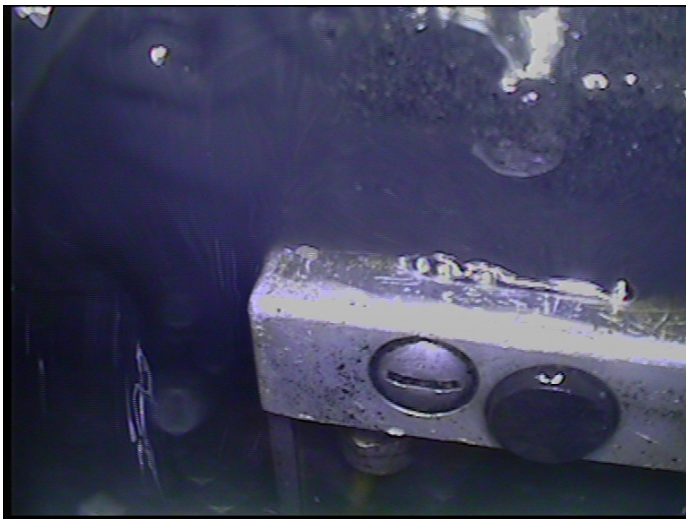
Code: **MWL**  
Description: **Water Level**

Distance (ft): **.0**  
Structural Grade: **0**  
O&M Grade: **0**  
Clock Start/From:  
Clock To:  
1st Value:  
2nd Value:  
Value Percent: **15.000**  
Continuous Index:  
Within 8" of Joint: **NO**  
Remarks:

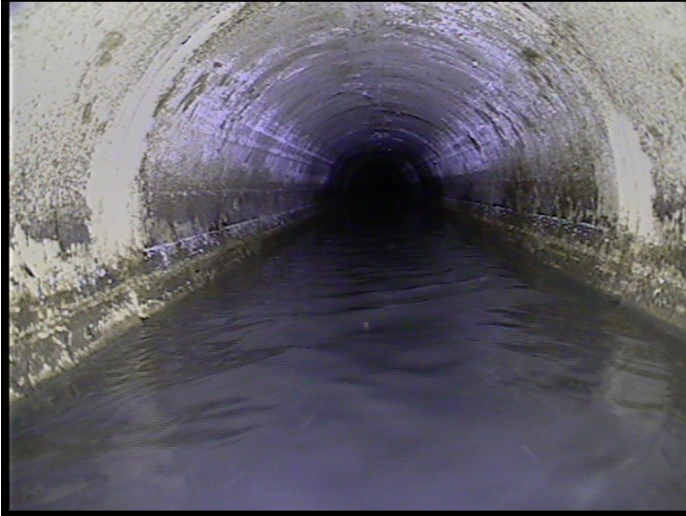
Code: **DSF**  
Description: **Deposits Settled Fine**

Distance (ft): **3.9**  
Structural Grade: **0**  
O&M Grade: **3**  
Clock Start/From: **5**  
Clock To: **7**  
1st Value:  
2nd Value:  
Value Percent: **15.000**  
Continuous Index:  
Within 8" of Joint: **YES**  
Remarks:
