## Profile/Photo Observation Report

Date:	<b>05/03/2018</b>	Weather:		Coding:	<b>PACP 6.0</b>
Pipe Length (ft):		Owner:	<b>City of Hobart</b>	Pre Clean:	<b>No Pre-Cleaning</b>
P.O.#:	<b>177</b>	Surveyor:	<b>M. Pielacha</b>	PSR:	<b>P-905-020-066</b>
Customer:	<b>City of Hobart</b>	Clean Date:		Shape:	<b>C</b>

Street:	<b>State Road 130</b>	Flow Control:	<b>Not Controlled</b>
City:	<b>Hobart, IN</b>	Year Renewed:	
Location:	<b>Parking Lot</b>	Tape/Media #:	<b>DEP 177</b>
Purpose:	<b>Routine Assessment</b>	Dia/Height:	<b>6"</b>
Use:	<b>Sanitary</b>	Material:	<b>PVC</b>
Drain Area:		Lining:	
Category:	<b>NA</b>		
Comment:	<b>5-21-2018</b>		
Location Details:		Direction of Survey:	<b>Downstream</b>
US MH:	<b>M-905-020</b>	DS MH:	<b>M-805-066</b>
		Total Length Surveyed (ft):	<b>51.9</b>

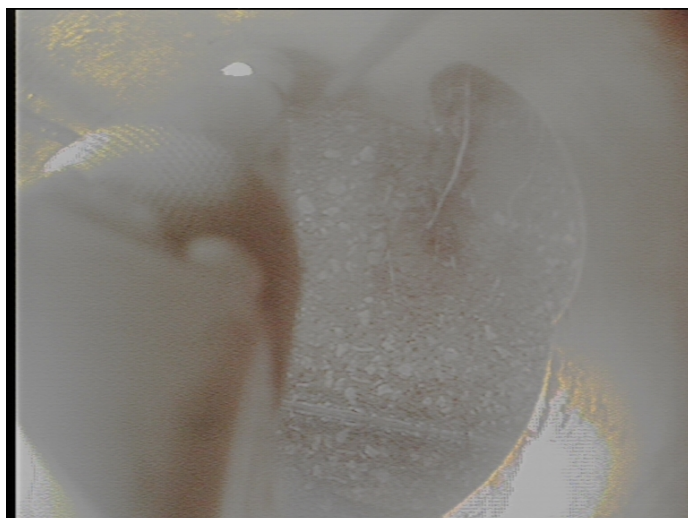
Code: **AMH**  
 Description: **Manhole**

Distance (ft): **.0**  
 Structural Grade: **0**  
 O&M Grade: **0**  
 Clock Start/From:  
 Clock To:  
 1st Value:  
 2nd Value:  
 Value Percent:  
 Continuous Index:  
 Within 8" of Joint: **NO**  
 Remarks: **M-905-020**

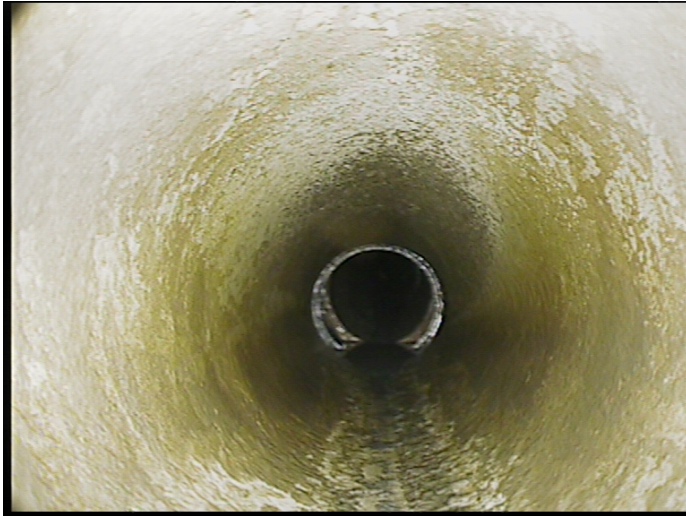
Code: **MWL**  
Description: **Water Level**

Distance (ft): **.0**  
Structural Grade: **0**  
O&M Grade: **0**  
Clock Start/From:  
Clock To:  
1st Value:  
2nd Value:  
Value Percent: **5.000**  
Continuous Index:  
Within 8" of Joint: **NO**  
Remarks:

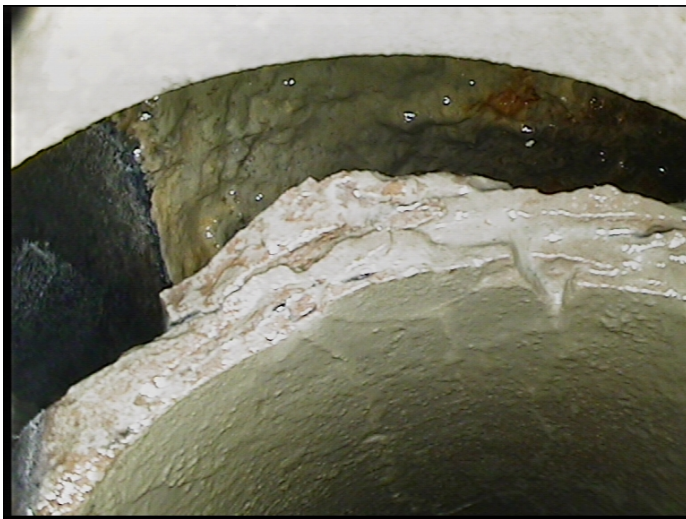
Code: **JSJ**  
Description: **Joint Separated Large**

Distance (ft): **6.3**  
Structural Grade: **2**  
O&M Grade: **0**  
Clock Start/From:  
Clock To:  
1st Value:  
2nd Value:  
Value Percent:  
Continuous Index:  
Within 8" of Joint: **NO**  
Remarks:

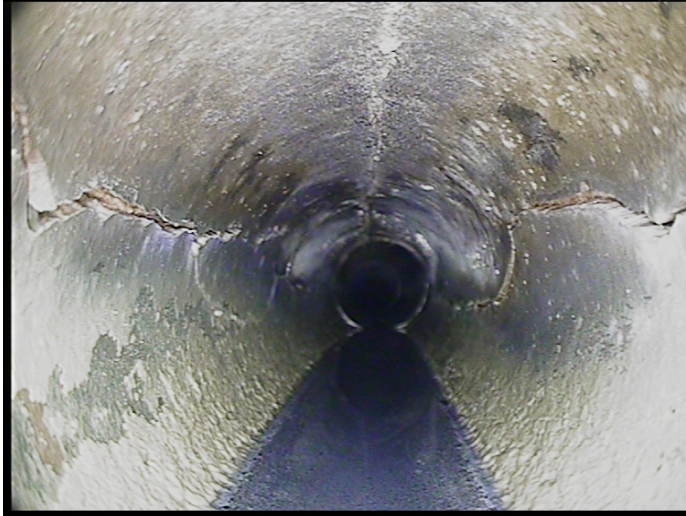
Code: **FH2**  
Description: **Fracture Longitudinal Hinge, 2**

Distance (ft): **9.0**  
Structural Grade: **4**  
O&M Grade: **0**  
Clock Start/From: **9**  
Clock To: **3**  
1st Value:  
2nd Value:  
Value Percent:  
Continuous Index: **S01**  
Within 8" of Joint: **YES**  
Remarks:

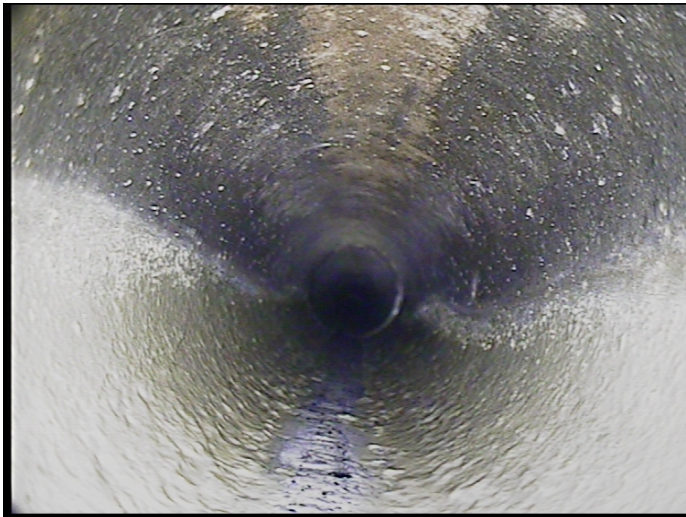
Code: **FH2**  
Description: **Fracture Longitudinal Hinge, 2**

Distance (ft): **13.0**  
Structural Grade: **4**  
O&M Grade: **0**  
Clock Start/From: **9**  
Clock To: **3**  
1st Value:  
2nd Value:  
Value Percent:  
Continuous Index: **F01**  
Within 8" of Joint: **NO**  
Remarks:

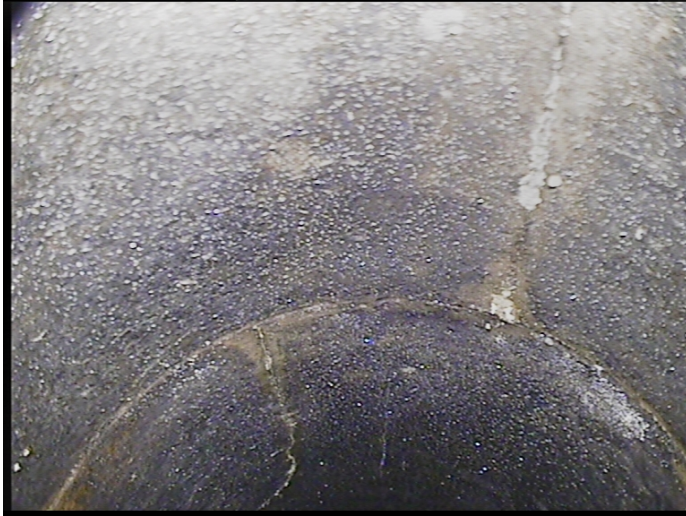
Code:	<b>FL</b>
Description:	<b>Fracture Longitudinal</b>
Distance (ft):	<b>20.3</b>
Structural Grade:	<b>3</b>
O&M Grade:	<b>0</b>
Clock Start/From:	<b>12</b>
Clock To:	
1st Value:	
2nd Value:	
Value Percent:	
Continuous Index:	
Within 8" of Joint:	<b>YES</b>
Remarks:

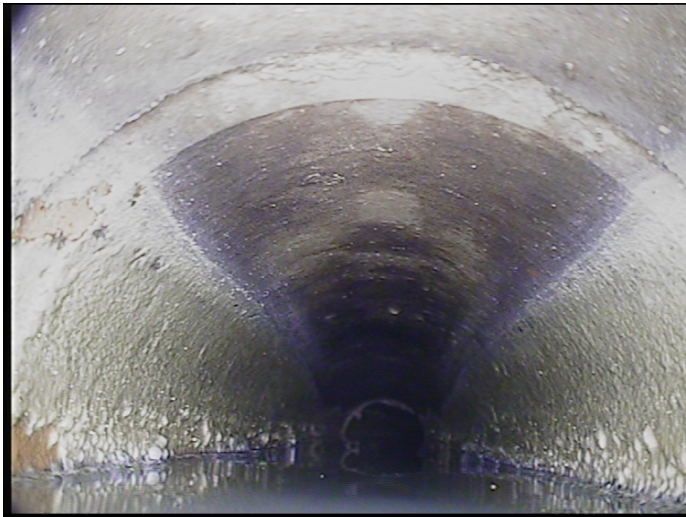
Code:	<b>MWL</b>
Description:	<b>Water Level</b>
Distance (ft):	<b>49.0</b>
Structural Grade:	<b>0</b>
O&M Grade:	<b>0</b>
Clock Start/From:	
Clock To:	
1st Value:	
2nd Value:	
Value Percent:	<b>35.000</b>
Continuous Index:	
Within 8" of Joint:	<b>NO</b>
Remarks:

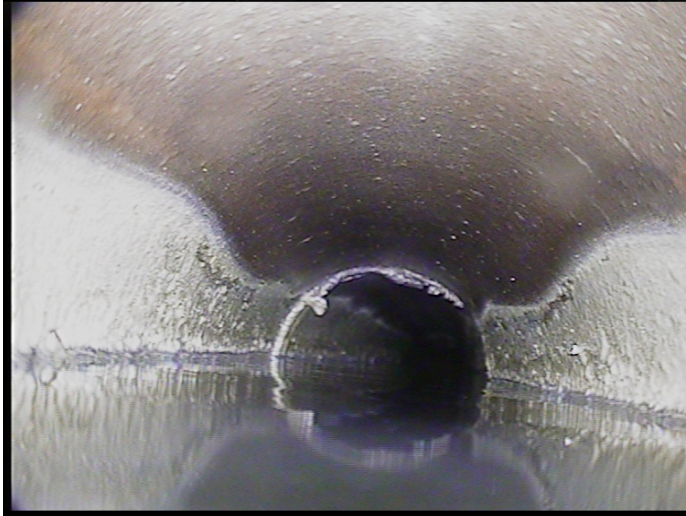
Code: **OBZ**  
Description: **Obstacle Other**

Distance (ft): **51.8**  
Structural Grade: **0**  
O&M Grade: **3**  
Clock Start/From: **4**  
Clock To: **8**  
1st Value:  
2nd Value:  
Value Percent: **15.000**  
Continuous Index:  
Within 8" of Joint: **NO**  
Remarks: **Debris**

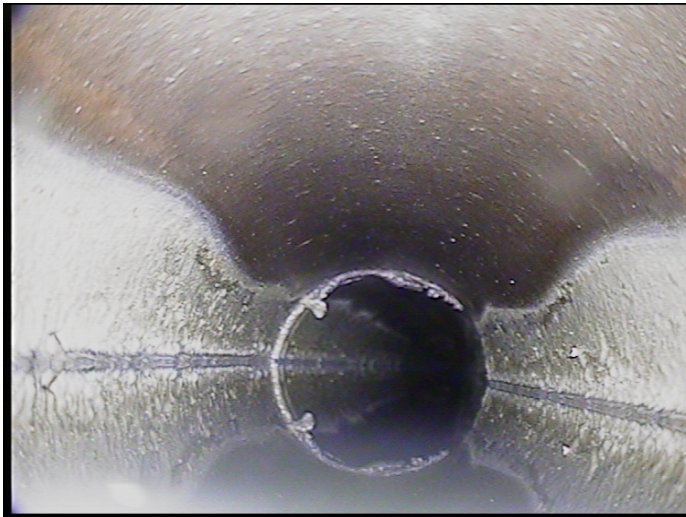
Code: **MSA**  
Description: **Abandoned Survey**

Distance (ft): **51.8**  
Structural Grade: **0**  
O&M Grade: **0**  
Clock Start/From:  
Clock To:  
1st Value:  
2nd Value:  
Value Percent:  
Continuous Index:  
Within 8" of Joint: **NO**  
Remarks: **debris**
