Profile/Photo Observation Report

Date:	03/05/2024	Weather:		Coding:	PACP 7.0
Pipe Length (ft):	184.0	Owner:	City of Hobart	Pre Clean:	Heavy Cleaning
P.O.#:		Surveyor:	S. Bucklin	PSR:	P-905-020-066
Customer:	City of Hobart	Clean Date:	10/14/2022	Shape:	C

Street:	SR-130	Flow Control:	Not Controlled
City:	Hobart, IN	Year Renewed:	
Location:	Parking Lot	Tape/Media #:	
Purpose:	Sewer System Evaluation Survey (SS	Dia/Height:	6"
Use:	Sanitary Sewage Pipe	Material:	VCP
Drain Area:		Lining:	None
Category:	NA		
Comment:			
Location Details:		Direction of Survey:	Upstream
US MH:	M-905-020	DS MH:	M-805-066
		Total Length Surveyed (ft):	183.1

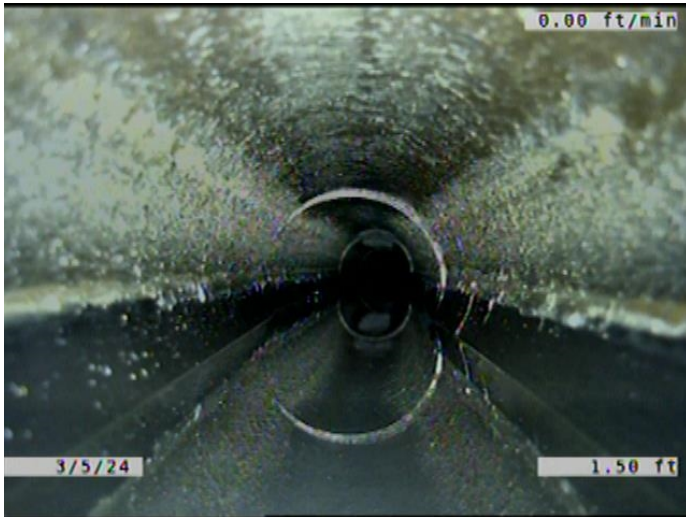
Code: **MGO**
Description: **Miscellaneous General Observation**

Distance (ft): **1.5**
Structural Grade: **0**
O&M Grade: **0**
Clock Start/From:
Clock To:
1st Value:
2nd Value:
Value Percent:
Continuous Index:
Within 8" of Joint: **NO**
Remarks: **DROP INTO THE MANHOLE. HAD TO START IN THE PIPE.**

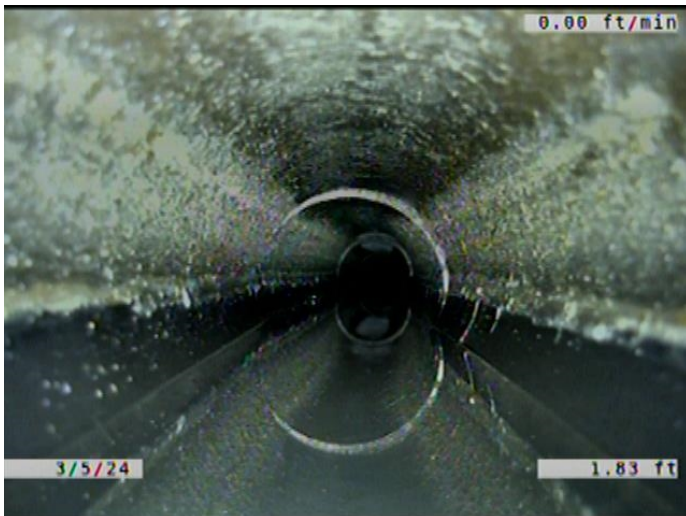
Code: **DAGS**
Description: **Deposits Attached Grease**

Distance (ft): **1.8**
Structural Grade: **0**
O&M Grade: **2**
Clock Start/From: **9**
Clock To: **3**
1st Value:
2nd Value:
Value Percent: **5.000**
Continuous Index: **S01**
Within 8" of Joint: **YES**
Remarks:

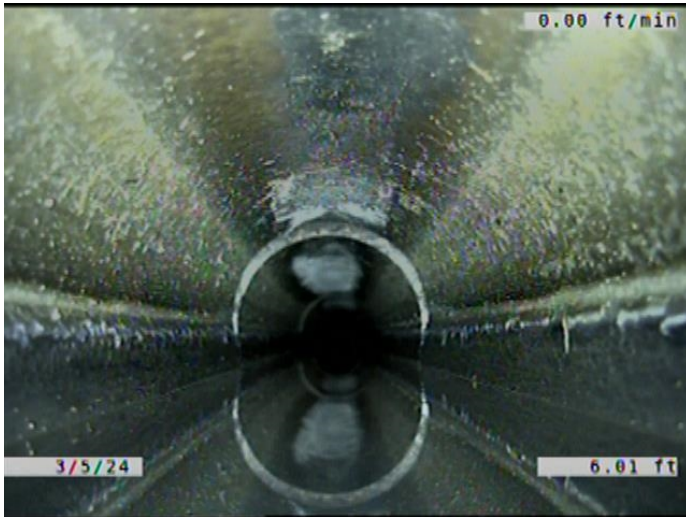
Code: **MWLS**
Description: **Miscellaneous Water Level Sag**

Distance (ft): **6.0**
Structural Grade: **2**
O&M Grade: **0**
Clock Start/From:
Clock To:
1st Value:
2nd Value:
Value Percent: **25.000**
Continuous Index: **S02**
Within 8" of Joint: **NO**
Remarks:

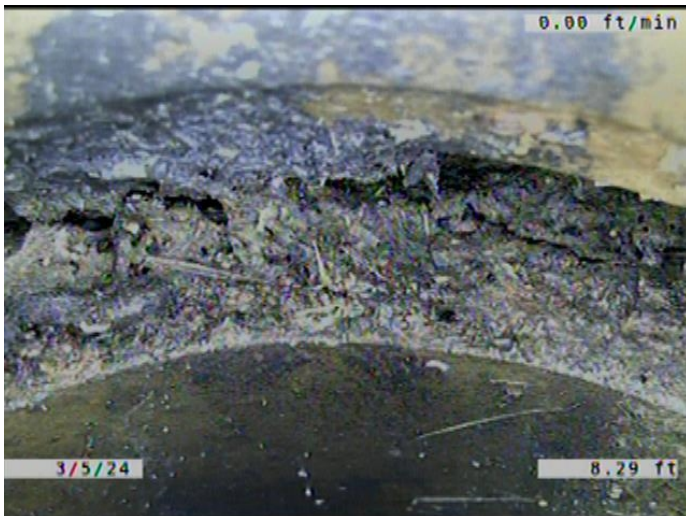
Code: **JOMD**
Description: **Joint Offset Medium Defective**

Distance (ft): **8.3**
Structural Grade: **3**
O&M Grade: **0**
Clock Start/From:
Clock To:
1st Value:
2nd Value:
Value Percent:
Continuous Index: **S03**
Within 8" of Joint: **NO**
Remarks:

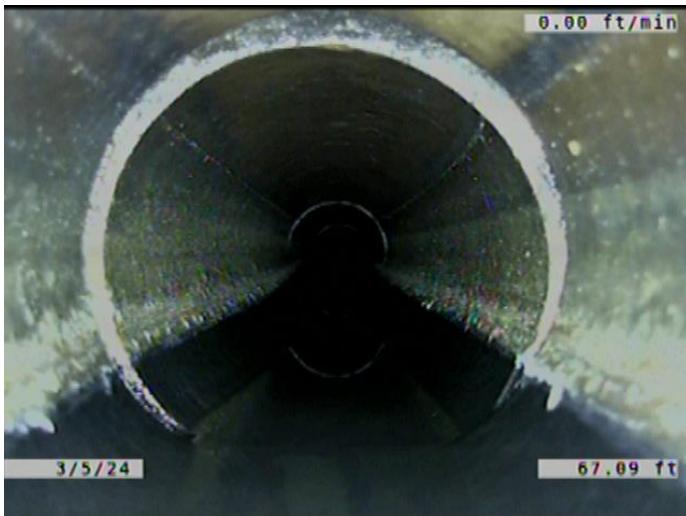
Code: **MWLS**
Description: **Miscellaneous Water Level Sag**

Distance (ft): **67.1**
Structural Grade: **2**
O&M Grade: **0**
Clock Start/From:
Clock To:
1st Value:
2nd Value:
Value Percent: **25.000**
Continuous Index: **F02**
Within 8" of Joint: **NO**
Remarks:

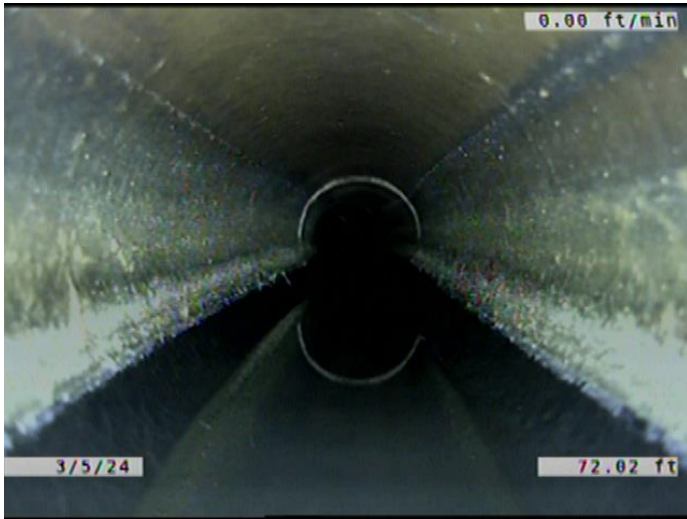
Code:	MWLS
Description:	Miscellaneous Water Level Sag
Distance (ft):	72.0
Structural Grade:	2
O&M Grade:	0
Clock Start/From:	
Clock To:	
1st Value:	
2nd Value:	
Value Percent:	5.000
Continuous Index:	
Within 8" of Joint:	NO
Remarks:

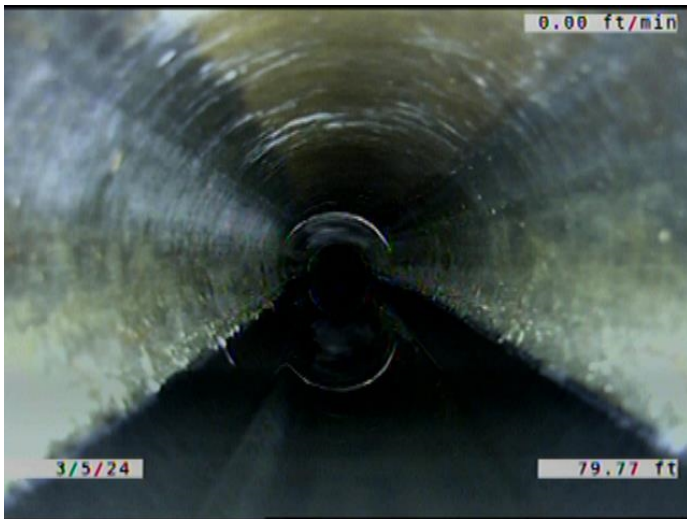
Code:	MWLS
Description:	Miscellaneous Water Level Sag
Distance (ft):	79.8
Structural Grade:	2
O&M Grade:	0
Clock Start/From:	
Clock To:	
1st Value:	
2nd Value:	
Value Percent:	20.000
Continuous Index:	S04
Within 8" of Joint:	NO
Remarks:

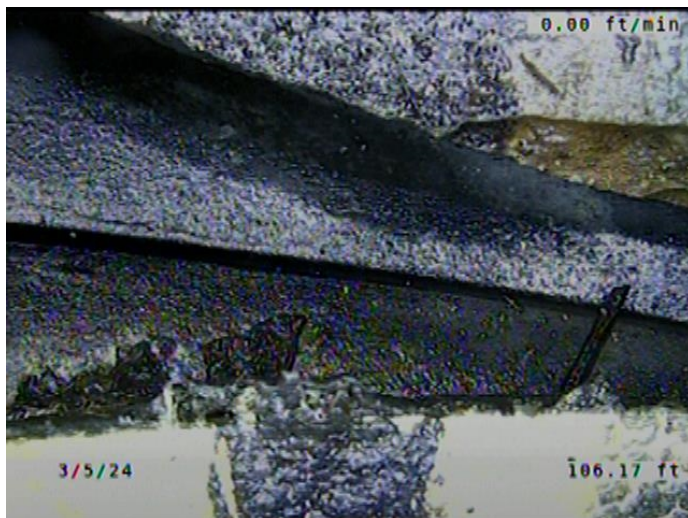
Code: **RPR**
 Description: **Point Repair Replacement**

Distance (ft): **106.2**
 Structural Grade: **0**
 O&M Grade: **0**
 Clock Start/From:
 Clock To:
 1st Value:
 2nd Value:
 Value Percent:
 Continuous Index:
 Within 8" of Joint: **YES**
 Remarks: **REPLACED WITH PVC.**

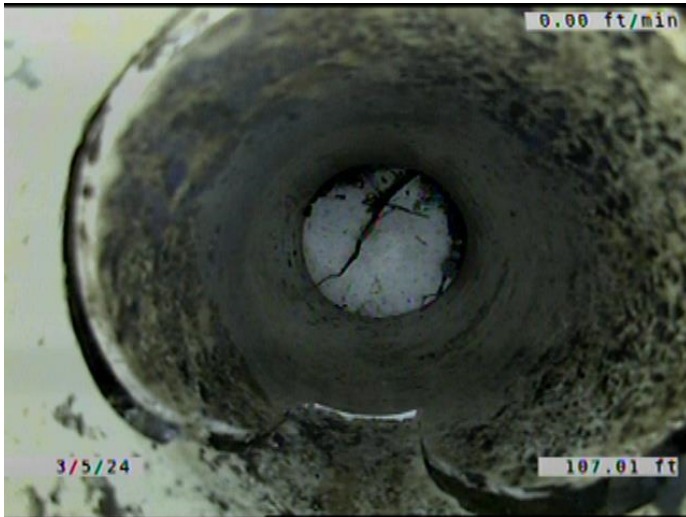
Code: **TFD**
Description: **Tap Factory Defective**

Distance (ft): **107.0**
Structural Grade: **0**
O&M Grade: **3**
Clock Start/From: **12**
Clock To:
1st Value: **6.000**
2nd Value:
Value Percent:
Continuous Index:
Within 8" of Joint: **YES**
Remarks: **TAP BROKEN. SERVICE BROKEN. SOIL VISIBLE. SERVICE CAPPED.**

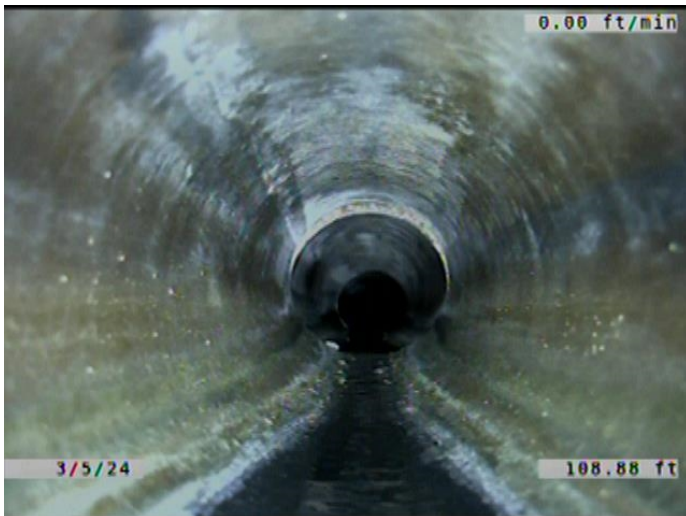
Code: **MWLS**
Description: **Miscellaneous Water Level Sag**

Distance (ft): **108.9**
Structural Grade: **2**
O&M Grade: **0**
Clock Start/From:
Clock To:
1st Value:
2nd Value:
Value Percent: **20.000**
Continuous Index: **F04**
Within 8" of Joint: **NO**
Remarks:

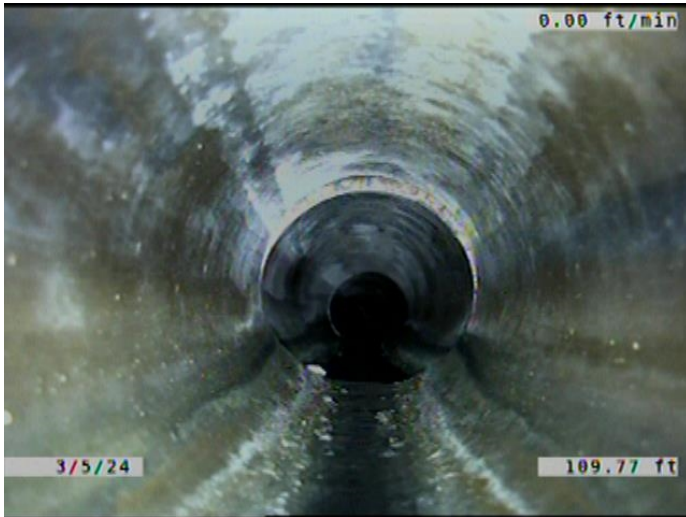
Code: **DAGS**
Description: **Deposits Attached Grease**

Distance (ft): **109.8**
Structural Grade: **0**
O&M Grade: **2**
Clock Start/From: **9**
Clock To: **3**
1st Value:
2nd Value:
Value Percent: **5.000**
Continuous Index: **F01**
Within 8" of Joint: **YES**
Remarks:

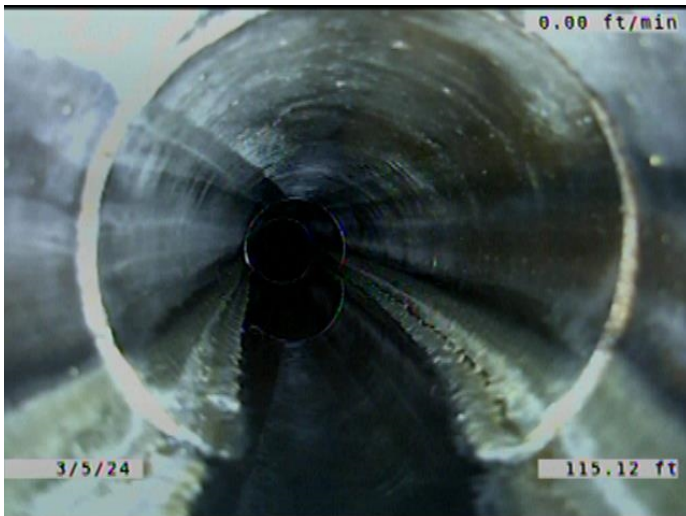
Code: **MWLS**
Description: **Miscellaneous Water Level Sag**

Distance (ft): **115.1**
Structural Grade: **2**
O&M Grade: **0**
Clock Start/From:
Clock To:
1st Value:
2nd Value:
Value Percent: **25.000**
Continuous Index: **S05**
Within 8" of Joint: **NO**
Remarks:

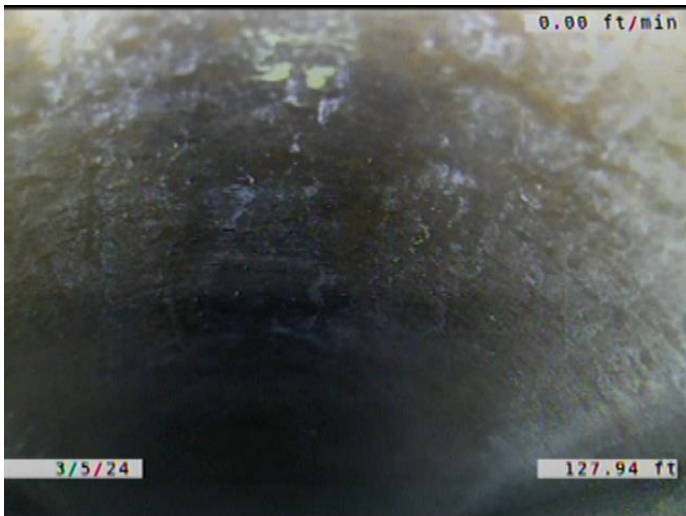
Code: **LL**
Description: **Line Left**

Distance (ft): **127.9**
Structural Grade: **0**
O&M Grade: **2**
Clock Start/From:
Clock To:
1st Value:
2nd Value:
Value Percent: **15.000**
Continuous Index:
Within 8" of Joint: **NO**
Remarks:

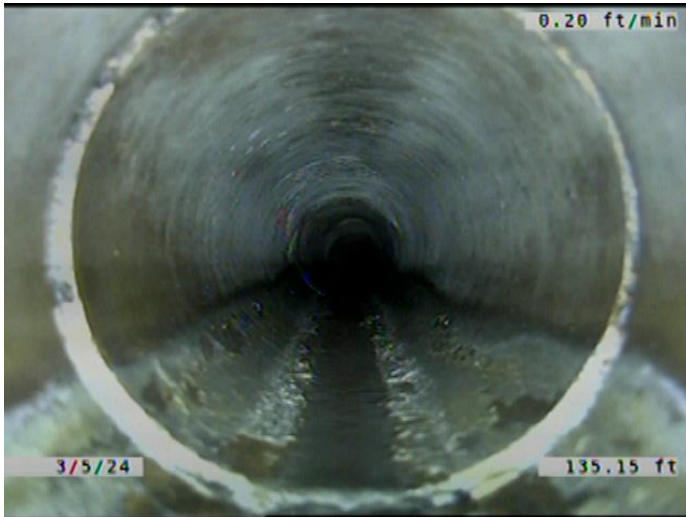
Code: **MWLS**
Description: **Miscellaneous Water Level Sag**

Distance (ft): **135.1**
Structural Grade: **2**
O&M Grade: **0**
Clock Start/From:
Clock To:
1st Value:
2nd Value:
Value Percent: **25.000**
Continuous Index: **F05**
Within 8" of Joint: **NO**
Remarks:

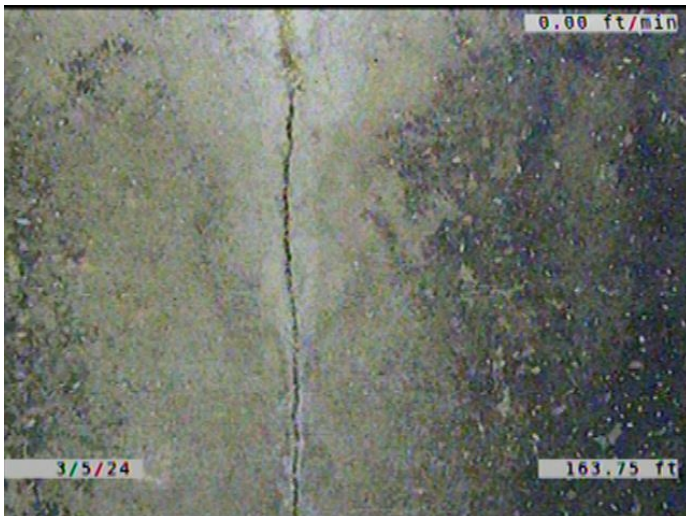
Code: **CS**
Description: **Crack Spiral**

Distance (ft): **163.8**
Structural Grade: **2**
O&M Grade: **0**
Clock Start/From: **12**
Clock To: **1**
1st Value:
2nd Value:
Value Percent:
Continuous Index:
Within 8" of Joint: **YES**
Remarks:

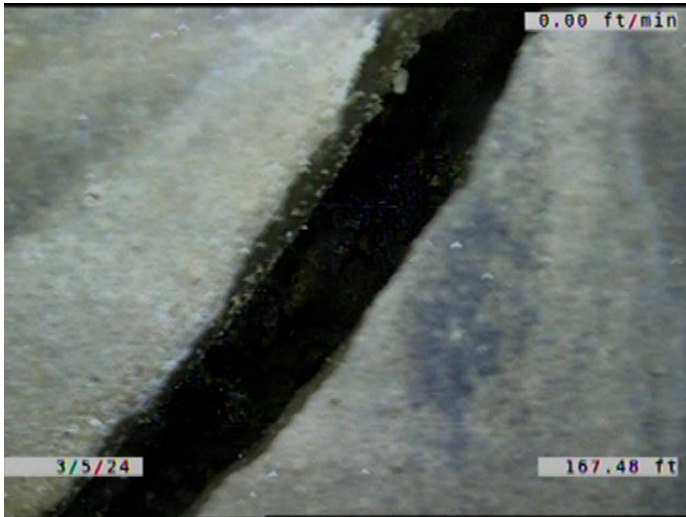
Code: **BVV**
Description: **Broken Void Visible**

Distance (ft): **167.5**
Structural Grade: **5**
O&M Grade: **0**
Clock Start/From: **12**
Clock To: **8**
1st Value:
2nd Value:
Value Percent:
Continuous Index:
Within 8" of Joint: **YES**
Remarks: **SOIL VISIBLE ALSO.**

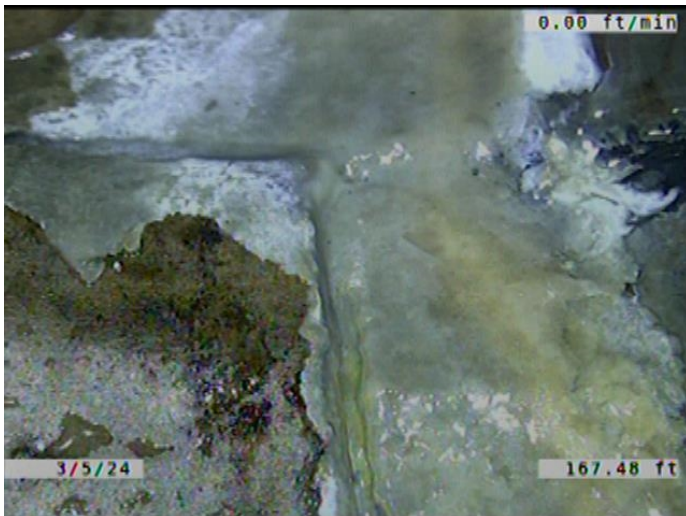
Code: **DAE**
Description: **Deposits Attached Encrustation**

Distance (ft): **167.5**
Structural Grade: **0**
O&M Grade: **2**
Clock Start/From: **2**
Clock To: **8**
1st Value:
2nd Value:
Value Percent: **5.000**
Continuous Index:
Within 8" of Joint: **YES**
Remarks:

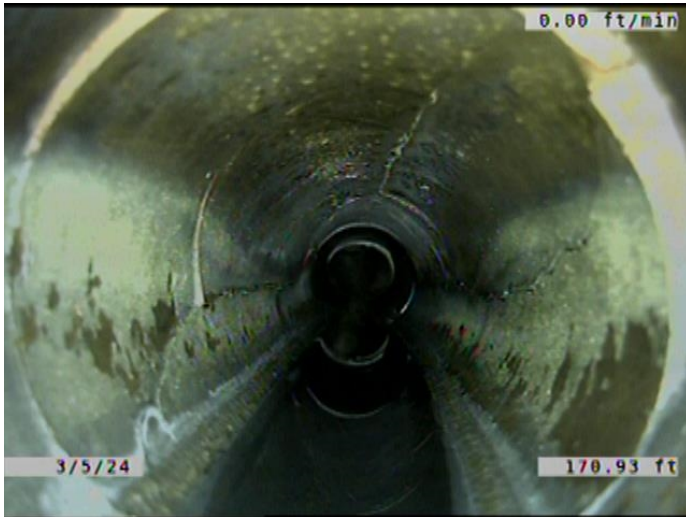
Code: **MWLS**
Description: **Miscellaneous Water Level Sag**

Distance (ft): **170.9**
Structural Grade: **2**
O&M Grade: **0**
Clock Start/From:
Clock To:
1st Value:
2nd Value:
Value Percent: **10.000**
Continuous Index: **S06**
Within 8" of Joint: **NO**
Remarks:

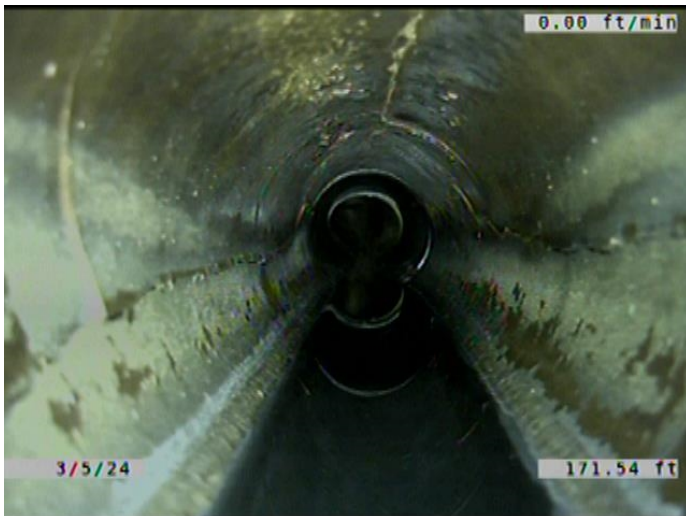
Code: **B**
Description: **Broken**

Distance (ft): **171.5**
Structural Grade: **4**
O&M Grade: **0**
Clock Start/From: **7**
Clock To: **5**
1st Value:
2nd Value:
Value Percent:
Continuous Index: **S07**
Within 8" of Joint: **YES**
Remarks:

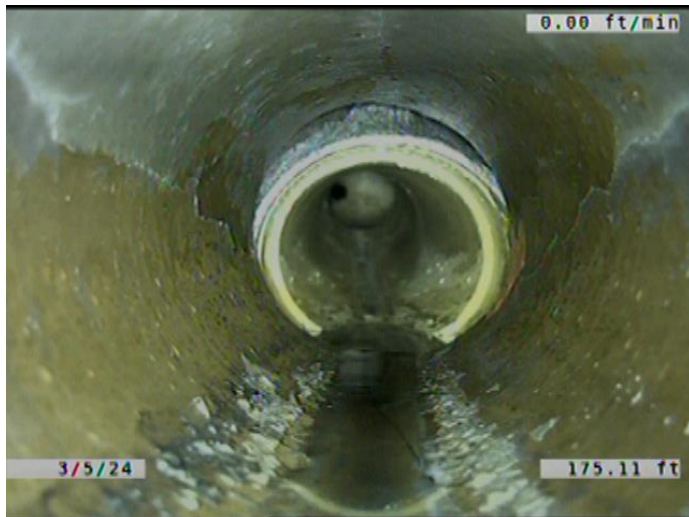
Code: **MWLS**
Description: **Miscellaneous Water Level Sag**

Distance (ft): **175.1**
Structural Grade: **2**
O&M Grade: **0**
Clock Start/From:
Clock To:
1st Value:
2nd Value:
Value Percent: **10.000**
Continuous Index: **F06**
Within 8" of Joint: **NO**
Remarks:

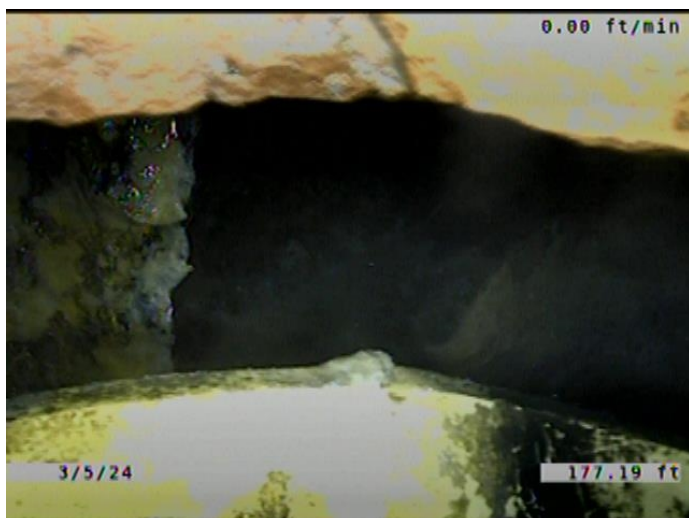
Code: **HVV**
Description: **Hole Void Visible**

Distance (ft): **177.2**
Structural Grade: **5**
O&M Grade: **0**
Clock Start/From: **12**
Clock To: **12**
1st Value:
2nd Value:
Value Percent:
Continuous Index:
Within 8" of Joint: **YES**
Remarks: **VOID AND SOIL VISIBLE. WATER EXITING THE PIPE.**

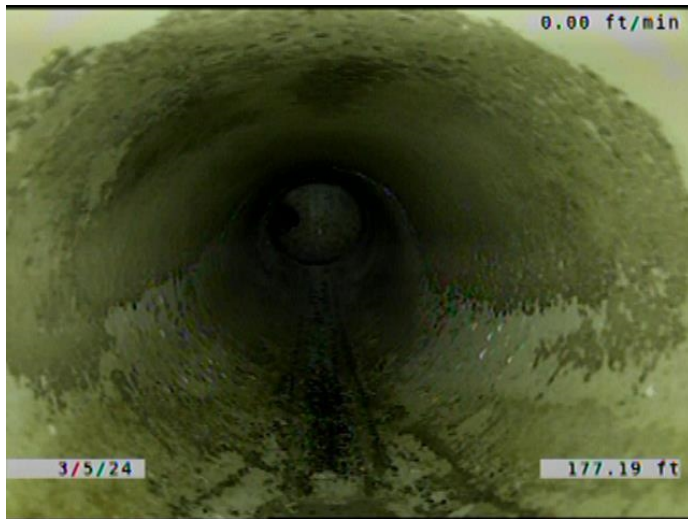
Code: **B**
Description: **Broken**

Distance (ft): **177.2**
Structural Grade: **4**
O&M Grade: **0**
Clock Start/From: **7**
Clock To: **5**
1st Value:
2nd Value:
Value Percent:
Continuous Index: **F07**
Within 8" of Joint: **YES**
Remarks:

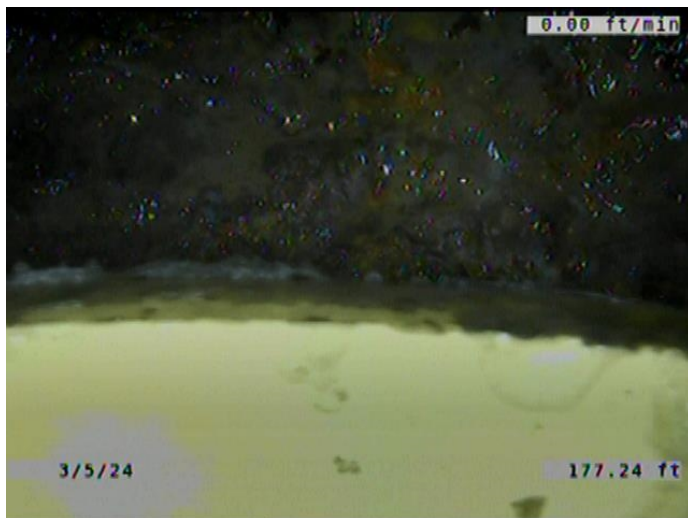
Code: **RPRD**
Description: **Point Repair Replacement Defective**

Distance (ft): **177.2**
Structural Grade: **4**
O&M Grade: **0**
Clock Start/From:
Clock To:
1st Value:
2nd Value:
Value Percent:
Continuous Index: **S08**
Within 8" of Joint: **YES**
Remarks: **REPLACED WITH PVC. HVV.**

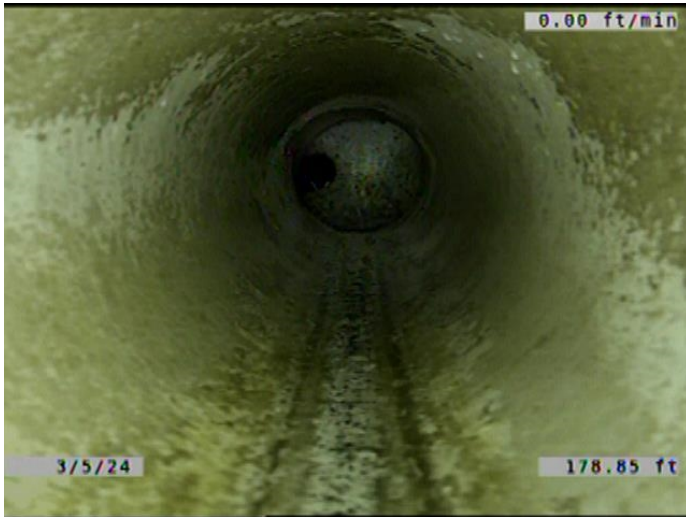
Code: **LU**
Description: **Line Up**

Distance (ft): **178.8**
Structural Grade: **0**
O&M Grade: **2**
Clock Start/From:
Clock To:
1st Value:
2nd Value:
Value Percent: **20.000**
Continuous Index:
Within 8" of Joint: **NO**
Remarks:

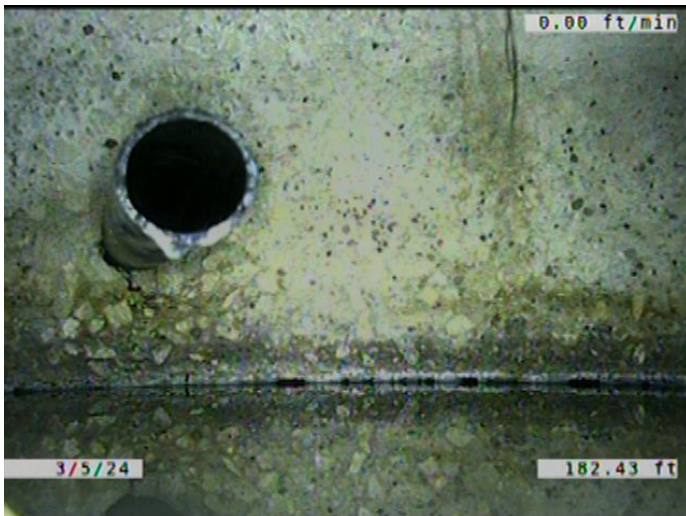
Code: **RPRD**
Description: **Point Repair Replacement Defective**

Distance (ft): **182.4**
Structural Grade: **4**
O&M Grade: **0**
Clock Start/From:
Clock To:
1st Value:
2nd Value:
Value Percent:
Continuous Index: **F08**
Within 8" of Joint: **YES**
Remarks: **REPLACED WITH PVC. HVV.**

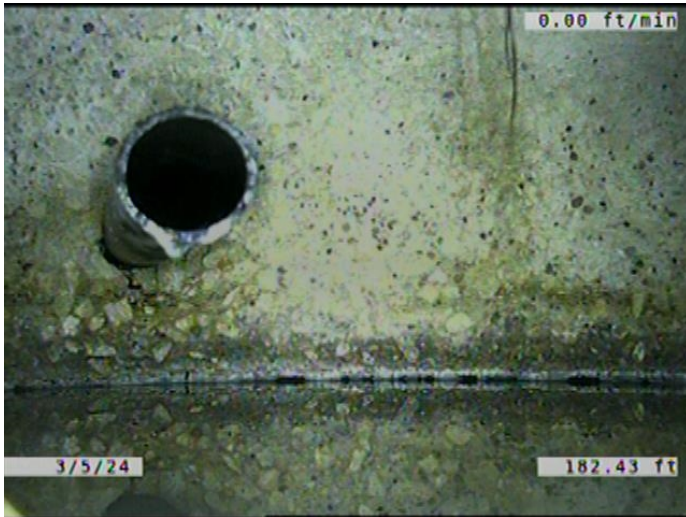
Code: **JOMD**
Description: **Joint Offset Medium Defective**

Distance (ft): **182.4**
Structural Grade: **3**
O&M Grade: **0**
Clock Start/From:
Clock To:
1st Value:
2nd Value:
Value Percent:
Continuous Index: **F03**
Within 8" of Joint: **NO**
Remarks:
