## **Profile/Photo Observation Report**

P.O.#: 180 Surveyor: M. Pielacha PSR: P-90 Customer: City of Hobart Clean Date: Shape: C  Street: Off State Road 130 Flow Control: Not Controlled City: Hobart, IN Year Renewed: Location: Parking Lot Tape/Media #: DEP 180 Purpose: Routine Assessment Dia/Height: 6" Use: Sanitary Material: PVC Drain Area: Lining: Category: NA Comment: 5-21-2018 Location Details: Direction of Survey: Downstream	e-Cleaning
Customer: City of Hobart Clean Date: Shape: C  Street: Off State Road 130 Flow Control: Not Controlled City: Hobart, IN Year Renewed: Location: Parking Lot Tape/Media #: DEP 180 Purpose: Routine Assessment Dia/Height: 6" Use: Sanitary Material: PVC Drain Area: Lining: Category: NA Comment: 5-21-2018 Location Details: Direction of Survey: Downstream	
Street: Off State Road 130 Flow Control: Not Controlled  City: Hobart, IN Year Renewed:  Location: Parking Lot Tape/Media #: DEP 180  Purpose: Routine Assessment Dia/Height: 6"  Use: Sanitary Material: PVC  Drain Area: Lining:  Category: NA  Comment: 5-21-2018  Location Details: Direction of Survey: Downstream	-022-015

Comment: 5-21-2018 Location Details: Direction of Survey: Downstream	
Location D

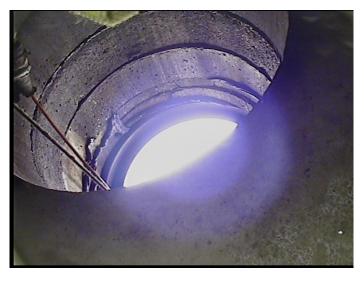
Description:	Manhole
Distance (ft):	.0
Structural Grade:	0
O&M Grade:	0
Clock Start/From:	
Clock To:	
1st Value:	
2nd Value:	
Value Percent:	
Continuous Index:	
Within 8" of Joint:	NO
Remarks:	M-905-022

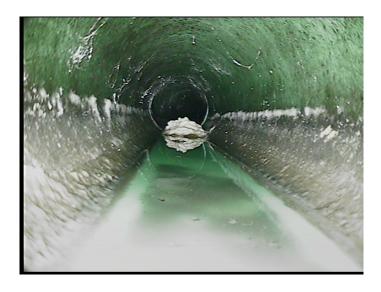
Code: MWL

Description: Water Level

Distance (ft): .0
Structural Grade: 0
O&M Grade: 0

Value Percent: 15.000

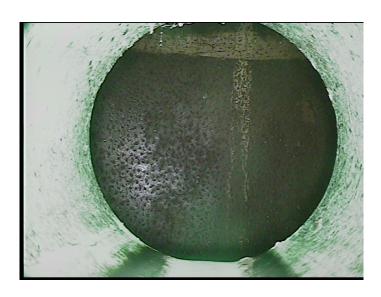
Code: AMH
Description: Manhole

Distance (ft): 297.6
Structural Grade: 0
O&M Grade: 0

Remarks: M-905-015
