Profile/Photo Observation Report

Date:	10/20/2021	Weather:		Coding:	PACP 6.0
Pipe Length (ft):		Owner:	Hobart, IN	Pre Clean:	Not Known
P.O.#:	907_1	Surveyor:	M. Pielacha	PSR:	P-905-027-029
Customer:	Hobart, IN	Clean Date:		Shape:	C

Street:	Public Works Lot	Flow Control:	Not Controlled
City:	Hobart, IN	Year Renewed:	
Location:	Parking Lot	Tape/Media #:	907
Purpose:	Routine Assessment	Dia/Height:	8"
Use:	Sanitary	Material:	PVC
Drain Area:		Lining:	
Category:	NA		
Comment:			
Location Details:		Direction of Survey:	Downstream
US MH:	M-905-27	DS MH:	M-905-29
		Total Length Surveyed (ft):	.1

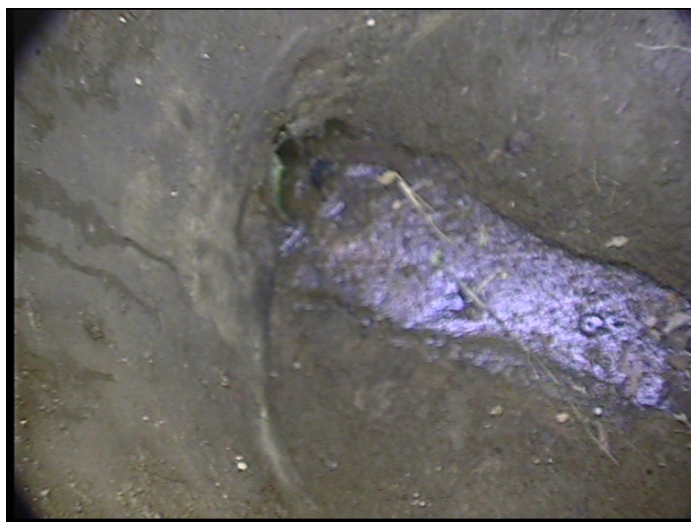
Code: **AMH**
 Description: **Manhole**

Distance (ft): **.0**
 Structural Grade: **0**
 O&M Grade: **0**
 Clock Start/From:
 Clock To:
 1st Value:
 2nd Value:
 Value Percent:
 Continuous Index:
 Within 8" of Joint: **NO**
 Remarks: **M-905-27**

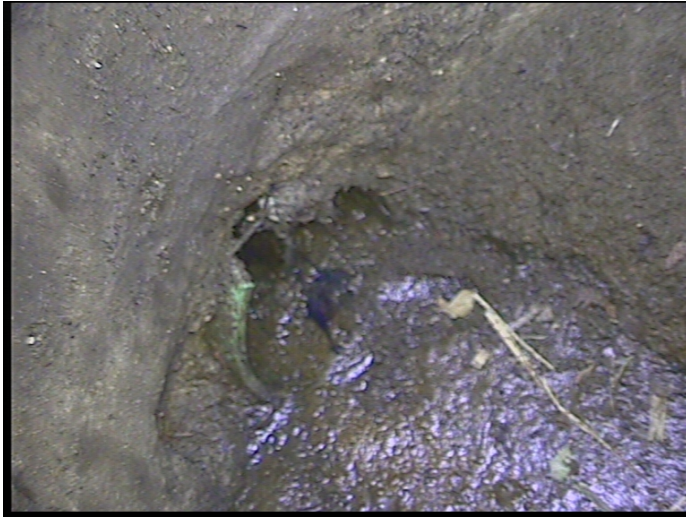
Code: **MWL**
Description: **Water Level**

Distance (ft): **.0**
Structural Grade: **0**
O&M Grade: **0**
Clock Start/From:
Clock To:
1st Value:
2nd Value:
Value Percent: **5.000**
Continuous Index:
Within 8" of Joint: **NO**
Remarks:

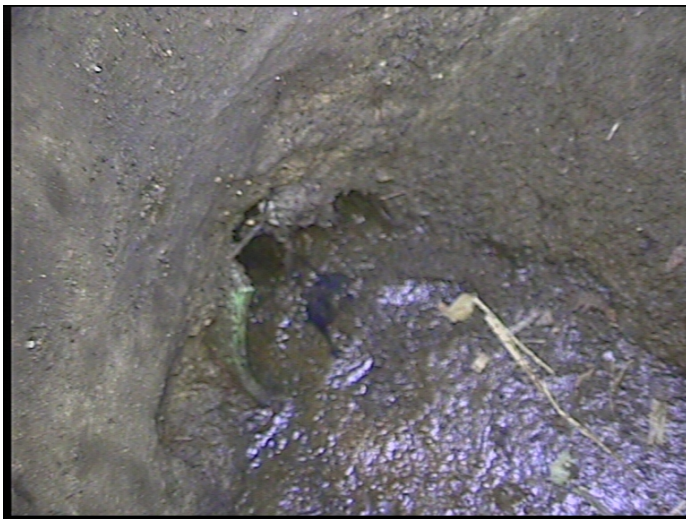
Code: **DSF**
Description: **Deposits Settled Fine**

Distance (ft): **.0**
Structural Grade: **0**
O&M Grade: **4**
Clock Start/From: **4**
Clock To: **8**
1st Value:
2nd Value:
Value Percent: **25.000**
Continuous Index:
Within 8" of Joint: **NO**
Remarks:

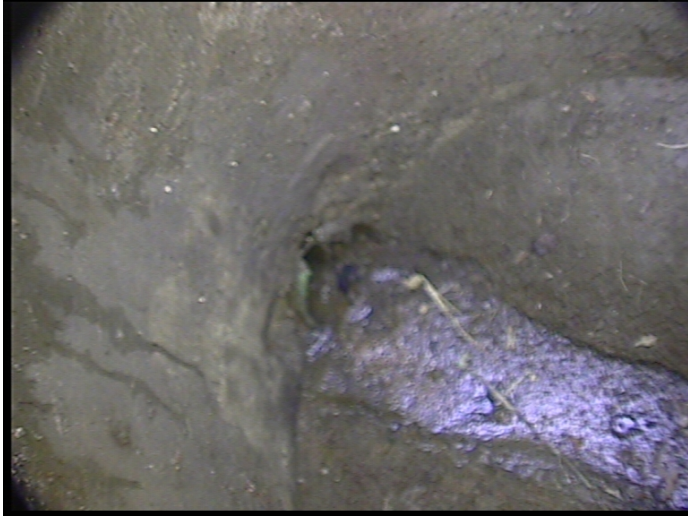
Code:	MSA
Description:	Abandoned Survey
Distance (ft):	.0
Structural Grade:	0
O&M Grade:	0
Clock Start/From:	
Clock To:	
1st Value:	
2nd Value:	
Value Percent:	
Continuous Index:	
Within 8" of Joint:	NO
Remarks:	Deep sediment
