Profile/Photo Observation Report

Date:	10/20/2021	Weather:		Coding:	PACP 6.0
Pipe Length (ft):		Owner:	Hobart, IN	Pre Clean:	Not Known
P.O.#:	908_1	Surveyor:	M. Pielacha	PSR:	P-905-027-029
Customer:	Hobart, IN	Clean Date:		Shape:	C

Street:	Public Works Lot	Flow Control:	Not Controlled
City:	Hobart, IN	Year Renewed:	
Location:	Parking Lot	Tape/Media #:	908
Purpose:	Reversal	Dia/Height:	8"
Use:	Sanitary	Material:	PVC
Drain Area:		Lining:	
Category:	NA		
Comment:			
Location Details:		Direction of Survey:	Upstream
US MH:	M-905-27	DS MH:	M-905-29
		Total Length Surveyed (ft):	.1

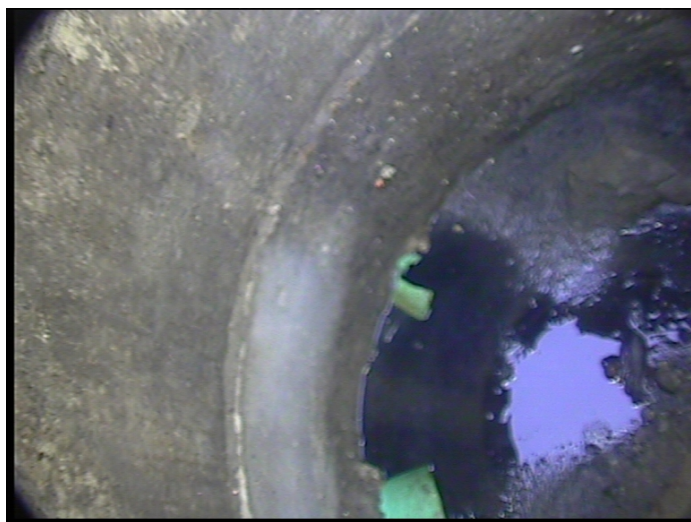
Code: **AMH**
Description: **Manhole**

Distance (ft): **.0**
Structural Grade: **0**
O&M Grade: **0**
Clock Start/From:
Clock To:
1st Value:
2nd Value:
Value Percent:
Continuous Index:
Within 8" of Joint: **NO**
Remarks: **M-905-29**

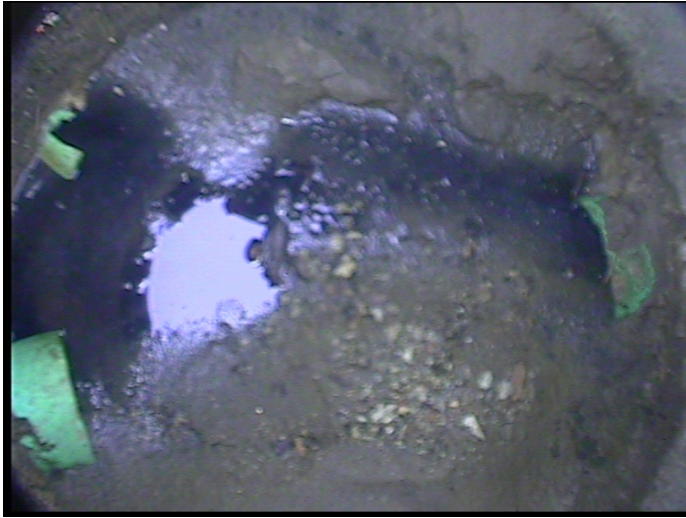
Code: **MWL**
Description: **Water Level**

Distance (ft): **.0**
Structural Grade: **0**
O&M Grade: **0**
Clock Start/From:
Clock To:
1st Value:
2nd Value:
Value Percent: **5.000**
Continuous Index:
Within 8" of Joint: **NO**
Remarks:

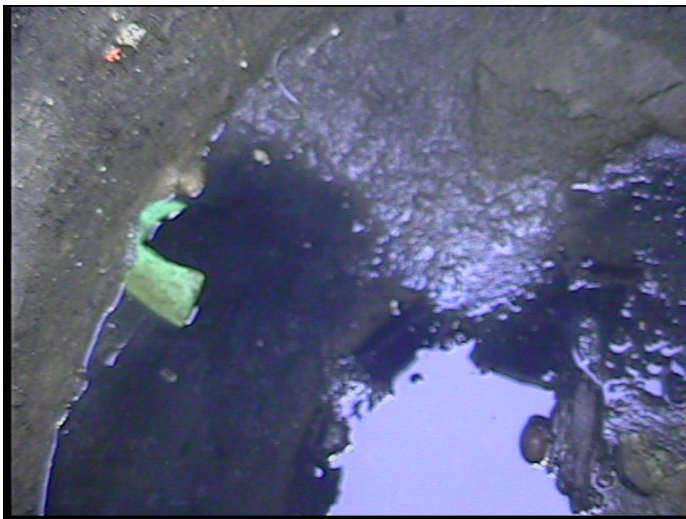
Code: **DSF**
Description: **Deposits Settled Fine**

Distance (ft): **.0**
Structural Grade: **0**
O&M Grade: **5**
Clock Start/From: **4**
Clock To: **8**
1st Value:
2nd Value:
Value Percent: **40.000**
Continuous Index:
Within 8" of Joint: **NO**
Remarks:

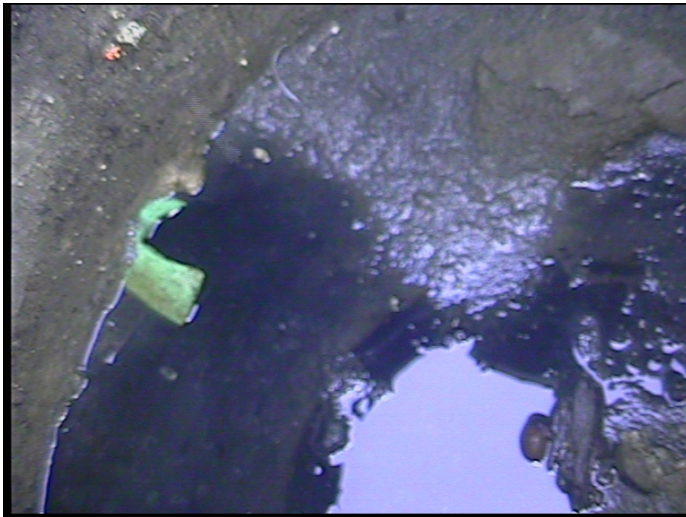
Code:	MSA
Description:	Abandoned Survey
Distance (ft):	.0
Structural Grade:	0
O&M Grade:	0
Clock Start/From:	
Clock To:	
1st Value:	
2nd Value:	
Value Percent:	
Continuous Index:	
Within 8" of Joint:	NO
Remarks:	Deep sediment
