Profile/Photo Observation Report

Street:	OFF S SHELBY ST	Flow Control:	Not Controlled
City:	Hobart, IN	Year Renewed:	
Location:	Parking Lot	Tape/Media #:	
Purpose:	Maintenance Related	Dia/Height:	8"
Use:	Sanitary	Material:	PVC
Drain Area:	NA	Lining:	Cured in Place
Category:	NA		
Comment:	Reverse setup.

Location Details:		Direction of Survey:	Upstream
US MH:	M-905-029	DS MH:	M-905-030
		Total Length Surveyed (ft):	2.9

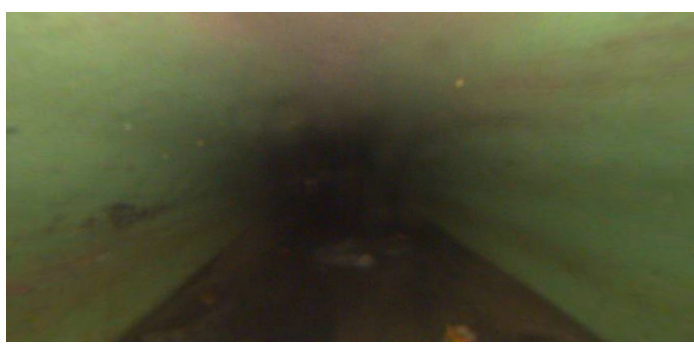
Code: **AMH**
Description: **Manhole**

Distance (ft): **.0**
Structural Grade: **0**
O&M Grade: **0**
Clock Start/From:
Clock To:
1st Value:
2nd Value:
Value Percent:
Continuous Index:
Within 8" of Joint: **NO**
Remarks: **M-905-030**

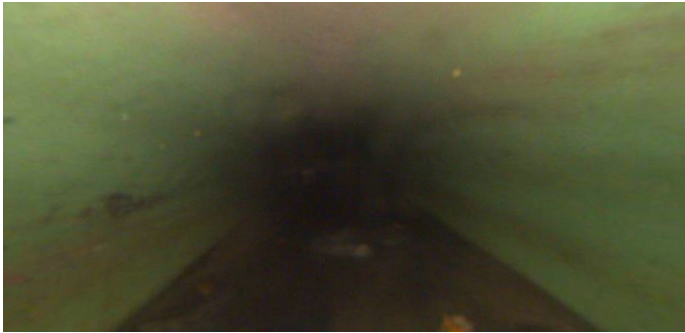
Code:	MWL
Description:	Water Level

Distance (ft):	.0
Structural Grade:	0
O&M Grade:	0
Clock Start/From:	
Clock To:	
1st Value:	
2nd Value:	
Value Percent:	20.000
Continuous Index:	
Within 8" of Joint:	NO
Remarks:

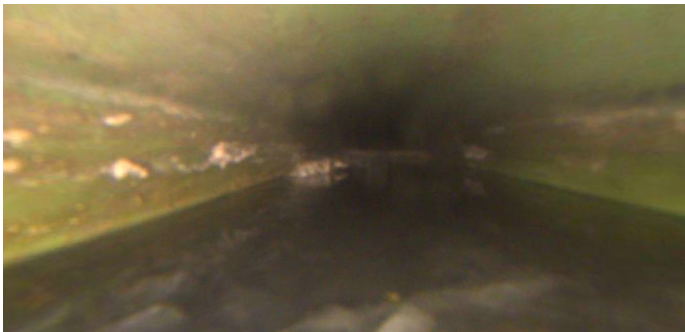
Code:	MSA
Description:	Abandoned Survey

Distance (ft):	2.9
Structural Grade:	0
O&M Grade:	0
Clock Start/From:	
Clock To:	
1st Value:	
2nd Value:	
Value Percent:	
Continuous Index:	
Within 8" of Joint:	NO
Remarks:	DEBRIS UNDER WATER
