## Profile/Photo Observation Report

Date:	<b>04/24/2018</b>	Weather:		Coding:	<b>PACP 6.0</b>
Pipe Length (ft):	<b>166.0</b>	Owner:	<b>NA</b>	Pre Clean:	<b>Not Known</b>
P.O.#:		Surveyor:	<b>Jen Costello</b>	PSR:	<b>P-905-029-030</b>
Customer:		Clean Date:	<b>01/01/1900</b>	Shape:	<b>C</b>

Location Details:		Direction of Survey:	<b>Upstream</b>
US MH:	<b>M-905-029</b>	DS MH:	<b>M-905-030</b>
		Total Length Surveyed (ft):	<b>2.9</b>

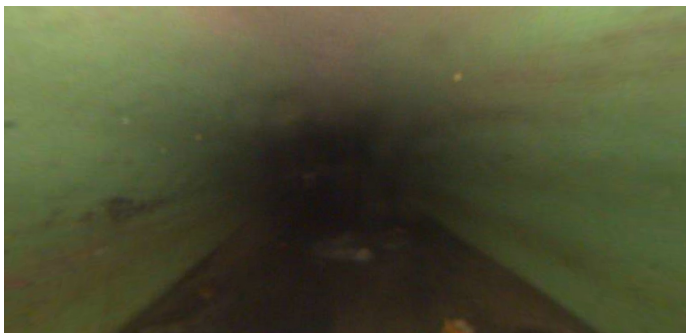
Code: **AMH**  
Description: **Manhole**

Distance (ft): **.0**  
Structural Grade: **0**  
O&M Grade: **0**  
Clock Start/From:  
Clock To:  
1st Value:  
2nd Value:  
Value Percent:  
Continuous Index:  
Within 8" of Joint: **NO**  
Remarks: **M-905-030**

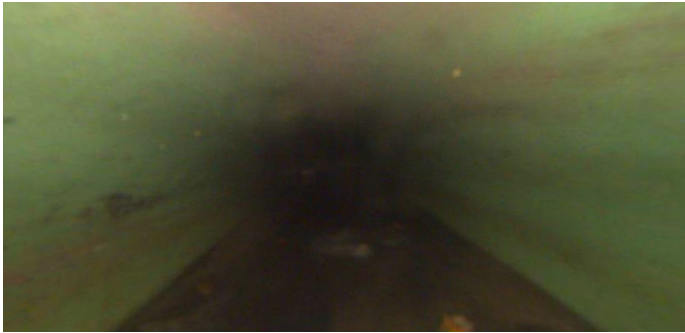
Code:	<b>MWL</b>
Description:	<b>Water Level</b>

Distance (ft):	<b>.0</b>
Structural Grade:	<b>0</b>
O&M Grade:	<b>0</b>
Clock Start/From:	
Clock To:	
1st Value:	
2nd Value:	
Value Percent:	<b>20.000</b>
Continuous Index:	
Within 8" of Joint:	<b>NO</b>
Remarks:

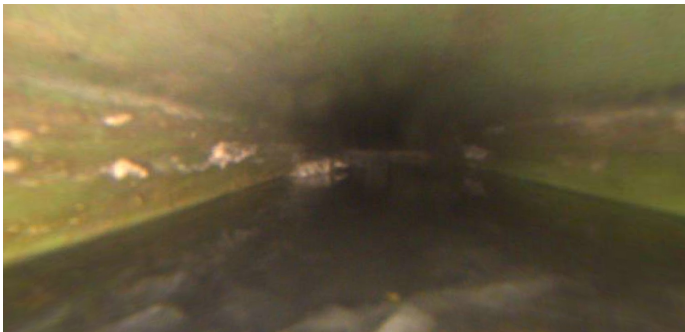
Code:	<b>MSA</b>
Description:	<b>Abandoned Survey</b>

Distance (ft):	<b>2.9</b>
Structural Grade:	<b>0</b>
O&M Grade:	<b>0</b>
Clock Start/From:	
Clock To:	
1st Value:	
2nd Value:	
Value Percent:	
Continuous Index:	
Within 8" of Joint:	<b>NO</b>
Remarks:	<b>DEBRIS UNDER WATER</b>
