Profile/Photo Observation Report

| Street: | S SHELBY ST | Flow Control: | Not Controlled |
| City: | Hobart, IN | Year Renewed: | |

| US MH: | M-905-030 | DS MH: | M-905-031 |

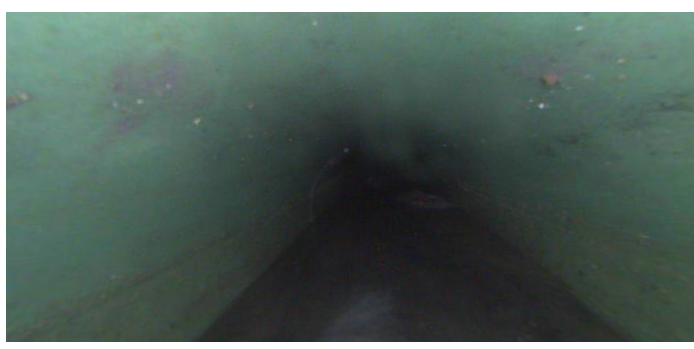
Code: **AMH**
Description: **Manhole**

Distance (ft): **.0**
Structural Grade: **0**
O&M Grade: **0**
Clock Start/From:
Clock To:
1st Value:
2nd Value:
Value Percent:
Continuous Index:
Within 8" of Joint: **NO**
Remarks: **M-905-030**

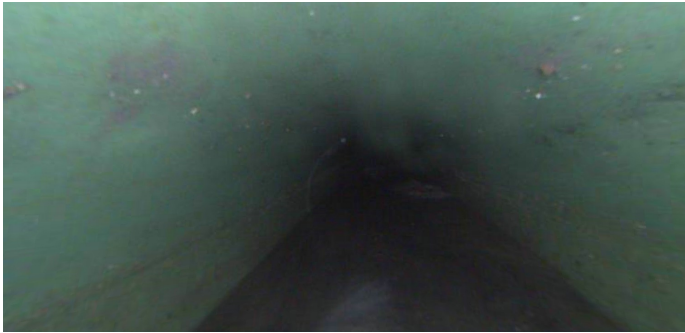
| Code: | MWL |
| Description: | Water Level |

| Value Percent: | 30.000 |

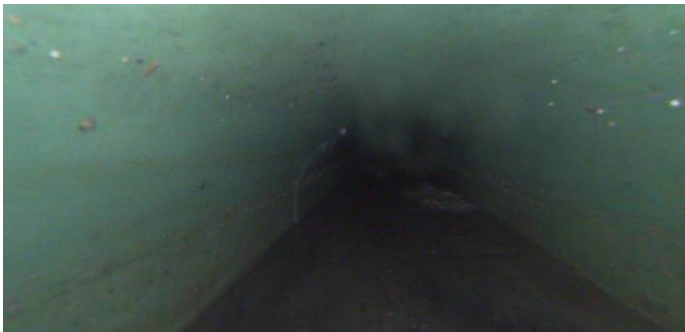
| Code: | MSA |
| Description: | Abandoned Survey |

| Distance (ft): | 1.3 |
| Remarks: | debris under water |
